# Solent Marine Heritage Assets: Defining, investigating, monitoring and reporting 2008-2011

## HMS *Invincible* Protected Wreck Site

March  
2010

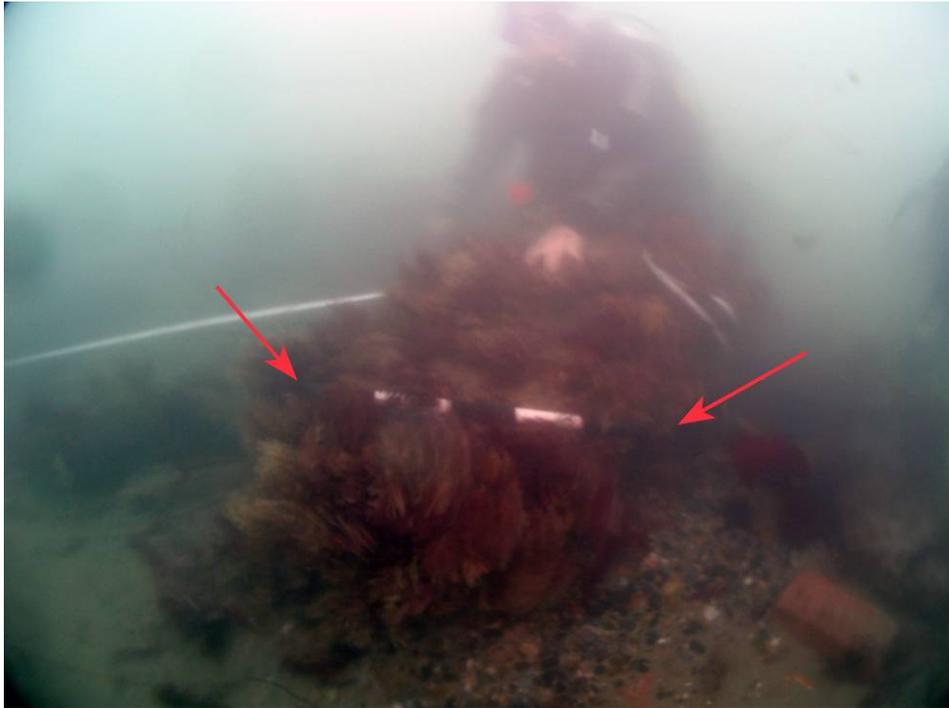
To the south east of the main wreck site, outboard of the stern, there appears to be more structure than has previously been recorded. The tape measure ran to the south east of the iron knee at the stern (Location 1) for 4 metres, and then around an iron concretion (Location 3) before continuing for another 8 metres to the south where elements of timber structure were observed. The measurement at the end of the tape was 12 metres (Location 4). The direct distance between the iron knee at the stern at Location 1, at the start of the tape measure, and the timber at 12 metre mark (Figure 4, Location 4) was 8 metres. The timber was heavily covered in weed, as visible in Figure 4.

*Figure 4 – Timber to south east of main wreck site (Location 4)  
(copyright HWTMA)*

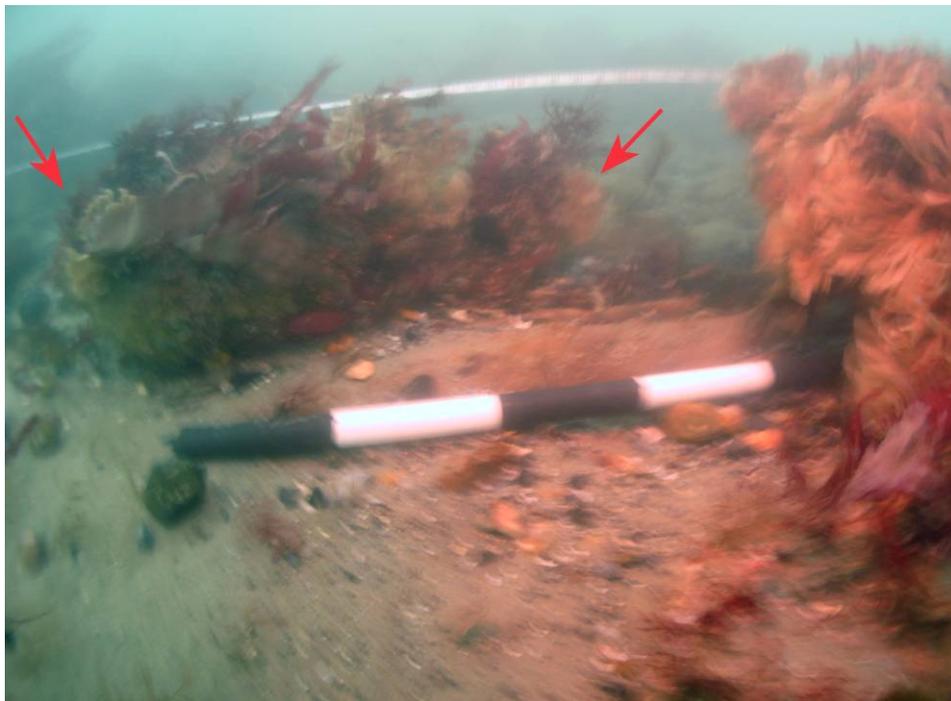
The timber appeared to be structural and was next to a concretion (Figure 5).

*Figure 5 – Concretion adjacent to timber south east of main wreck site (Location 4)  
(copyright HWTMA)*

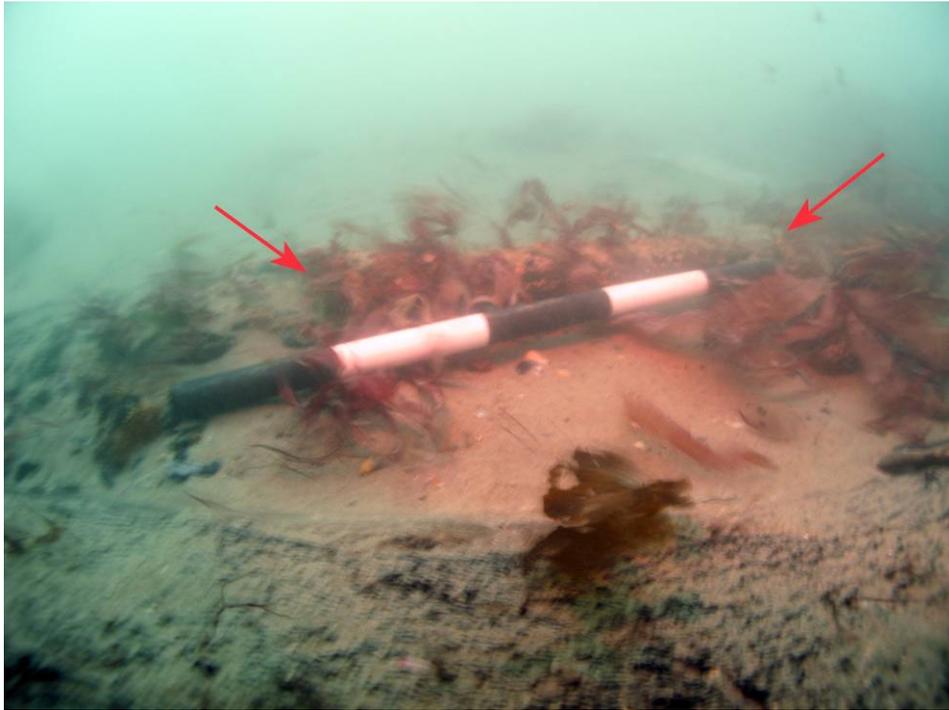
Close by lay an iron pipe concreted to the seabed, a possible future monitoring point for sand levels (Figure 6). Reels of cable/cordage were identified to the south of the concretion.

*Figure 6 – Iron pipe concreted to the seabed  
(copyright HWTMA)*

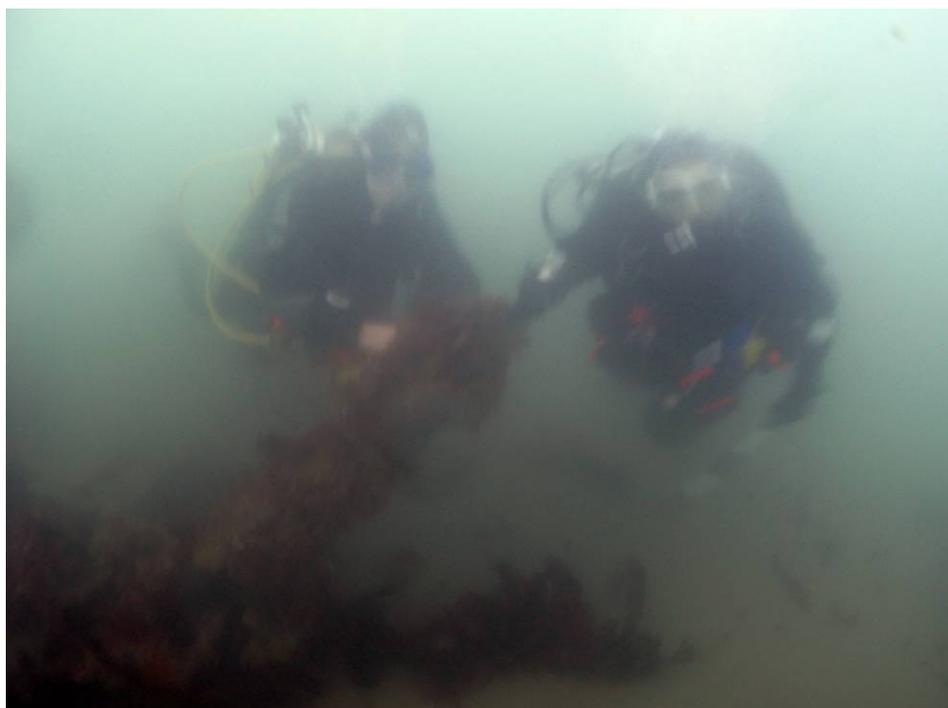
Directly to the north of the iron knee at the stern (Location 8) were three upstanding frames (Figure 7). Visible on the inside of one of the frames was an eroding iron bracket (Figure 8).

*Figure 7 – One of three upstanding frames at stern of wreck (Location 8)  
(copyright HWTMA)*

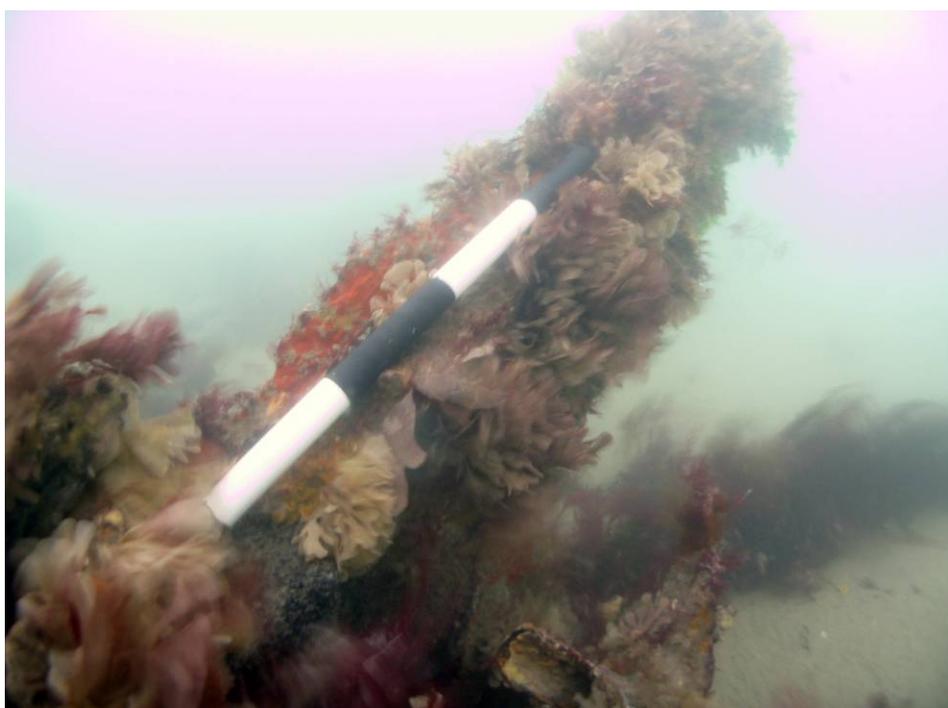
*Figure 8 – Eroding iron bracket on upstanding frame  
(copyright HWTMA)*

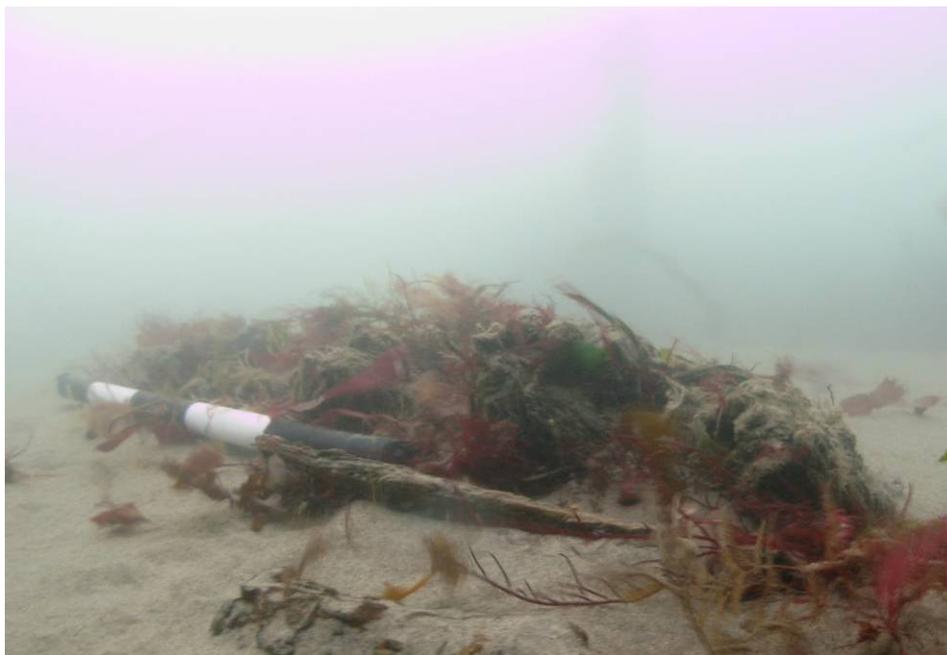
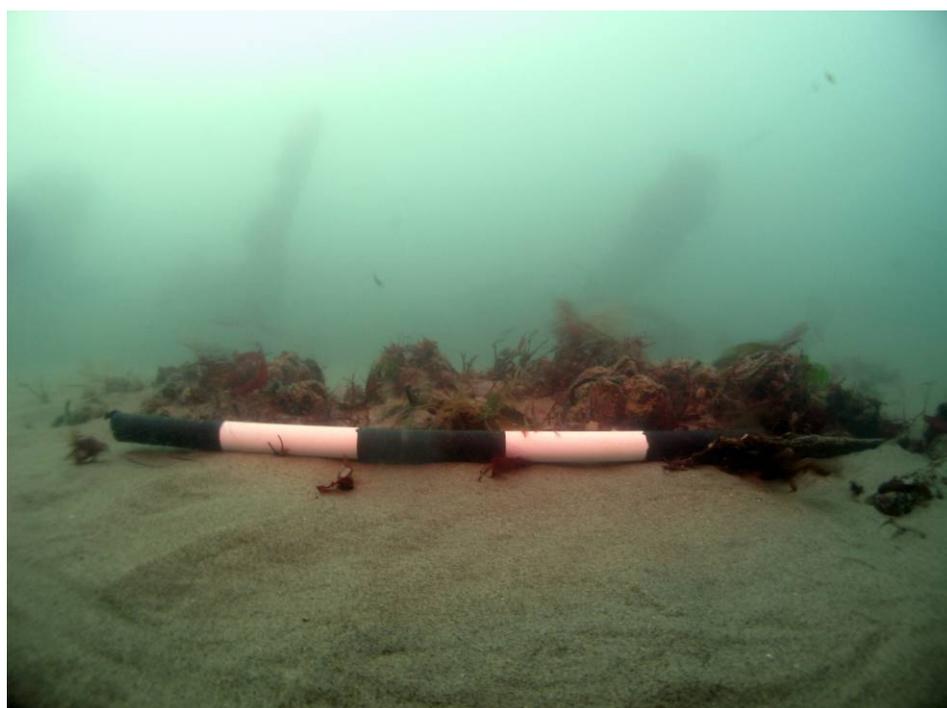
Moving directly south from the iron knee at Location 1, cordage/cable was identified protruding from the sand 4 metres to the south of the shot line at Location 1 (Figures 9 & 10, Location 9).

*Figure 9 – Cordage/cable protruding from the sand (Location 9)  
(copyright HWTMA)*

*Figure 10 – Cordage/cable protruding from the sand, upstanding frames at stern in background (Location 9)  
(copyright HWTMA)*

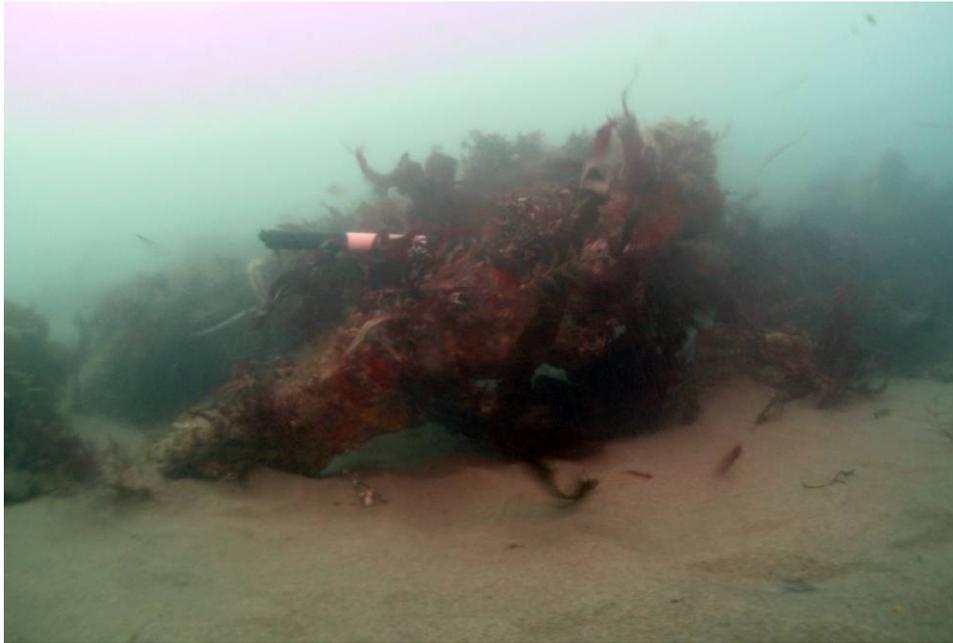
The baseline and associated tape measure ran the length of the wreck with exposed frames and planking visible along the entire distance. At the end of the baseline, 24.1 metres along the tape measure, lay the horizontal knees and associated timbers (Figure 11, Location 2).

*Figure 11 – Horizontal knees situated at the end of the baseline (Location 2)  
(copyright HWTMA)*

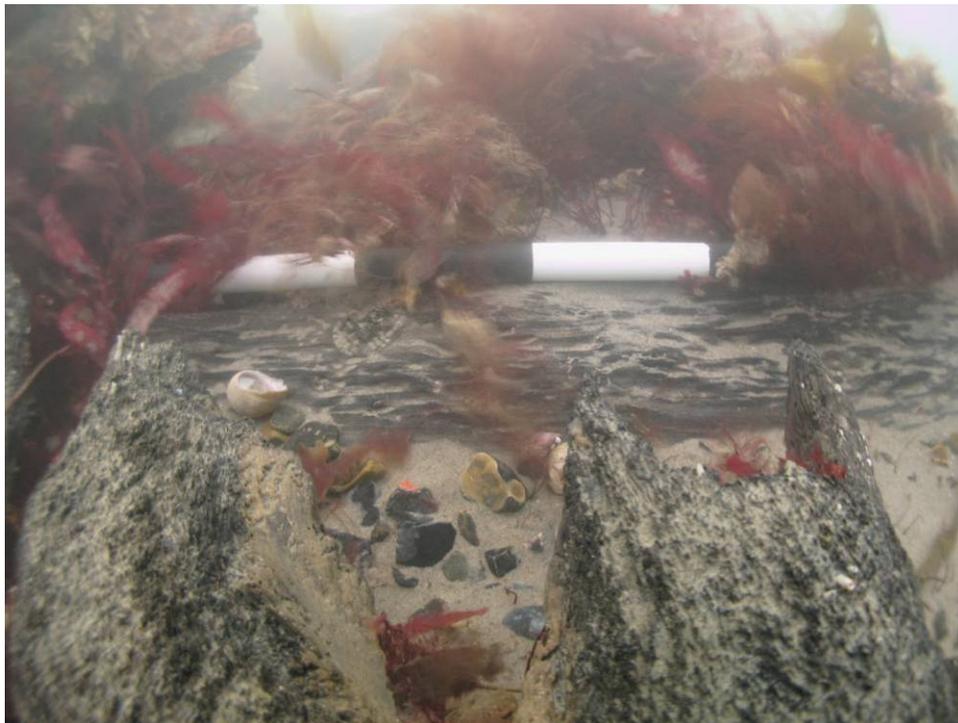
Immediately to the east at 23 metres along the baseline were planks with endings that had been subject to gribble attack (Figure 12, Location 10).

*Figure 12 – Plank endings subject to gribble attack (Location 10)  
(copyright HWTMA)*

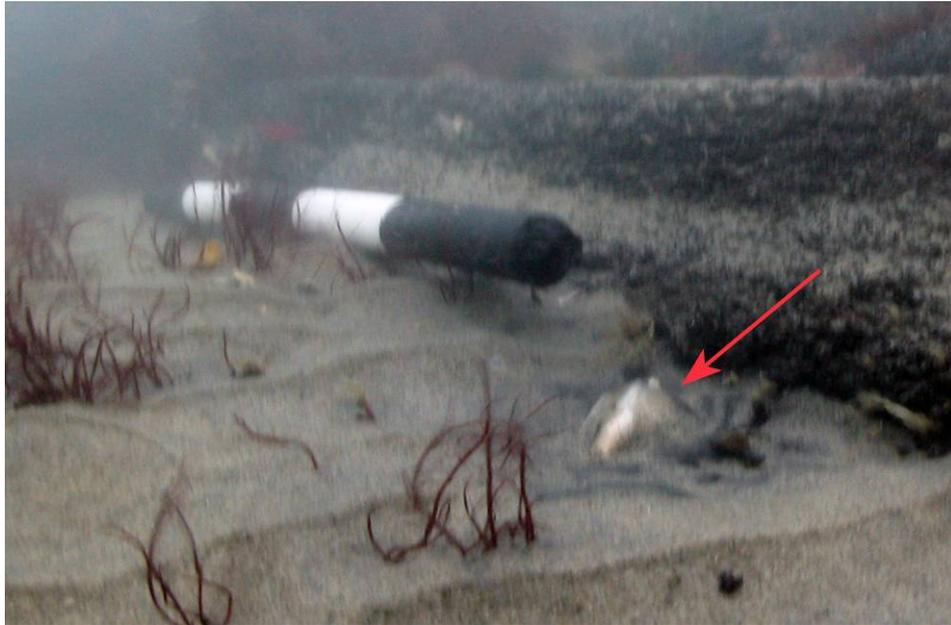
Whilst returning along the baseline towards the iron knee at the stern a tankard/jug was observed at 20.6 metres along the baseline (Location 11).

This was located in the sand immediately below the planking to the north east of the baseline (Figure 13).

*Figure 13 – Exposed tankard/jug (Location 11)  
(copyright HWTMA)*

The diver survey revealed that the HMS *Invincible* protected wreck site is relatively stable in terms of the structural remains extant on the seabed. These are subject to the degrading processes of seabed erosion and biological decay but there is limited alteration from season to season. Other objects recorded on the seabed are at higher risk, with vulnerable elements of cable/cordage observed deteriorating as they are revealed by seabed erosion. Smaller items such as the tankard/jug observed in the 2009 survey are at risk of removal through swell or tide.

Consideration must be given to the need to recover exposed artefacts at risk of loss. The gradual degradation of the seabed archive over time is resulting in the loss of information from this nationally important historic asset. Surface recovery provides for the positional recording of individual artefacts, which gives a broad understanding of their location within the ship. Although it should be noted that this course of action does not usually enable the full context of an artefact in relation to structural elements, contexts and deposits to be gained, as it would be during an excavation. All possible options should be explored for the organisation and funding of the recovery, documentation, conservation and archive deposition of vulnerable artefacts to ensure they are not lost.

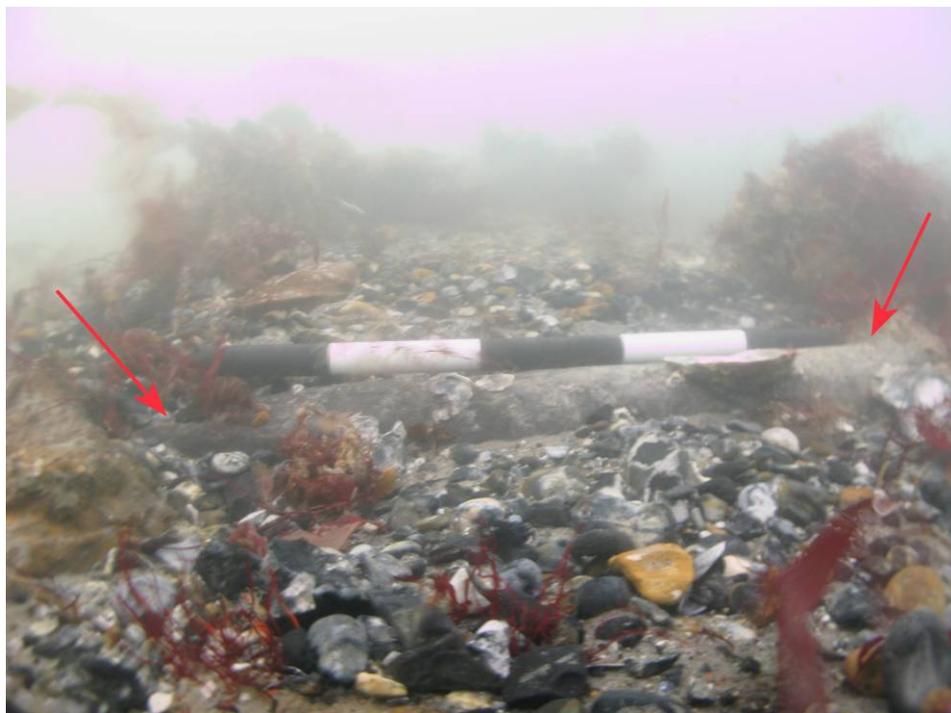
At 12 metres along the baseline a flanged lead pipe was identified. This could possibly make a good monitoring point for future dives (Figure 14, Location 12).

*Figure 14 – Flanged lead pipe (Location 12)  
(copyright HWTMA)*
