# Solent Maritime Heritage Assets

## The Fenna

### Site Assessment

September  
2010

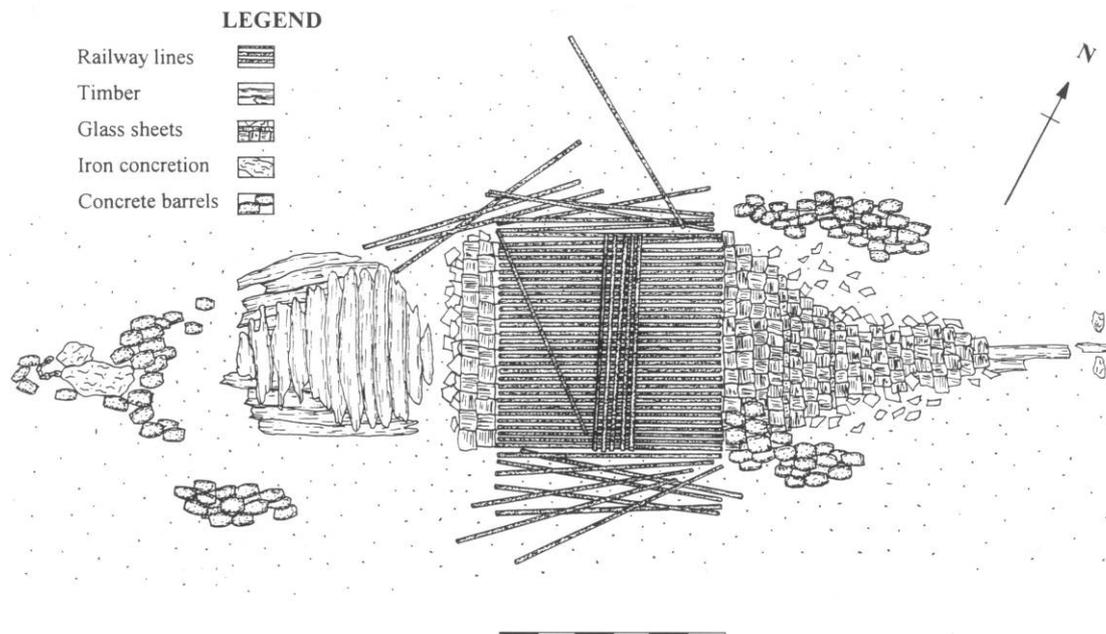
Figure 2. Provisional site plan of the shipwreck, recorded in 2002 by HWTMA, scale equals six metres.

The most striking feature of the remains is undoubtedly the cargo of the vessel, which even after deposition on the seafloor has retained its locational arrangement and contextual relationship within the vessel (Figure 2). The cargo rises 2.5 metres from the seafloor and consists of glass sheets (Figure 3) and iron (Figure 4). Recent diving has noted a mixture of artefacts overlying the cargo in the centre of the vessel. It is thought that these are remnants of the vessel's fixtures and fittings, rather than cargo remains (Mark James, pers.com.).

One obvious anomaly in the cargo remains is the large empty space in the forward half of the vessel, clearly visible in Figure 2. The heavy nature and good survival *in-situ* of the remaining cargo makes it unlikely that this area carried similar objects that have disappeared naturally. Two explanations may be offered. Firstly that a limited salvage of the vessel took place following its sinking. The reported presence of the vessel's masts above the sea as a navigational hazard would have made locating the vessel relatively simple. Secondly, the vessel may have also been carrying a cargo of perishable goods, that have since degraded, in this area of the hold. If the latter is the case, it is strange that such an item was not included in the list of goods given in the various historical sources relating to the site.

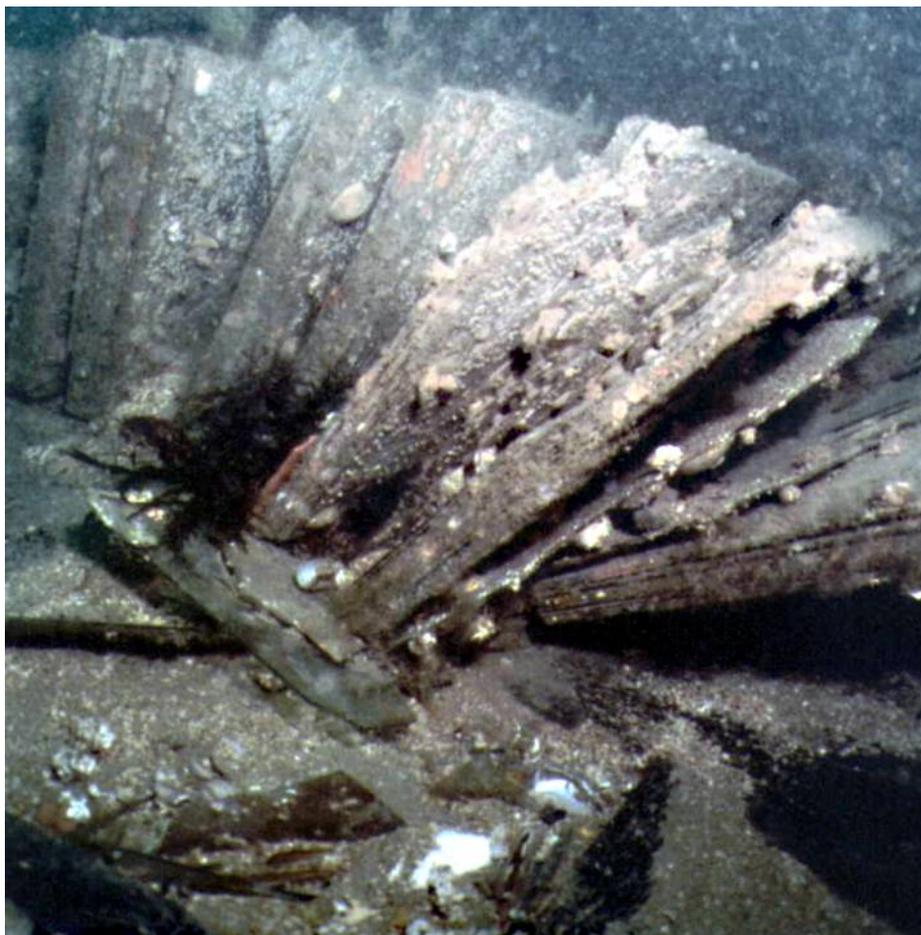
Figure 3. Glass sheets stacked up in the hold of the vessel.

The glass elements of the cargo comprise glass sheets, originally packed in boxes and stacked in the hold of the vessel. The packing boxes have degraded leaving the glass sheets still stacked in-situ. In all observed cases the glass sheets were stacked vertically on their edges.

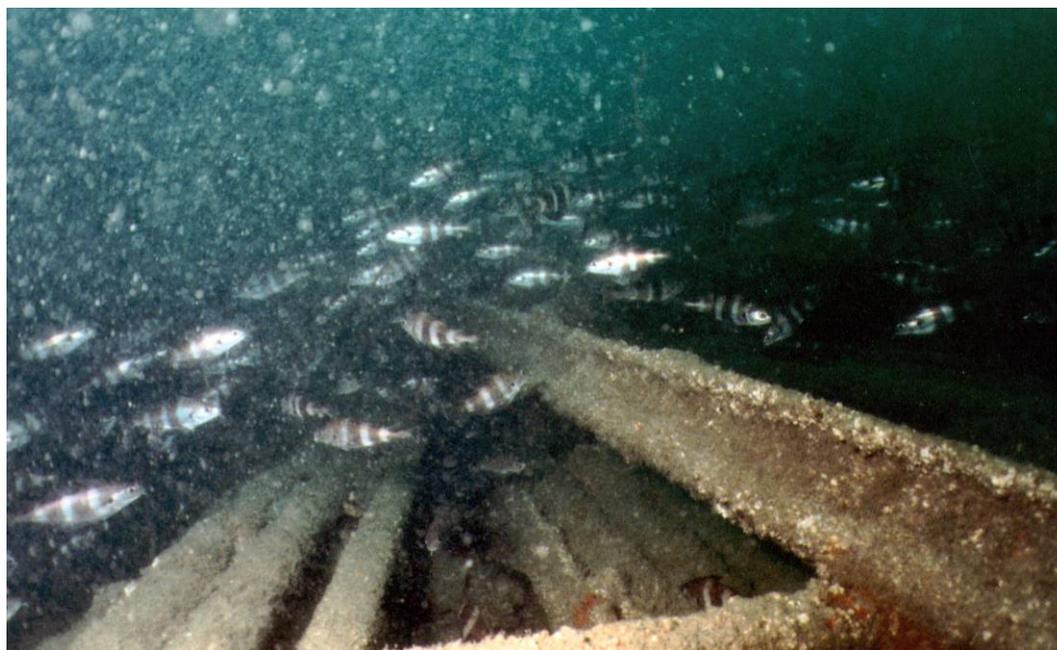
Figure 4. Iron bars/girders stacked in the midships area of the vessel.

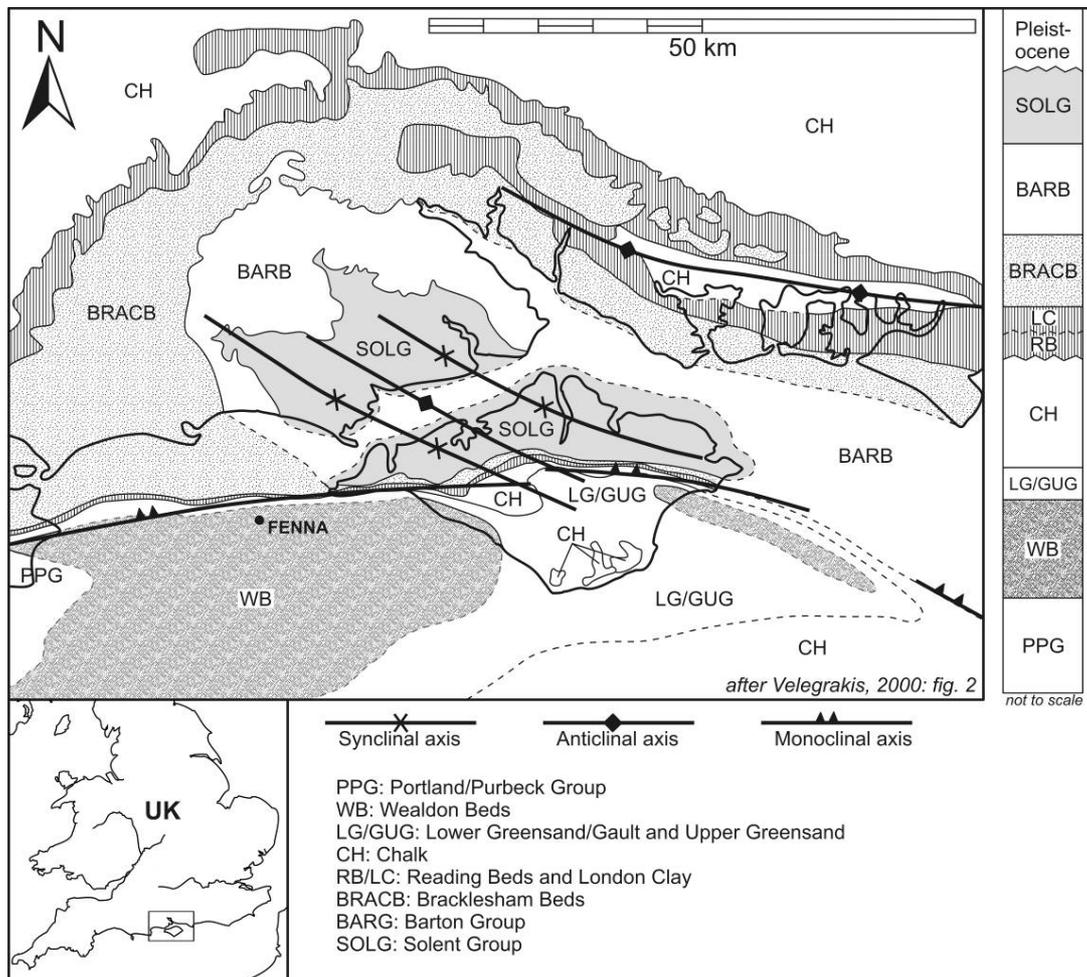
Figure 5. Overview of the underlying geology of the shipwreck site under assessment, marked as the *Fenna* (after Velegrakis 2000: fig. 2).

The immediate seabed around the wreck site is flat and level, comprising a mixture of sand and gravel (as might be expected from the preceding discussion). This is poorly sorted and composed of 50-60% gravel and 40-50% sand. The sediment movement and tidal/wave regime does not seem to be impacting upon the wreck. The hydrographic echosounder survey of the site in June 1988 noted that there was no scour around the wreck (NMR Monument Report, ID 832528). Comparable surveys by Mr Wendes, conducted using a side-scan sonar unit, since 2000 also indicate that there is no scour around the wreck. This has been confirmed during diving on the site undertaken by the HWTMA. The site does not appear to have been subject to either sediment loss or accumulation during the past twenty-two years.
