Netley Pier

*Archaeological
Fieldwork Report*

**Netley Pier
Archaeological Fieldwork Report**

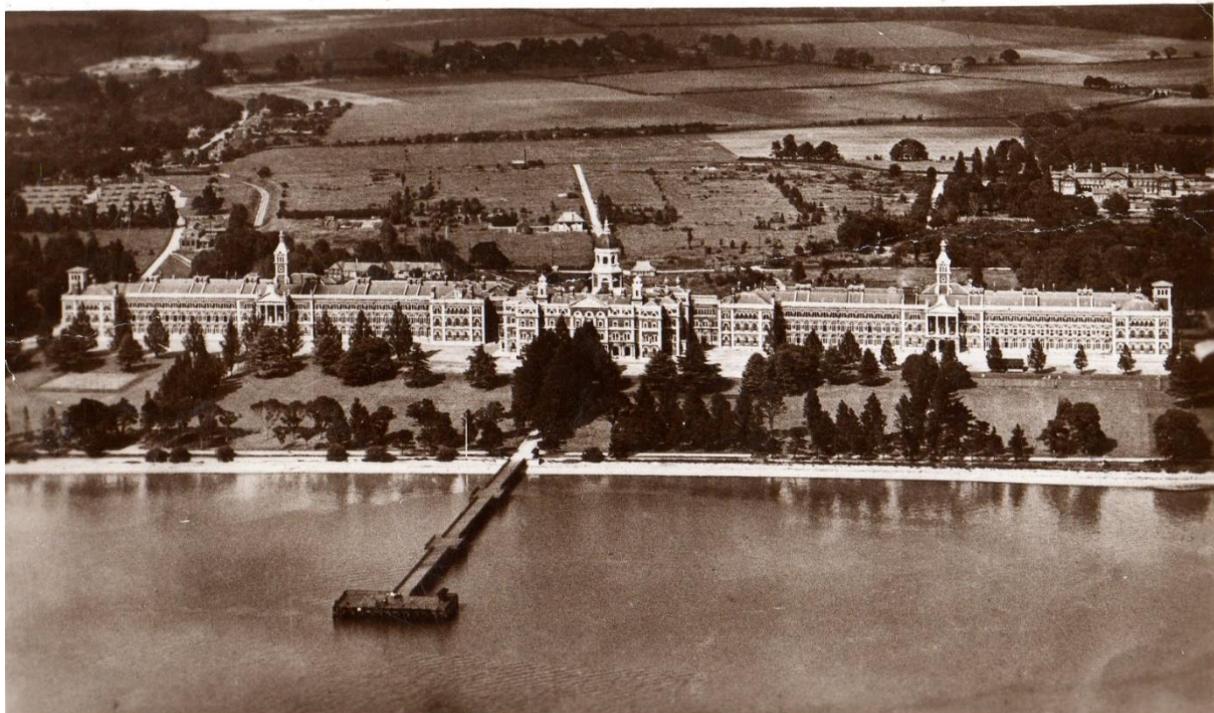
655

Figure 2. Postcard showing Royal Victoria Hospital and its pier at high water. The date is unknown, but the lack of a tented hospital to the rear of the main building indicates that it is not during either of the World Wars (copyright unknown).

Netley Pier was chosen as one of the Forgotten Wrecks coastal case study sites as it represents a pier structure constructed for the dedicated role of serving the monumental, purpose-built, Royal Victoria Military Hospital. The hospital and its pier (Figure 2) were both in use prior to, throughout, and after, the First World War. Additionally, the relatively benign intertidal conditions afford the opportunity to use it as a volunteer training site.

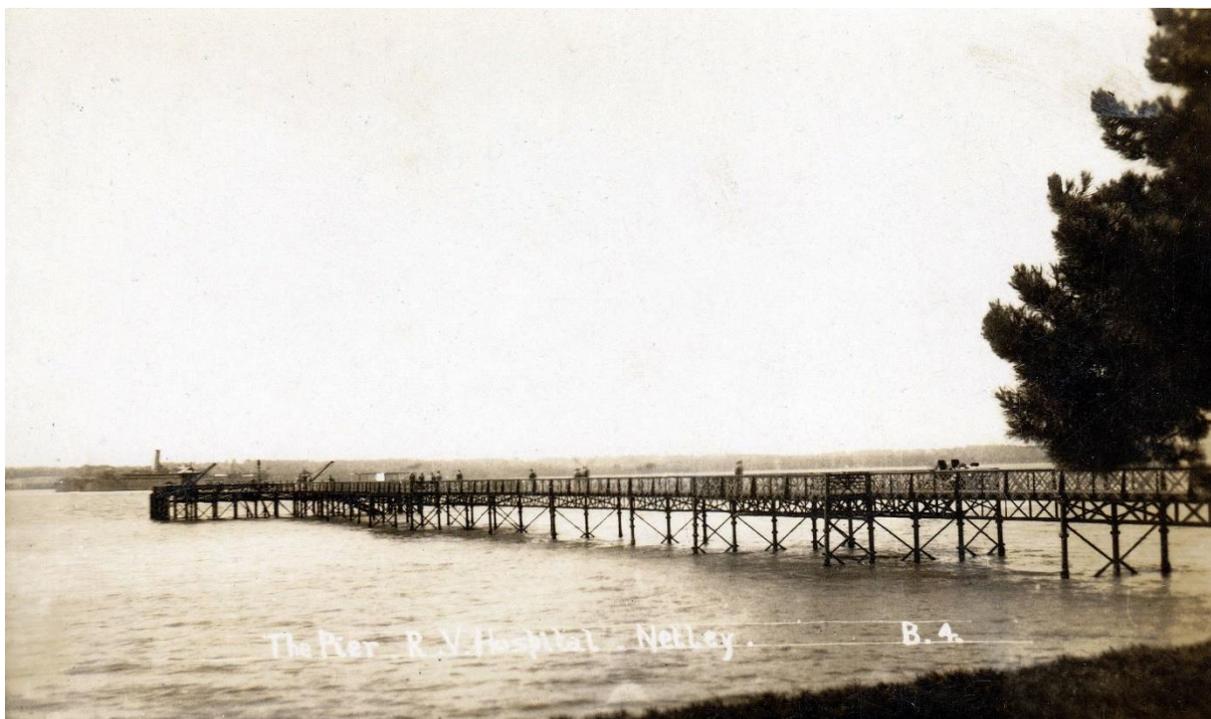
Figure 3. Historical postcard of Netley Pier, date unknown, showing a rare view of the pier as viewed from the shore, rather than looking towards the main hospital building. The cranes and boarding steps are visible at the pierhead, while in the distance a liner passes down Southampton Water.

The hospital pier itself (Figure 3) was opened in 1864/5, having been designed and constructed by Eugenius Birch, a noted Victorian pier engineer, and utilising cast-iron screwpile construction (Hoare, 2002: 115). It replaced the original temporary wooden pier known as the 'Queen's stairs' that was used by Queen Victoria when laying the foundation stone in 1856. The hospital pier was presumably intended as the point at which wounded troops could be disembarked from ships directly onto the hospital site. But, the pier was never built to the length required to reach the deep-water channel in Southampton Water and so transfer by smaller vessels of shallower draught was required (Fairman, 1984: 17). Hoare observes (2002: 115) that the pier was only ever built to half (560') the length originally planned. An original length of 1200' was reported by the *Hampshire Independent* in an article on the construction work at the hospital on 1st December 1860. The resulting transfer problem led to the construction of a purpose built vessel called the *Florence Nightingale* that could access the pier at low tide (Hoare, 2002: 115-6).

The overall nature of the construction can be discerned from historic photographs (e.g. Figure 3 and 4) which indicate that the main groups of iron piles, termed 'bents', were laterally placed in groups of three with additional diagonal cross-bracing running from the upper and lower ends of the outer piles, to the centre of the middle pile. The two rectangular bays were supported by an additional pile at each corner, making for a bent comprising five piles at the seaward and landward end of each bay. Photographs of troops convalescing on the pier during the First World War indicate a balustrade running around the edge of the pier, in-filled with diagonal cross-bracing and a small diagonal lattice work for further security.

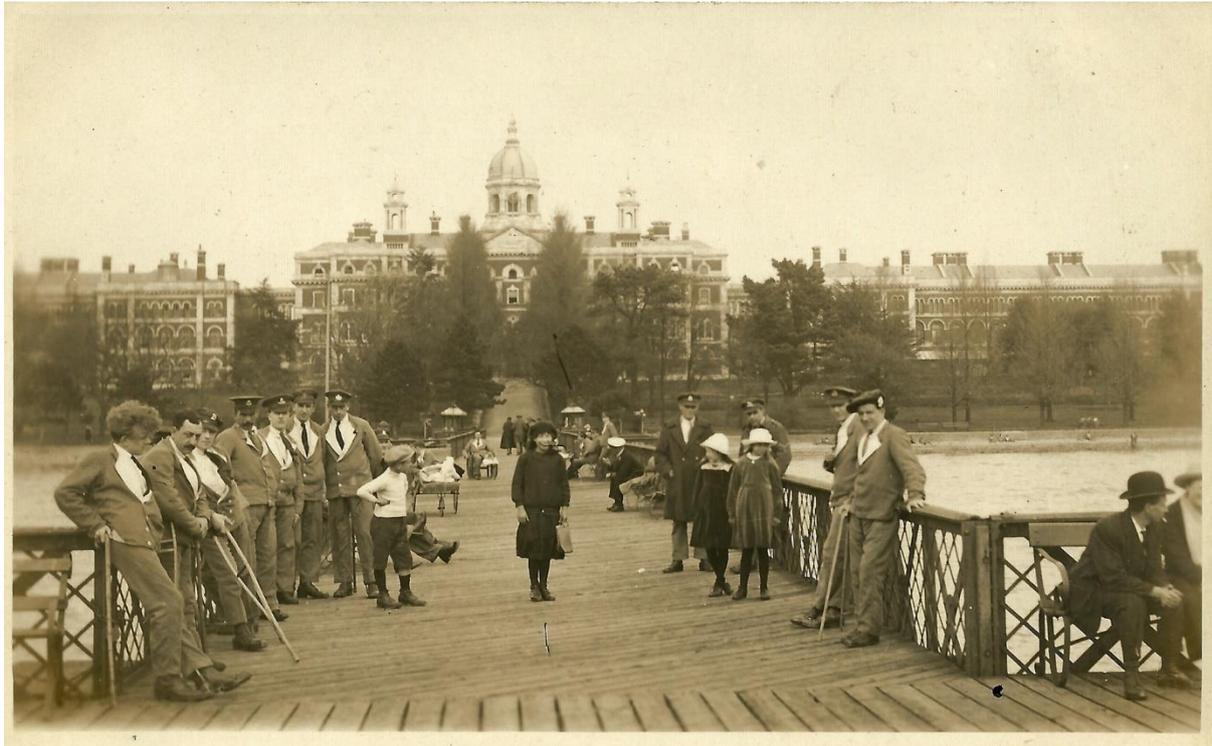
Figure 4. Hospital patients convalescing on the pier during the First World War (Image copyright: Marion Ivey).

The wooden planked deck of the pier's main walkway and bays is shown in images dating to the First World War as being diagonally laid at an angle of about 45 degrees to the central axis of the pier (Figure 4). The pierhead itself has deck planking laid in-line with the central axis. The diagonal decking of the main walkway can be identified as a replacement, given that in-line planking can be seen in an earlier photograph dating to the 1870s. On this basis at least one alteration/repair to the pier can be identified from the available historical photos in the form of replacement of in-line planking with diagonally laid planks on the main walkway by the time of the First World War.

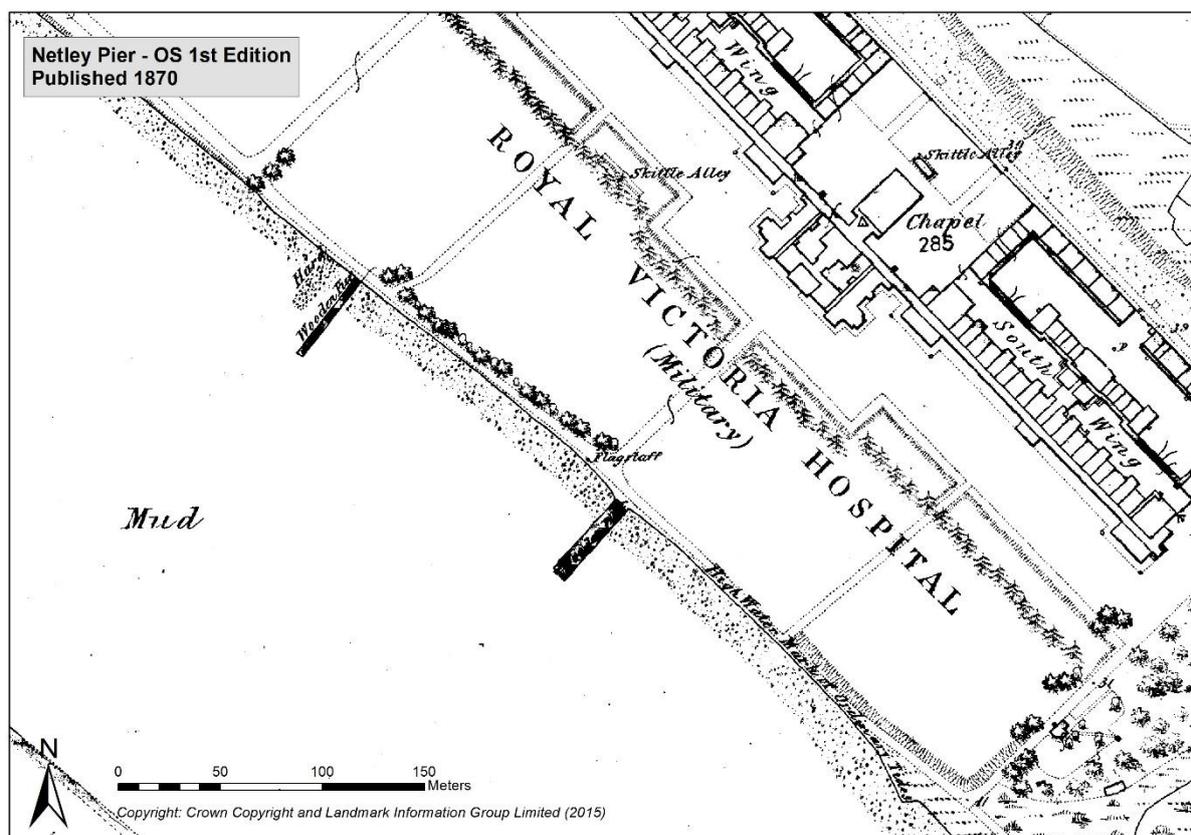
Figure 5. First Edition OS map, published in 1870, showing the wooden landing stages on the foreshore in front of the main hospital building (Copyright: Crown Copyright and Landmark Information Group 2015).

The earliest historic Ordnance Survey (OS) map of the area is the first edition OS map published in 1870 which shows the main hospital building but not the pier (Figure 5). Instead, a pair of wooden landing stages are shown on the foreshore in front of the hospital, one of which is directly adjacent to the location subsequently occupied by the pier, and a second a short distance to the northwest. Although the publication date of the map is 1870, the absence of the pier, despite its well documented completion in 1865 indicates that the actual OS survey for the area for the first edition was conducted prior to 1865.

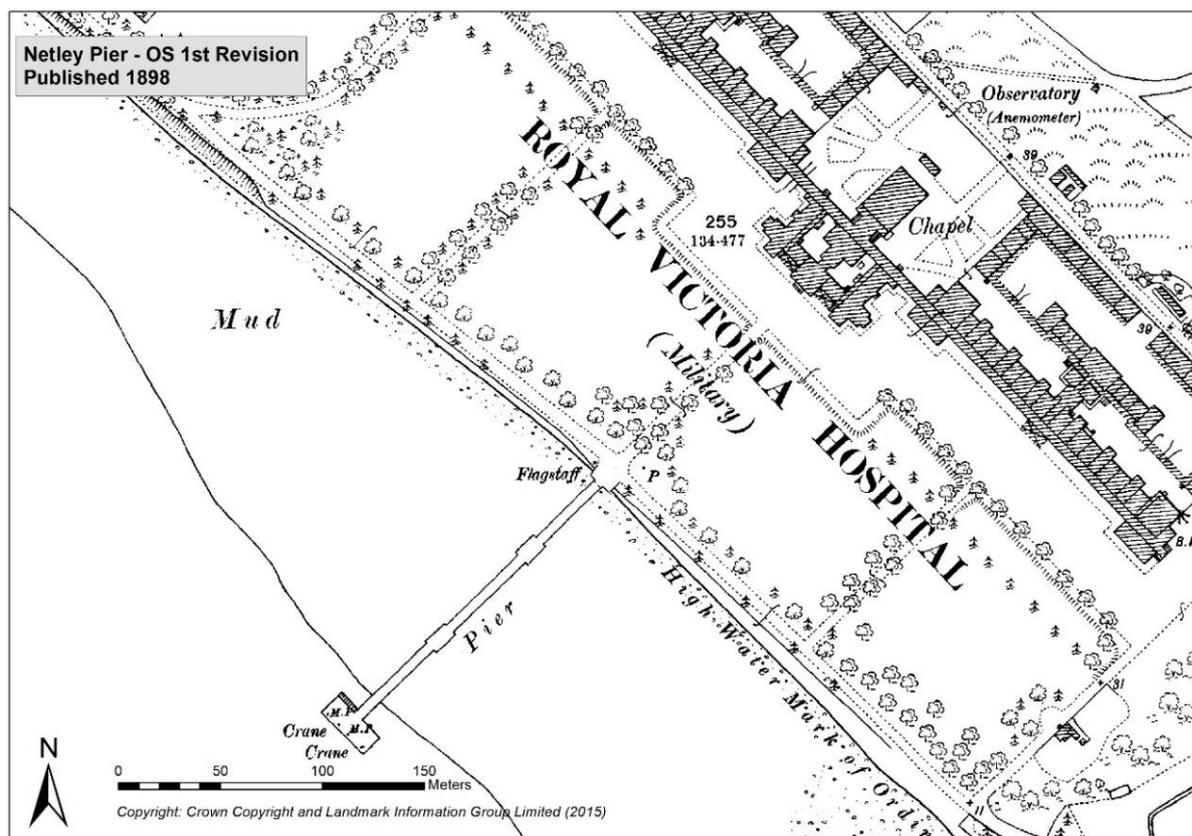
Figure 6. First Revision OS map, published in 1898, showing the disposition of the iron pier on the foreshore in front of the main hospital building (Copyright: Crown Copyright and Landmark Information Group 2015).

The following first revision to the OS mapping was published in 1898 (Figure 6) and illustrates the pier in its completed form which correlates with the available historical photos (e.g. Figure 2). The wooden landing stages shown in the 1870 map are now absent, presumably indicating their dismantling or destruction following the construction of the main pier. Measurements taken from the 1898 map illustrate that the pier was originally built to a total length of 572' (174m). The main walkway of the pier was 16.5' (5m) wide, finishing in a rectangular pierhead 94.5' (28.8m) in length and 38.5' (11.7m) in width, set perpendicular to the pier. A flight of steps along the north-eastern side of the pierhead, and a pair of cranes on the seaward side (the southwest) are also indicated. At one-third and two-thirds along the length of the pier were two rectangular bays set in-line with the main walkway and

measuring 42' (12.8m) long and 30' (9.1m) wide. Subsequent OS maps published in 1909 (2nd Revision) and 1939 (3rd Revision) show the same overall disposition to the pier.

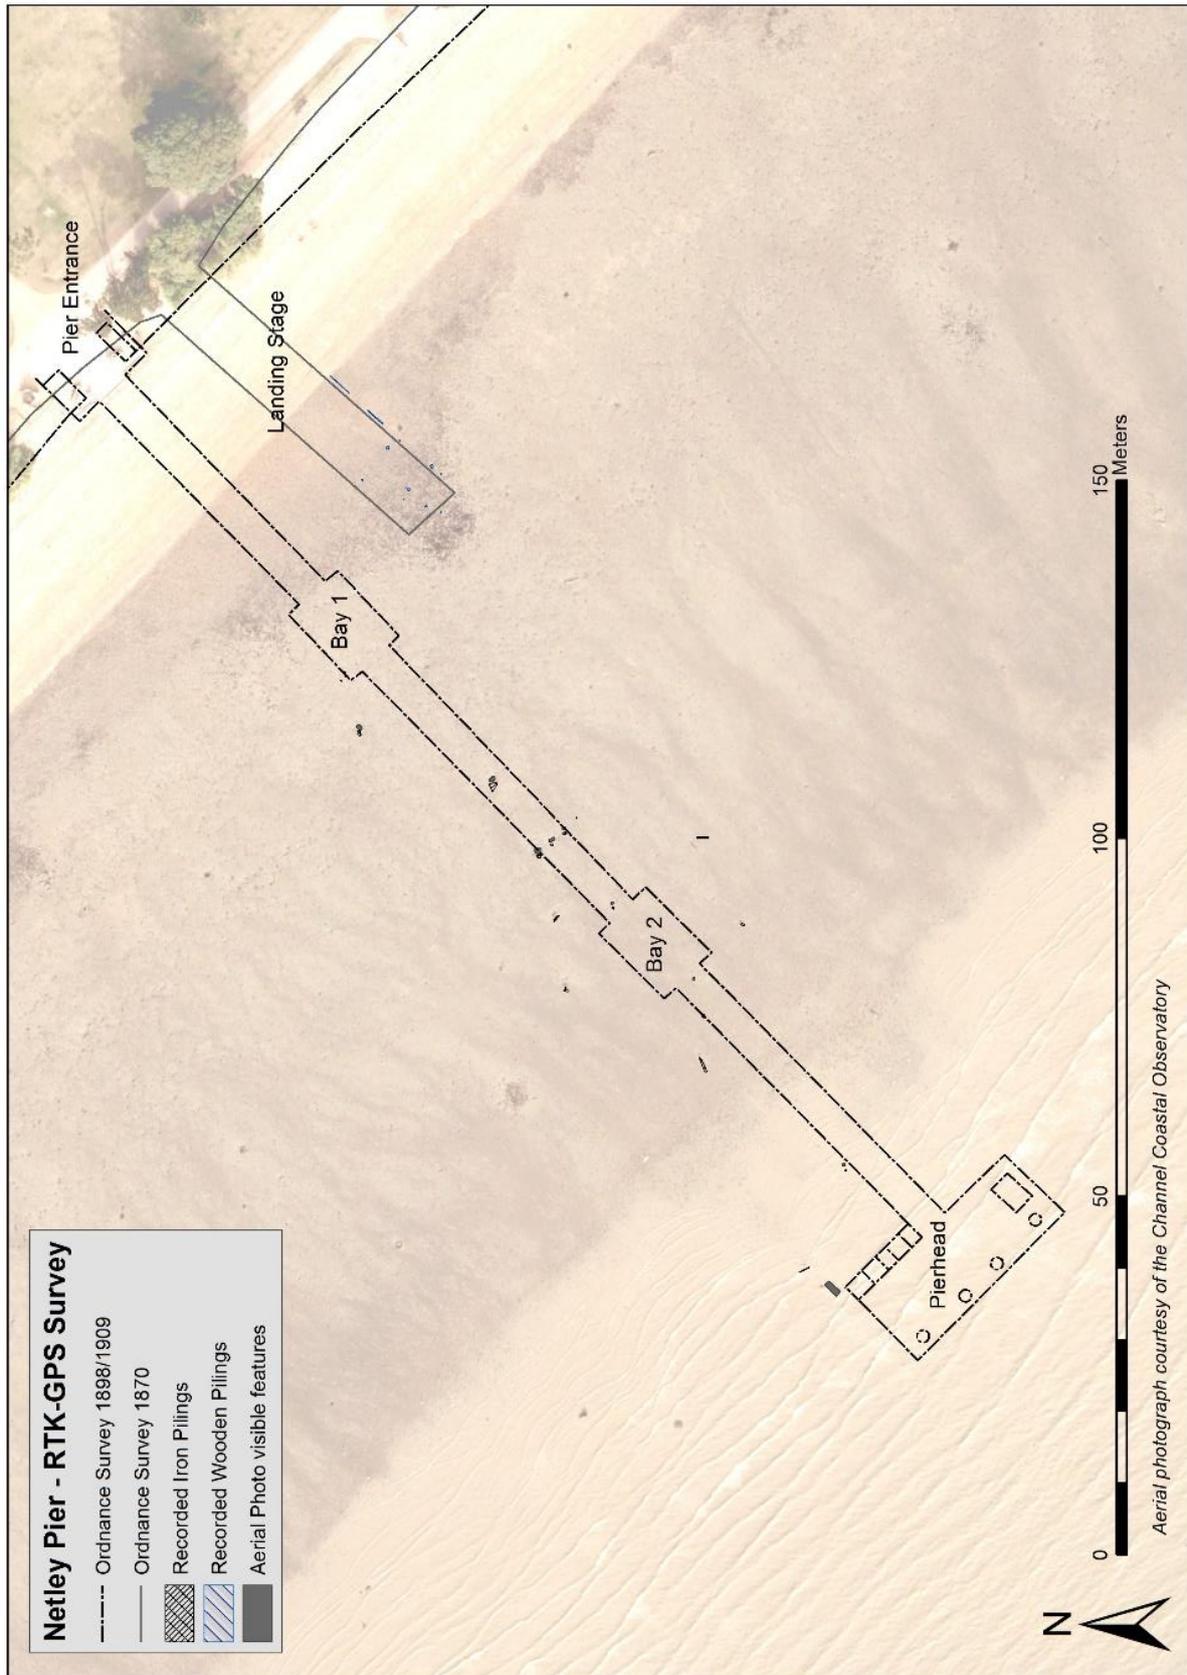
Figure 7. Combined RTK-GPS survey, historically derived disposition of structures and modern aerial photographs (Aerial photographs courtesy of the Channel Coastal Observatory).

The RTK-GPS survey was successful in recording the locations of the extant structural remains relating to the main pier, and the earlier wooden landing stage identified during the DBA work. The locations of these features correlate to the outlines of both pier and wooden landing stage that were extracted from the historical mapping during the DBA work, as shown in Figure 7.

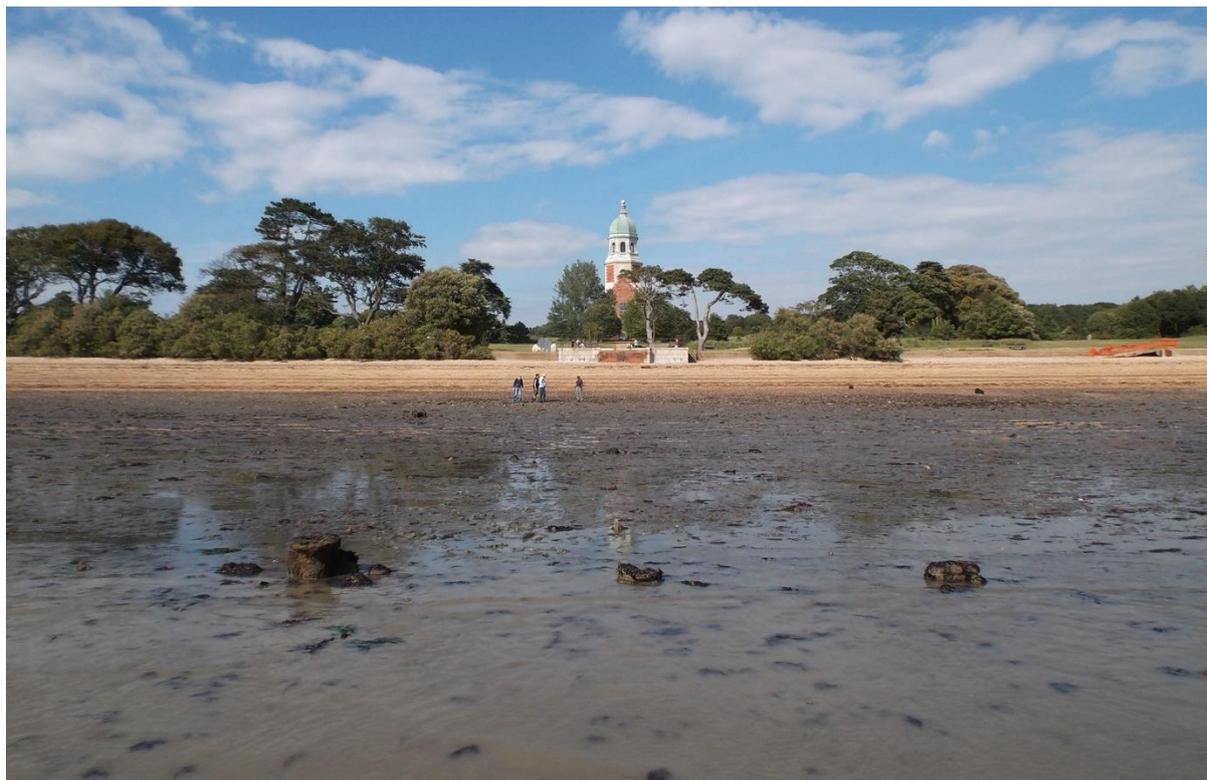
Figure 8. View from the water's edge north-east towards the pier entrance along the central axis of the pier. A complete bent of pilings is visible in the foreground with a spacing of eight foot between piles.

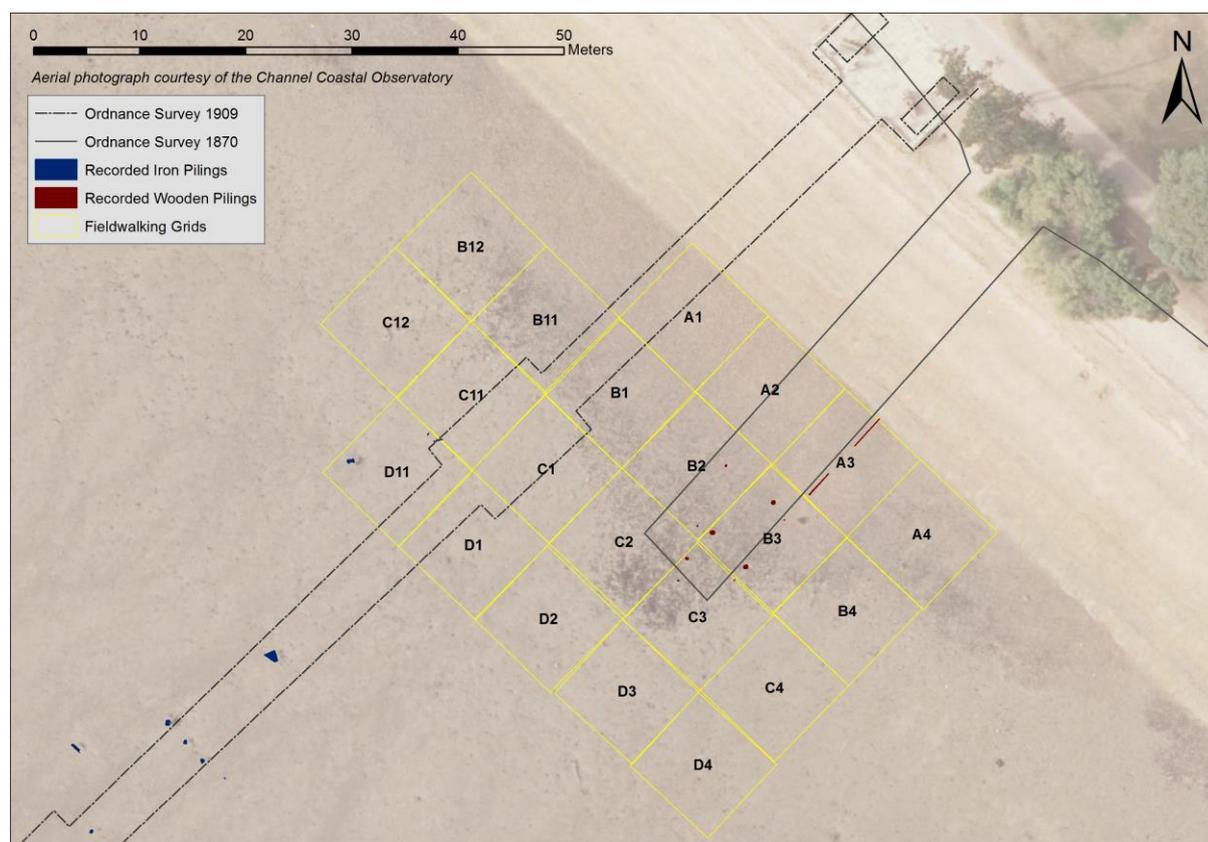
Figure 9. Distribution of fieldwalking grids across the site. Grid IDs are given in the centre of each grid square.

Fieldwalking was undertaken by volunteers across a total of twenty-one 10m² grid squares that straddled the main debris field identified during the initial site visit (Figure 9). The overall results for each material type within each grid square are provided in Table 1. A small number of artefacts were recovered as a result of the fieldwalking and these are presented and discussed in Section 4.4. As noted in Section 3.2 material was simply recorded by type, e.g. brick, rubble, slate, etc. It is possible to provide further information on what each of these material classes represents in the context of their presence on the site.

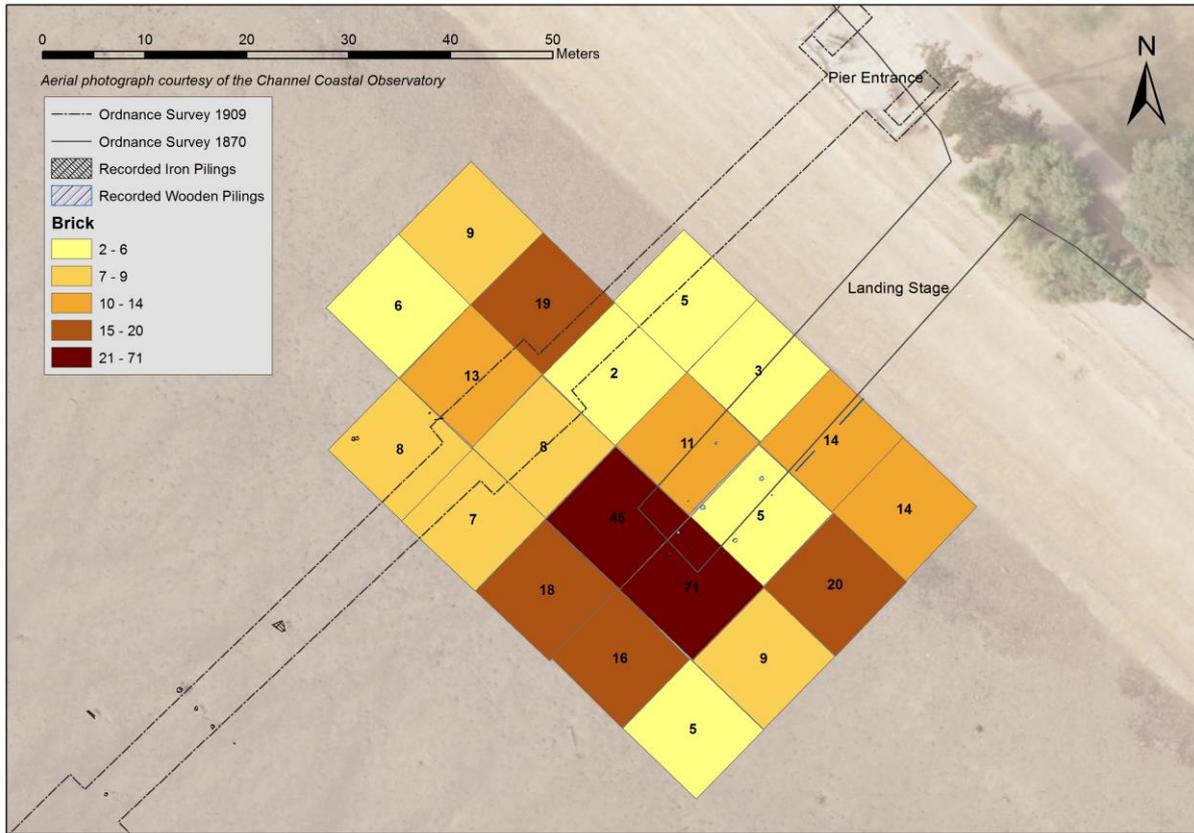
Figure 10. Recorded distribution of brick across the site.

In the majority of grid squares, very low levels of material were recorded, reflecting the initial impression of the site that only limited archaeological material remained. As a result of this, detailed statistical or graphical examination of the distribution of material is difficult because of the low numbers of many types of material class. But, some notable concentrations of brick, slate and general rubble identified, and these are illustrated in Figures 10 to 12. Of these, significant quantities of brick and slate were located at the southwest end of the wooden landing pier with a further smaller quantity to the northeast of Bay 1 on the iron pier. Both these locations, and the area between them also contained significant quantities of general building rubble that spreads across the southwestern side of the gridded area.

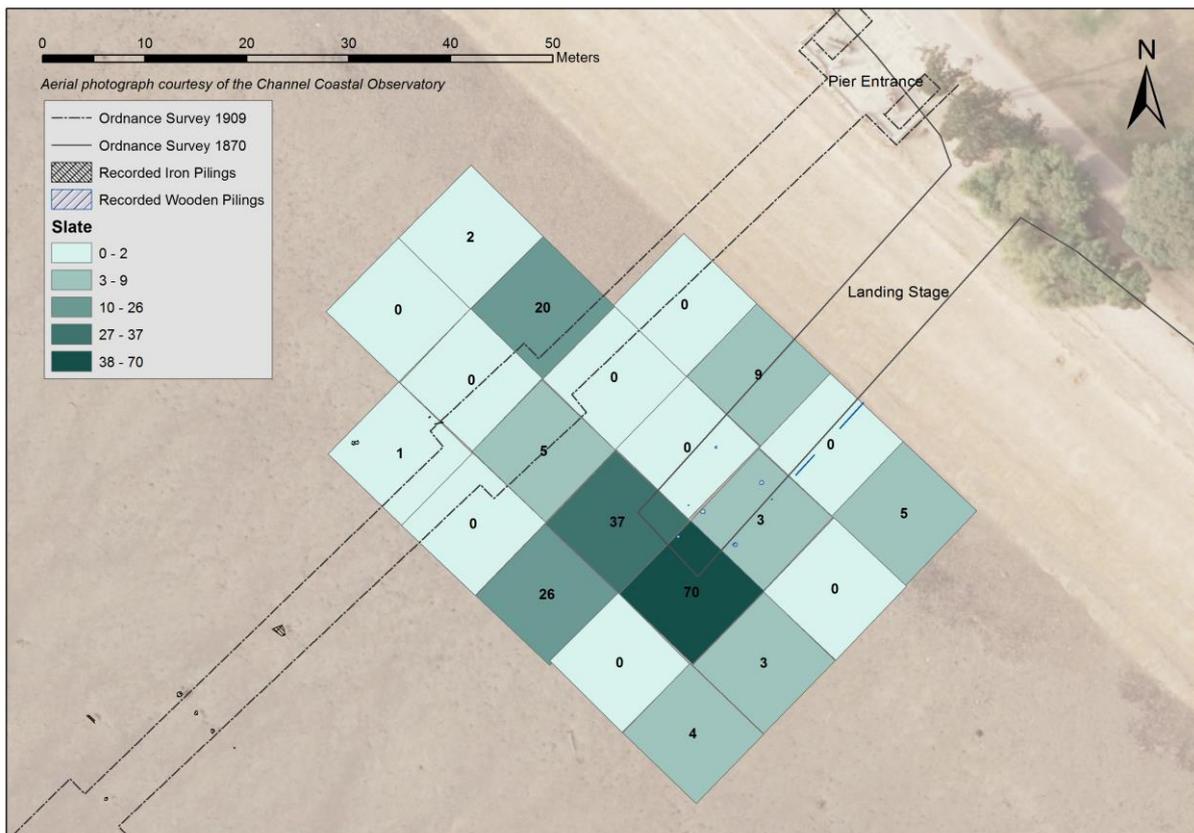
Figure 11. Recorded distribution of slate across the site.

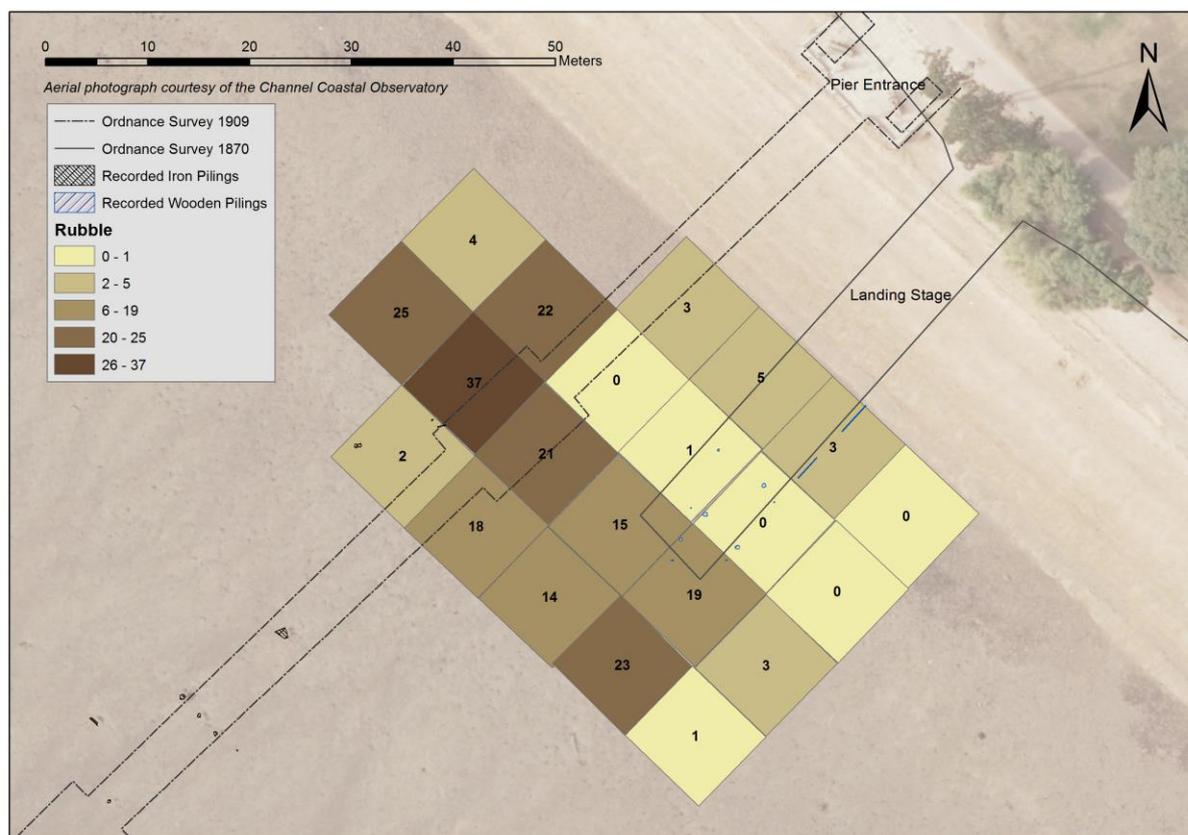
Figure 12. Recorded distribution of rubble across the site.

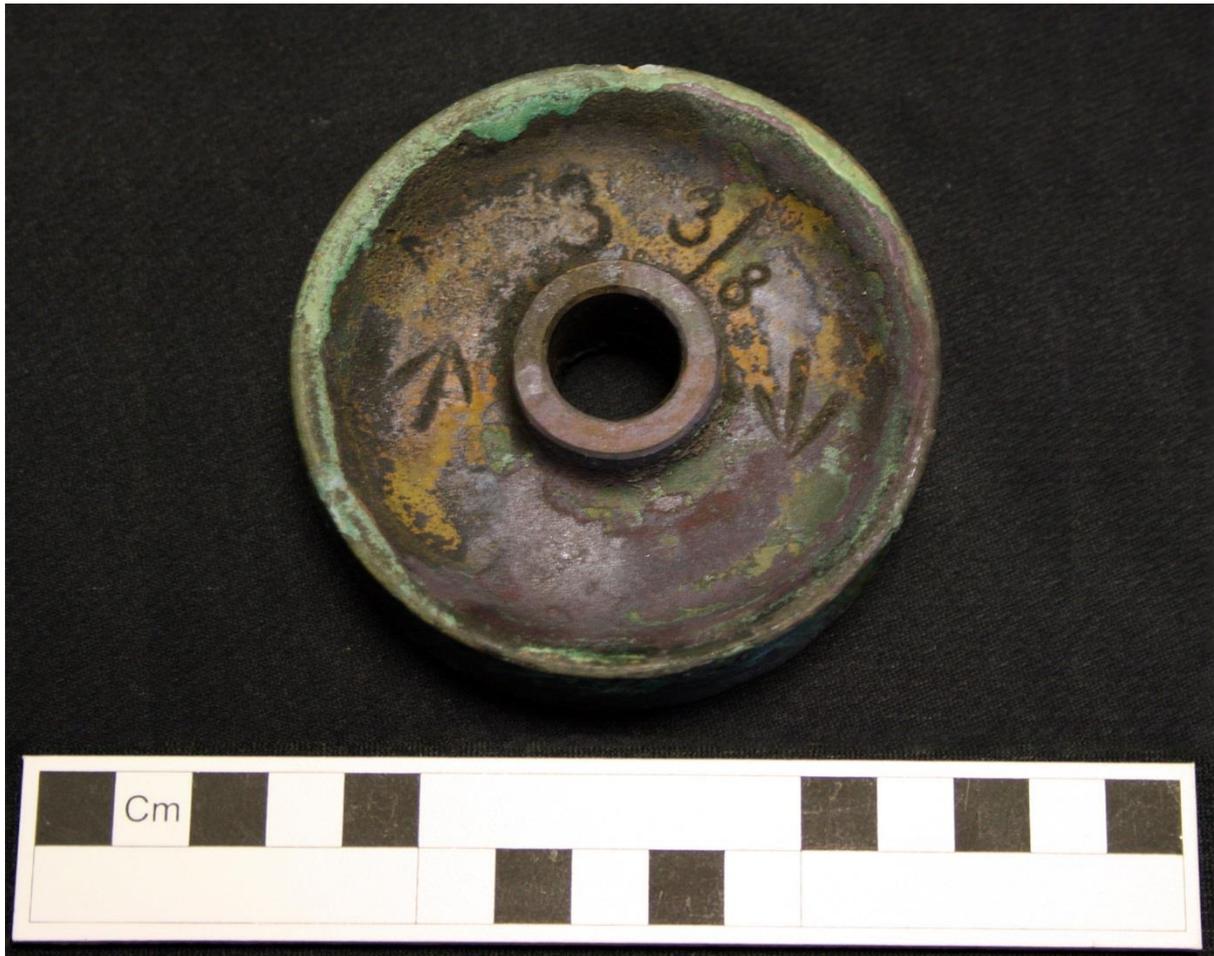
Figure 13. Brass sheave (pulley wheel) stamped with a broad arrow and diameter markings.

Of the recovered artefacts, three are potentially diagnostic; the two smoking-pipe bowls and the brass sheave. The latter (FWNP008, Figure 13) is stamped with a broad arrow indicative of ownership by the Crown and/or British military, including institutions such as the Royal Navy, War Department, etc. and it is also marked with its diameter in inches ($3\frac{3}{8}$). The date of the sheave cannot be securely placed on this information alone, but it is certainly compatible with the construction and use of the hospital and pier from the mid-19th century onwards. Likewise, its broad arrow stamp correlates with the military origins of Royal Victoria Hospital. Potentially, the sheave could originate from one of the cranes located at the pierhead, but its small, mobile nature means that this is far from certain.

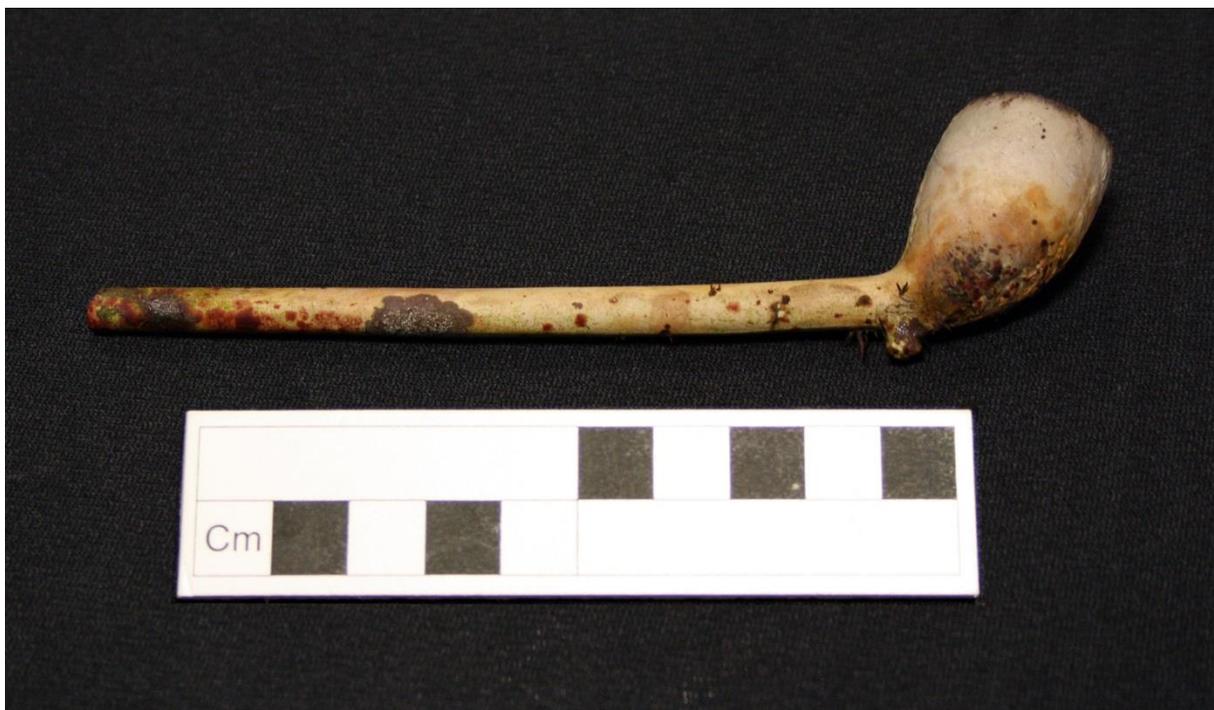
Figure 14. Clay smoking pipe bowl and partial stem, possibly discarded during the construction phase of the hospital and pier. Oak leaf decoration is visible on the outer side of the bowl, running between the bowl rim and the pipe heel.

The two smoking-pipe bowls offer contrasting potential dates. The older of the two (FWNP007, Figure 14) is of conventional clay manufacture with a bowl shape fitting the period 1820-1850 as set out by Noël Hume (2001: 303) in relation to English clay tobacco pipes. The mould-lines on the pipe-bowl are obscured by two runs of oak leaf decoration which, along with the bowl shape, have parallels in the 1850s (e.g. Beckey, 2014: fig. 2, nos 3-7). The shape of the pipe bowl and its decoration are therefore both compatible with a date during the initial construction of the hospital and pier during the 1850s and early 1860s.
