# LCT(A) 2428

An Assessment  
for Scheduling in  
the Marine Zone

Project Report

# LCT(A) 2428: An Assessment for Scheduling in the Marine Zone

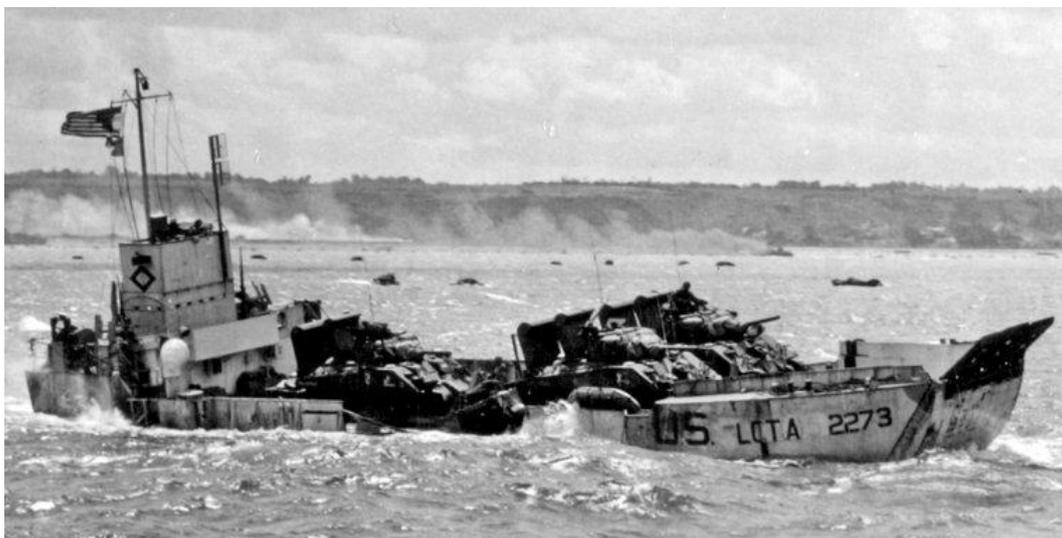
Figure 2.1. LCT(A) 2237 of the US Gunfire Support Group off Omaha Beach on D-Day, the vessel is carrying two Sherman tanks in the firing position with a tank-bulldozer behind them (Source: Robert Hurst, via [www.navsourc.org](http://www.navsourc.org)).

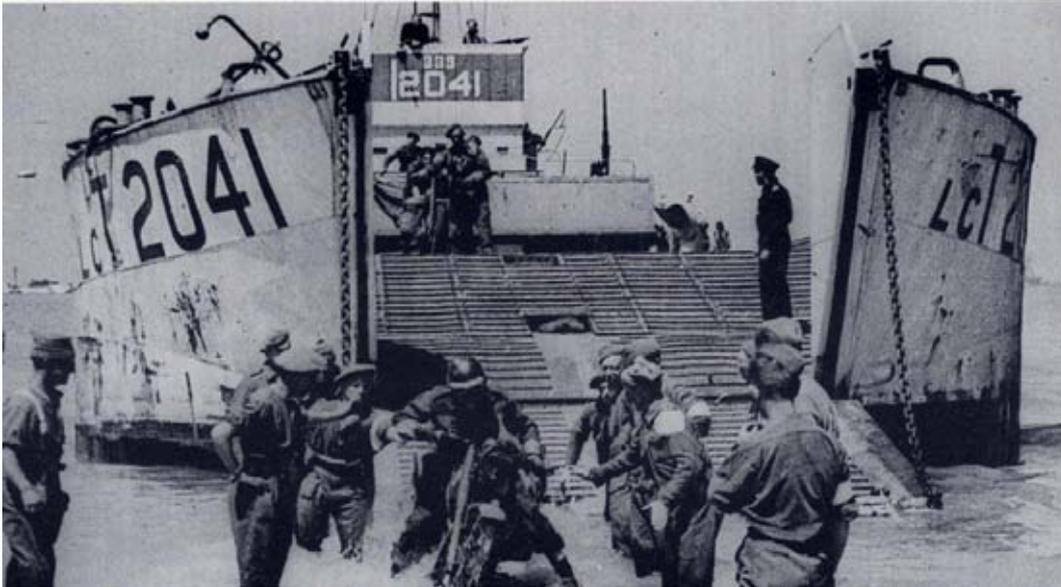
Figure 2.2. LCT(CB) 2041 ashore, Norman Vingoe can be seen on the right hand side of the bow ramp (Source: Landing Craft Veterans' Association).

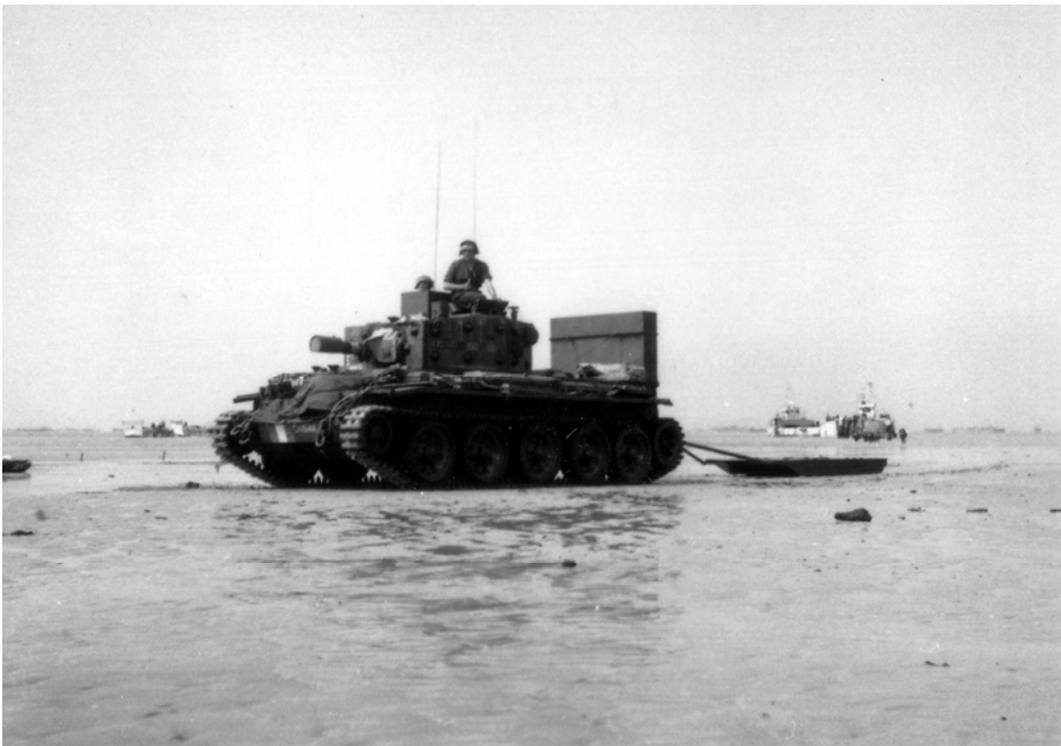
Figure 2.3. Canadian Centaur CSIV Tank on the beach at Courseulles, Normandy, towing a porpoise ammunition sled (Source: Conseil Régional de Basse-Normandie/National Archives of Canada).

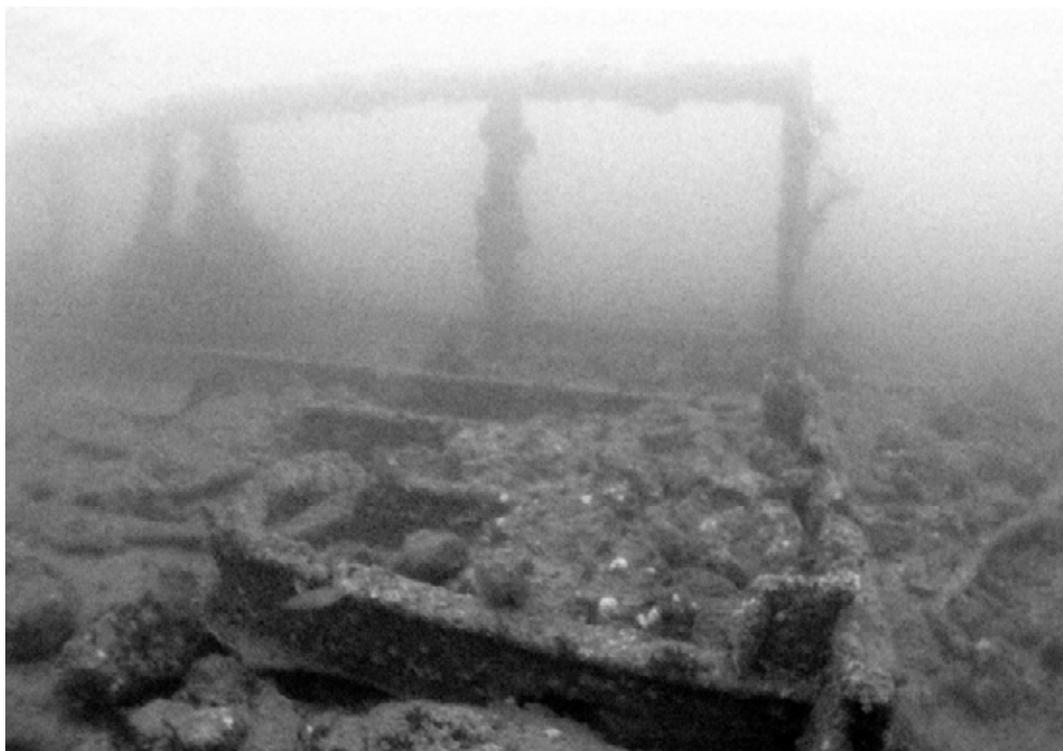
*Figure 4.13. General view of the southern section of remains and bulkhead 1, further framing, originally on the underside of the deck is visible in the foreground (Source: HWTMA).*

The upside-down orientation of the vessel noted by the UKHO (Section 2.3.2) was confirmed through the survey of the southern section of remains. Original plans of LCT MkV show the presence of an 8" pipe fender running along the outside of the vessel, just below the level of the deck. The remains of this were observed at either side of the southern section (Figure 4.14). The distance between this pipe fender and the top of the bulkhead corresponds with the distance shown in plans from the pipe fender to the bottom of the vessel. The steel plate visible on the seafloor underneath the southern bulkhead is therefore very likely to be the remains of the vessel's deck, seen from the underside. This also explains the structural elements that are visible in this area, between the deck, the bulkhead and the other steel framing elements (Figure 4.15).

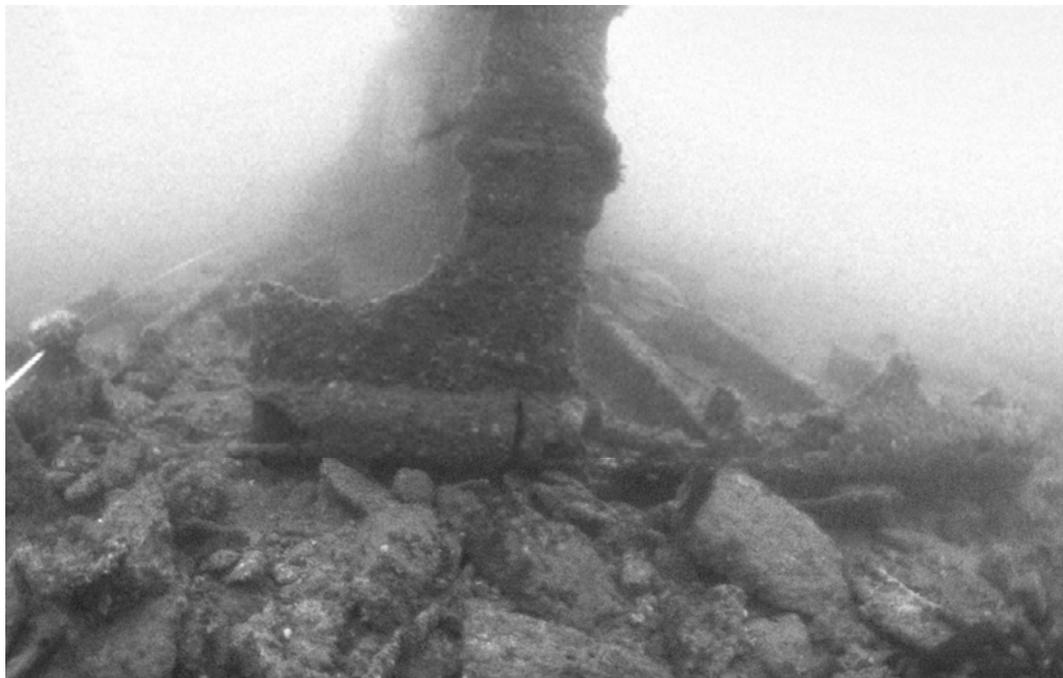
*Figure 4.14. Pipe fender running along the side of the vessel at bulkhead 1 (Source: HWTMA).*

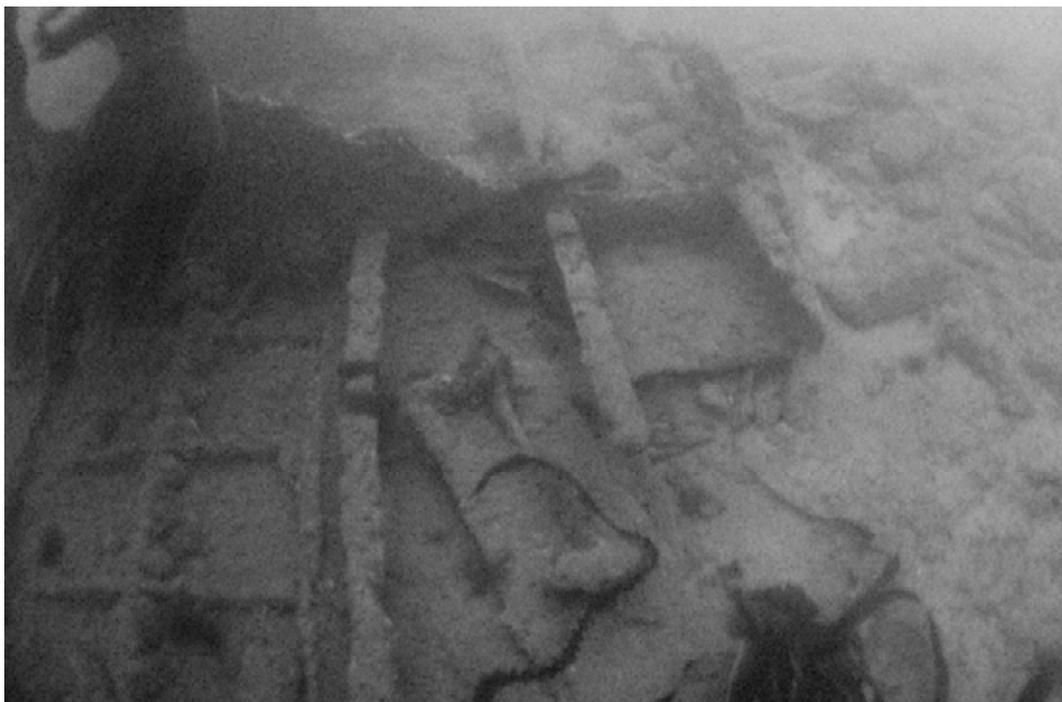
Figure 4.15. The southern extent of the vessel remains, including the broken edge of the vessel's deck, seen from the underside (Source: HWTMA).

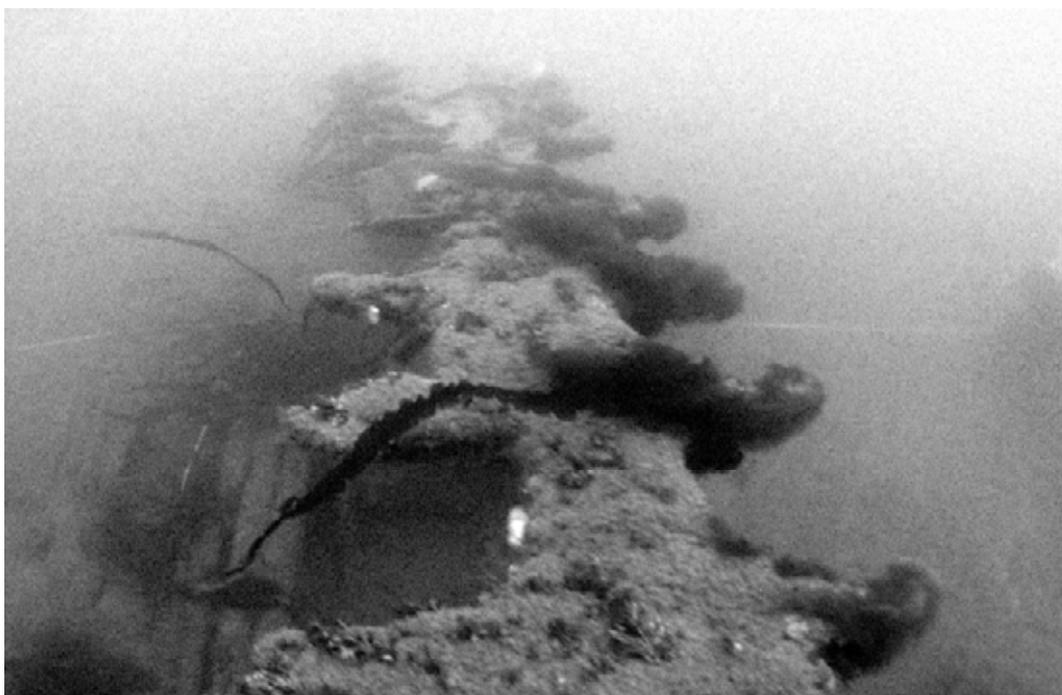
Figure 4.16. The upper face of bulkhead 1, with remnants of what was formerly the bottom of the landing craft (Source: HWTMA).

Establishing the upside-down orientation of the vessel illustrates that virtually the entire hull of the vessel has been lost, with the exception of the small elements still attached to the bulkhead (Figure 4.16). The edge of the vessel's deck can be seen on both the north and south side of the southern section, suggesting that this section of the vessel has become totally detached from the northern section of remains. Mayor (2010: part 4, pp 7) notes that the wire sweep of the site in 2003 may have contributed to the overall broken-up nature of the site. This conclusion seems to be borne out by the observations made during the current survey and provides a striking contrast with the UKHO listing which describes the vessel as 'intact'. Figure 4.17 illustrates the extent of lost material by overlaying the current site-plan against the outline plan of an LCT MkV.

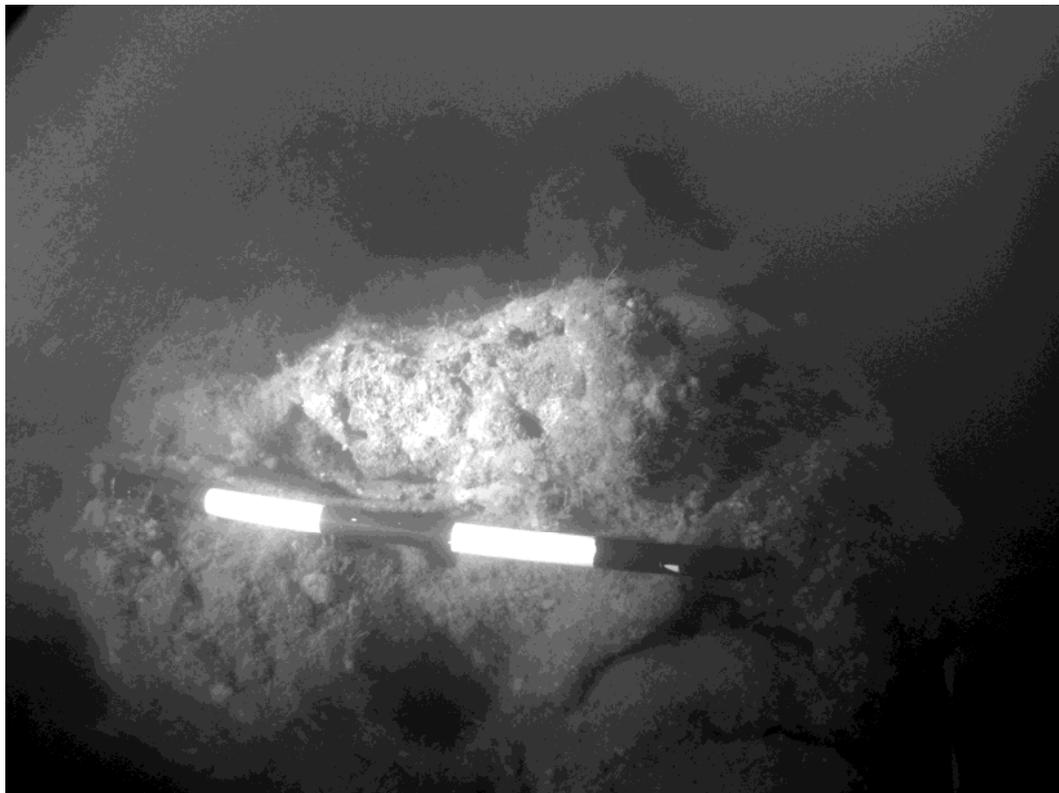
Figure 4.18. Concreted remains of an engine block, scale: 50cm (Photo: Jim Fuller, SSAC).

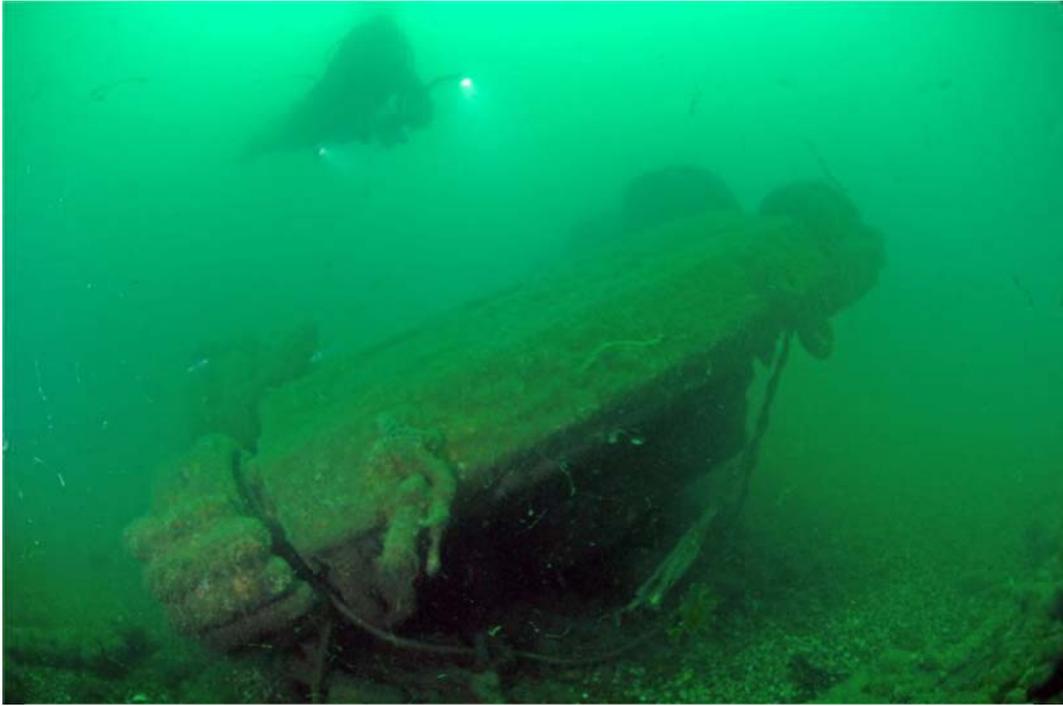
SSAC surveys of the site recorded ropes wrapped around Tank A, which were gone by the time of the present surveys in 2010. The damage to the tracks of Tank A seem to have occurred in a single incident, indicated by the corrosion and concretion on all of the resulting exposed areas of wheels, which is uniform in nature. The disposition of the displaced track elements suggests that the vessel was struck from its western side, resulting in segments of track lying across the underside of the vehicle. The fact that these track sections have stayed together, suggests a reasonable elapse of time between the deposition of the vehicle and the damage. At least long enough for the individual track pieces to become concreted together. The detachment and dislocation of the blade of Bulldozer B also seems likely to have occurred at a single point of time and provides a marked contrast with the coherent nature of Bulldozer A. The possible cause of these incidents of damage is discussed in Section 5.2.

Figure 4.21. Tank A, viewed from the north (Image: Martin Davies, SSAC).

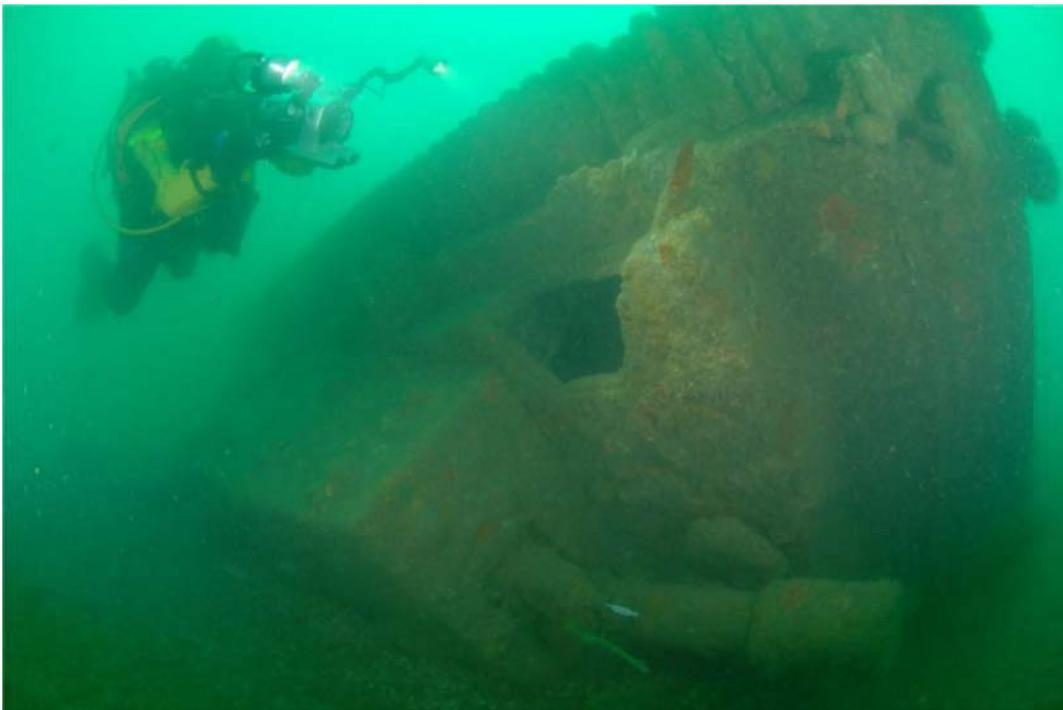
Figure 4.22. Tank B, viewed from the north-east (Image: Alison Mayor, SSAC).

- Two Centaur CSIV tanks, lying slightly west of a north/south alignment, the tanks have been designated Tank A (Figure 4.21) and Tank B (Figure 4.22), moving from west to east respectively.

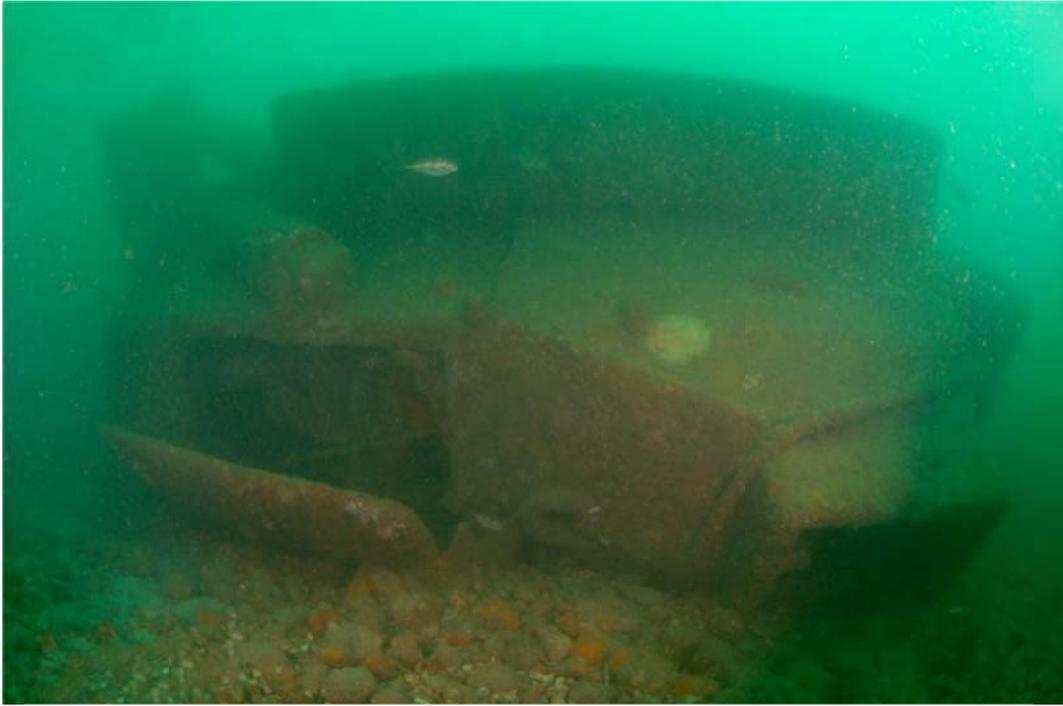
Figure 4.23. Bulldozer A, viewed from the west (Image: Martin Davies).

- Two D7 armoured bulldozers lying to the south of the tanks, on a similar general alignment and designated in the same way; Bulldozer A to the west (Figure 4.23) and Bulldozer B to the east (Figure 4.24). Bulldozer A lies 4m south of Tank A while Bulldozer B lies 8m south of Tank B.

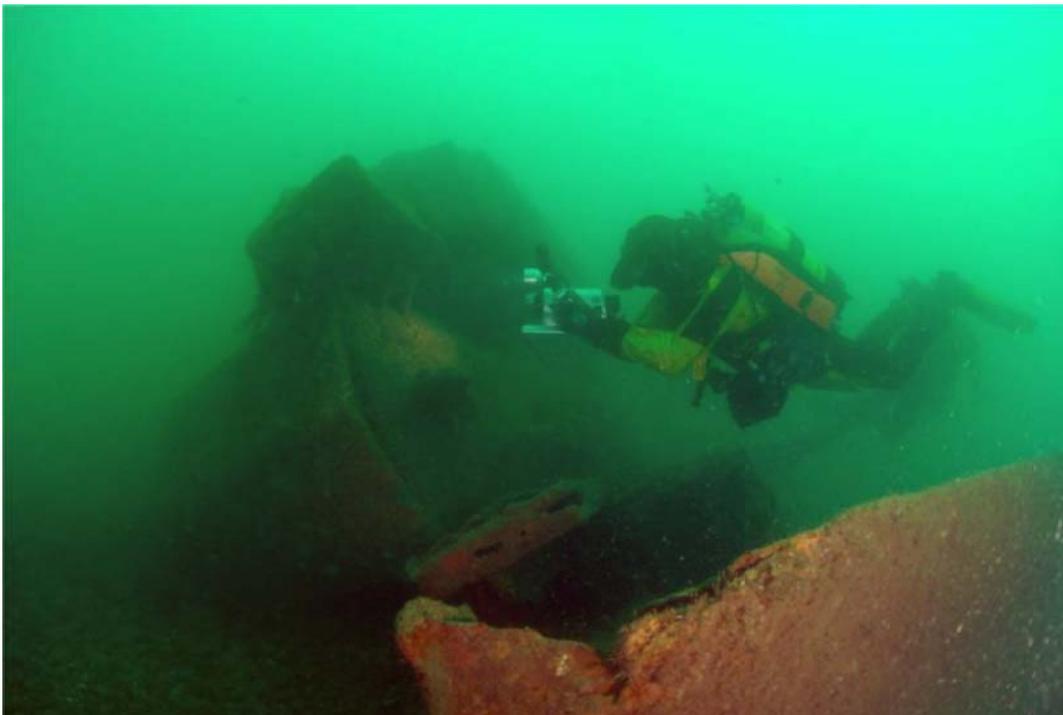
Figure 4.24. Bulldozer B, viewed from the north (Image: Alison Mayor, SSAC).

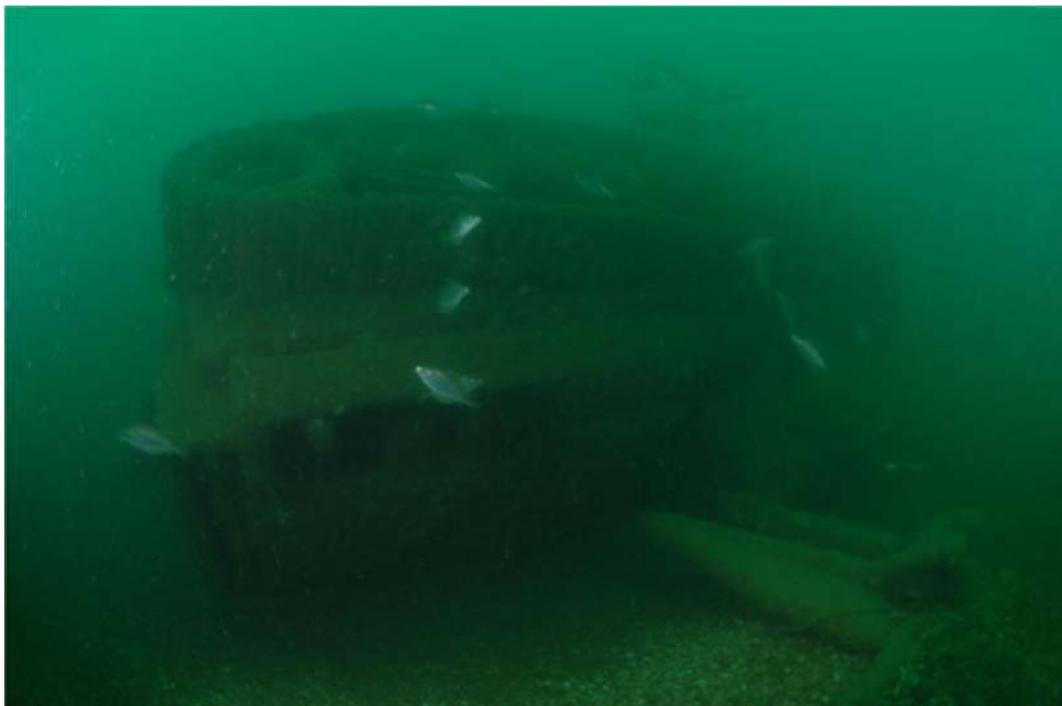
- A kedge anchor, partially lying under Tank B, on its eastern side (Figure 4.25).
- Vehicle remains, possibly that of a jeep, heavily degraded, lying to the north of Tank A (Figure 4.26).

Figure 4.25. Kedge anchor lying underneath the eastern side of Tank B (Image: Martin Davies, SSAC).

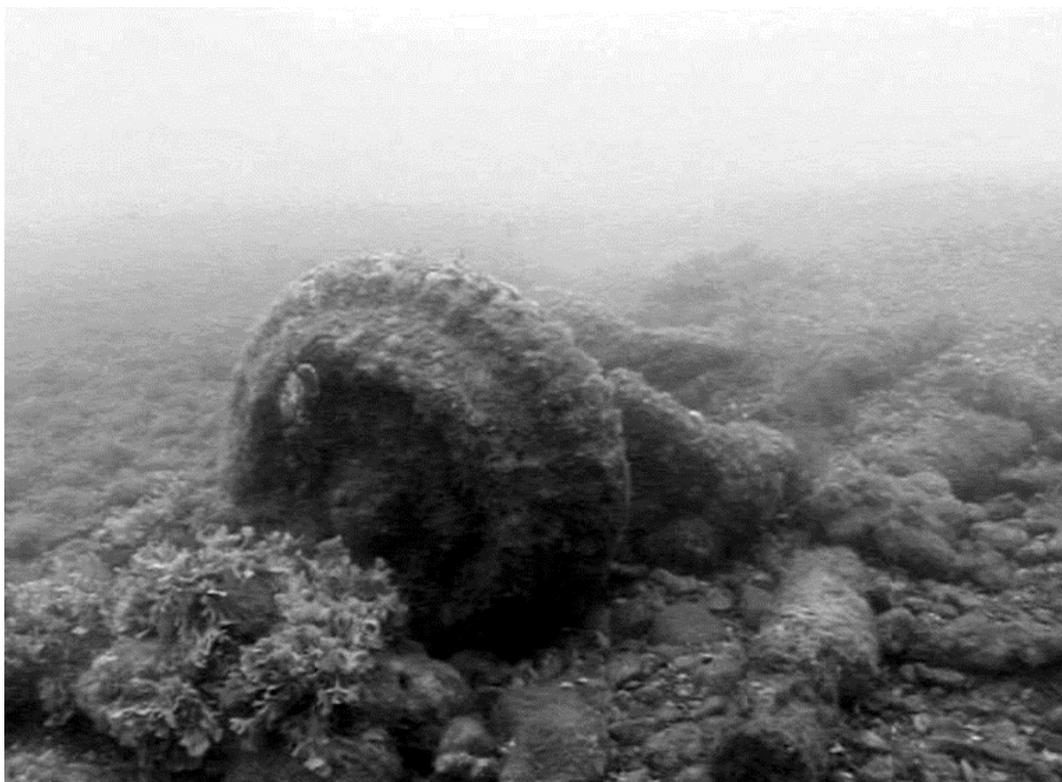
Figure 4.26. Heavily degraded remains of a jeep.

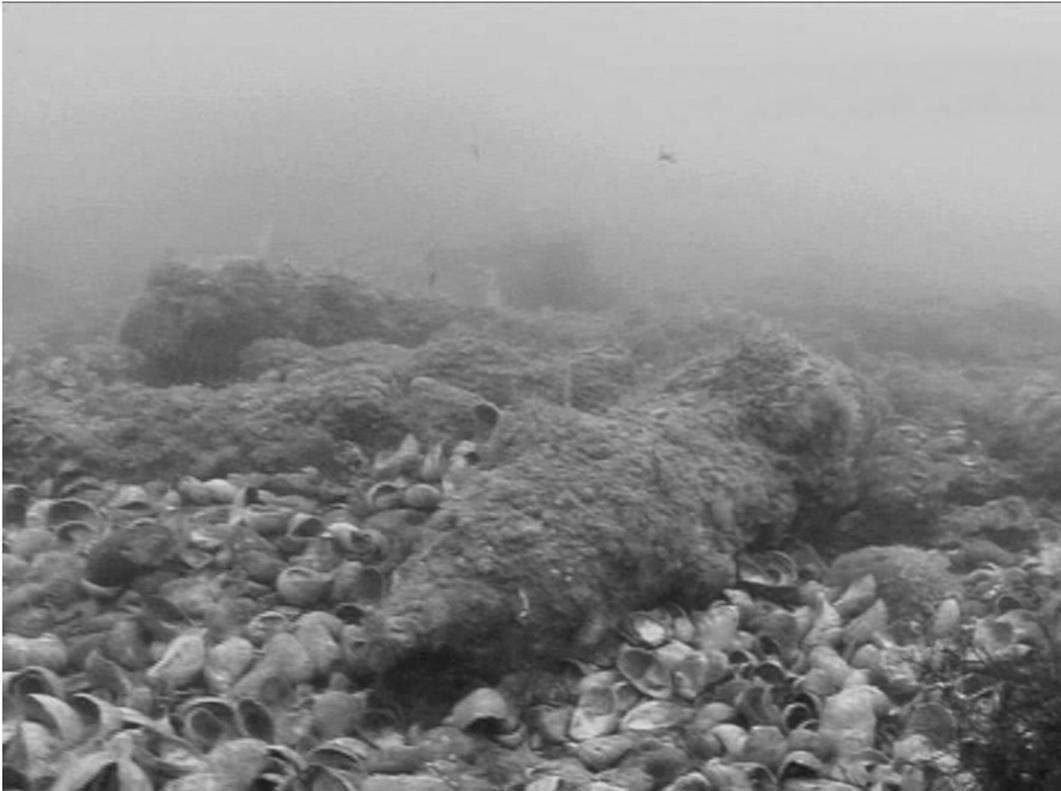
Figure 4.27. Remains of 95mm ammunition, located to the north of the tanks.

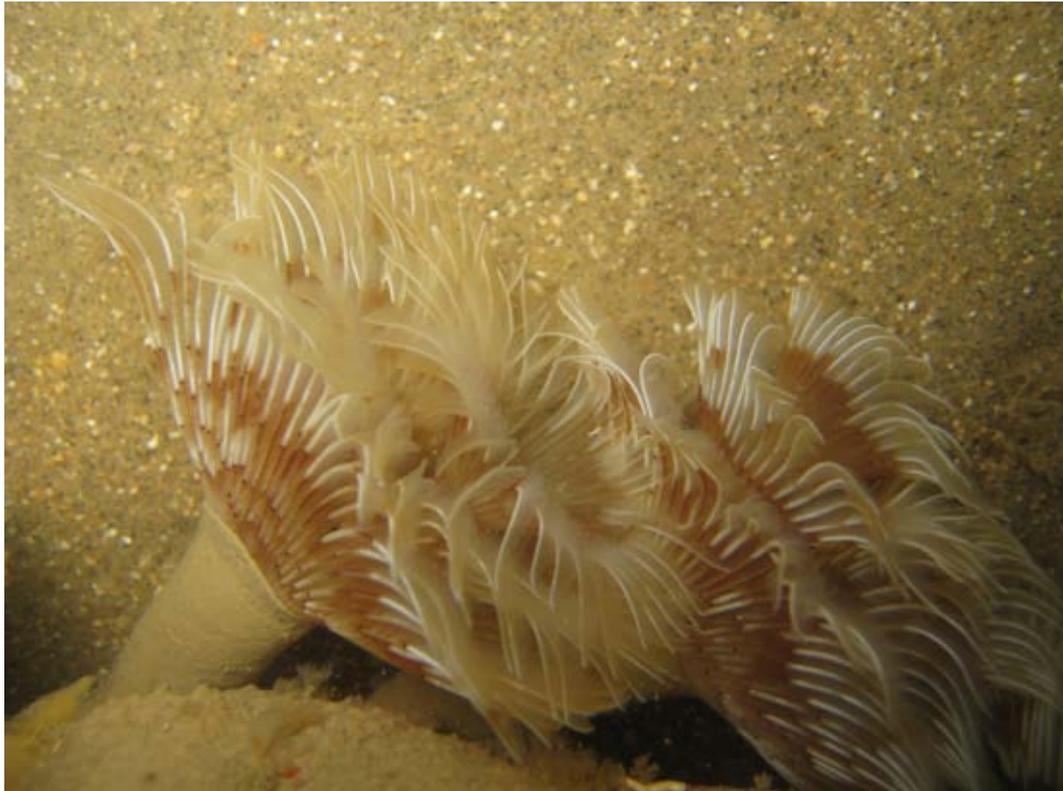
Figure 4.29. *Bispira volutacornis*, double spiral worm (Image: HIWWT).

In total, 42 taxa were recorded (Table 3 – Species List), representing 8 phyla (1 algae, 2 annelids (Figure 4.29), 4 bryozoans, 7 cnidarians (Figure 4.30), 5 crustaceans, 1 mollusc, 14 chordata and 8 sponges). Wreckage provided both a hard substrate for attachment of sessile species, and crevices/overhangs for cryptic species. Wreckage was substantially encrusted with *Turbularia indivisa* (oaten pipe hydroids), barnacle species, and *Molgula* sea squirts. Fish were also seen regularly on this site with *Ctenolabrus rupestris* (goldskinny wrasse), *Gobiusculus flavescens* (two-spotted goby), *Parablennius gattorugine* (tompot blenny) and *Trisopterus luscus* (bib) all seen frequently. Some crevices were large enough to provide shelter for small shoals of *Trisopterus luscus* (bib) and *Pollachinus pollachius* (Pollock). Sediment consisted predominantly of chalk covered with sand, with several large mats of *Molgula* sp. (colonial sea squirt) and patches of *Flustra foliacea* (hornwrack).

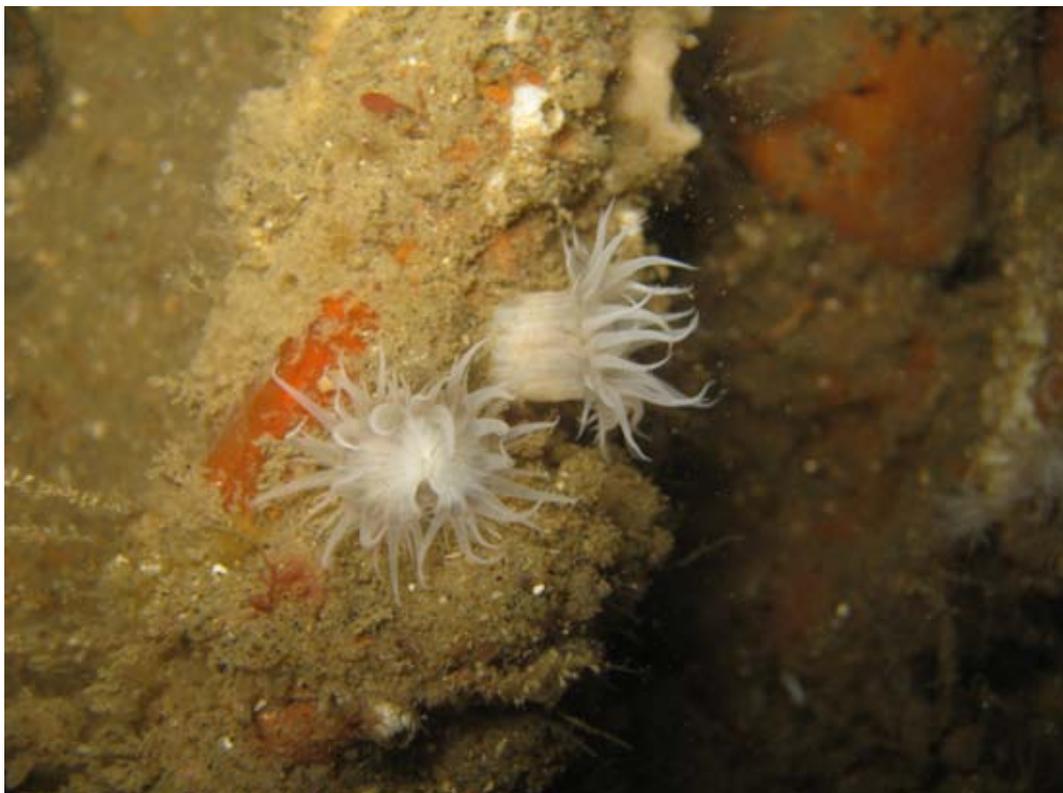
Figure 4.30. *Actinothoe sphyrodeta*, white-striped/fried egg anemone (Image: HIWWT).

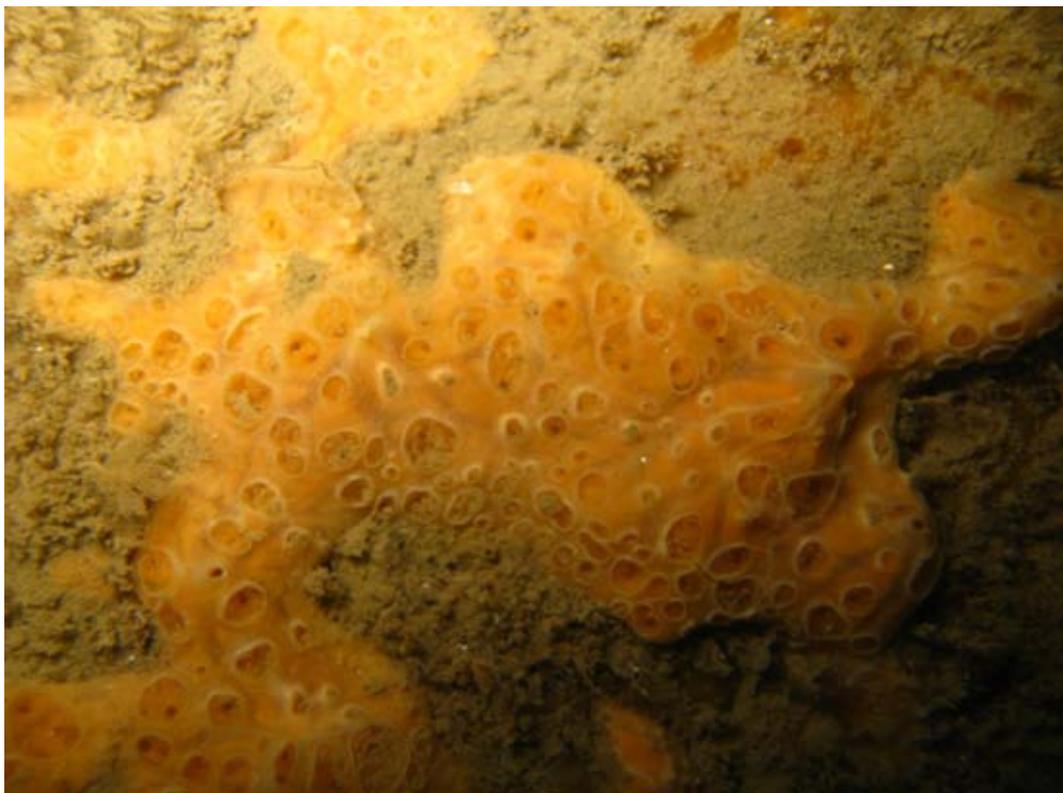
Figure 4.32. Hemimycale columella, crator sponge (Image: HIWWT)

In total, 45 taxa were recorded (Table 4 – Species List), representing 8 phyla (1 annelid, 10 bryozoans, 10 cnidarians, 5 crustaceans, 1 echinoderm, 2 molluscs, 8 chordata and 8 sponges (Figure 4.32)). Both provided hard substrate for attachment of sessile species, and crevices/overhangs for cryptic species. All the wreckage surveyed was substantially encrusted with bryozoans and hydroid turf and *Parablennius gattorugine* (tompot blennies) were seen regularly (Figure 4.33). The wreckage of Tank B provided shelter for several large *Conger conger* (conger eels) and *Galathea strigosa* (squat lobsters). *Cancer pagurus* (edible crabs) and *Dysidea fragilis* (goosebump sponge) were also common on wreckage. Sediment consisted of gravel, pebbles and cobbles with empty *Crepidula fornicata* (slipper limpet) shells, and was generally fairly bare and flat, with the exception of *Nemertesia antennina* (antenna hydroids) and *Flustra foliacea* (hornwrack) attached to cobbles.

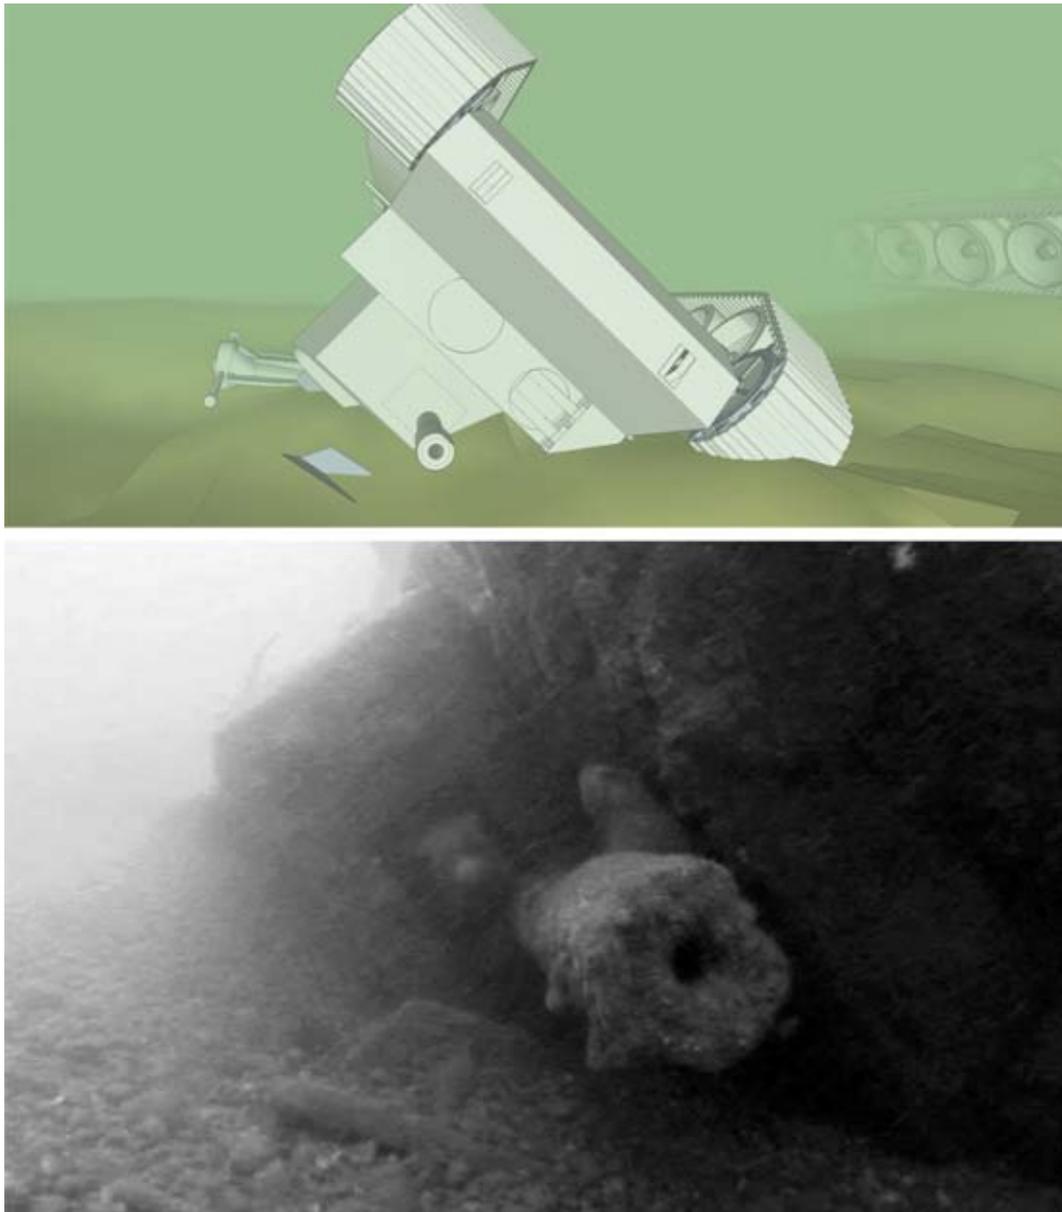
Figure 5.3. Example of virtual viewpoint on the vehicle assemblage site. Top: Tank B seen from monitoring point TB01. Bottom: Diver viewpoint from comparable position in average visibility.
