Forgotten Wrecks of the First World War

German Destroyers

V44 & V82

*Archaeological
Report*

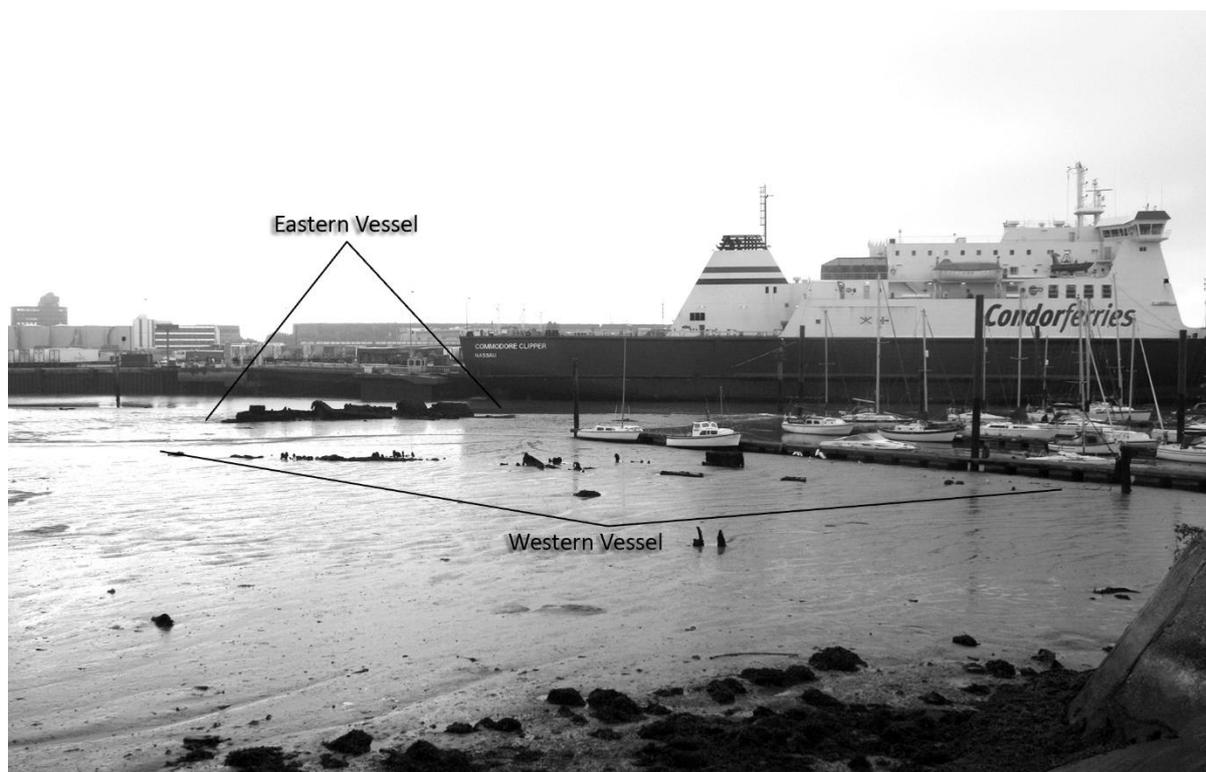
Figure 3. General view of the site looking south-east during a site visit undertaken at a low spring tide at 7am on the 1st September 2015. The upstanding remains of the eastern vessel are visible at the far edge of the mudflats, while the western remains comprise the low-lying remains in front of the marina pontoon. The dredged Rudmore Channel lies between the eastern remains and the ferry.

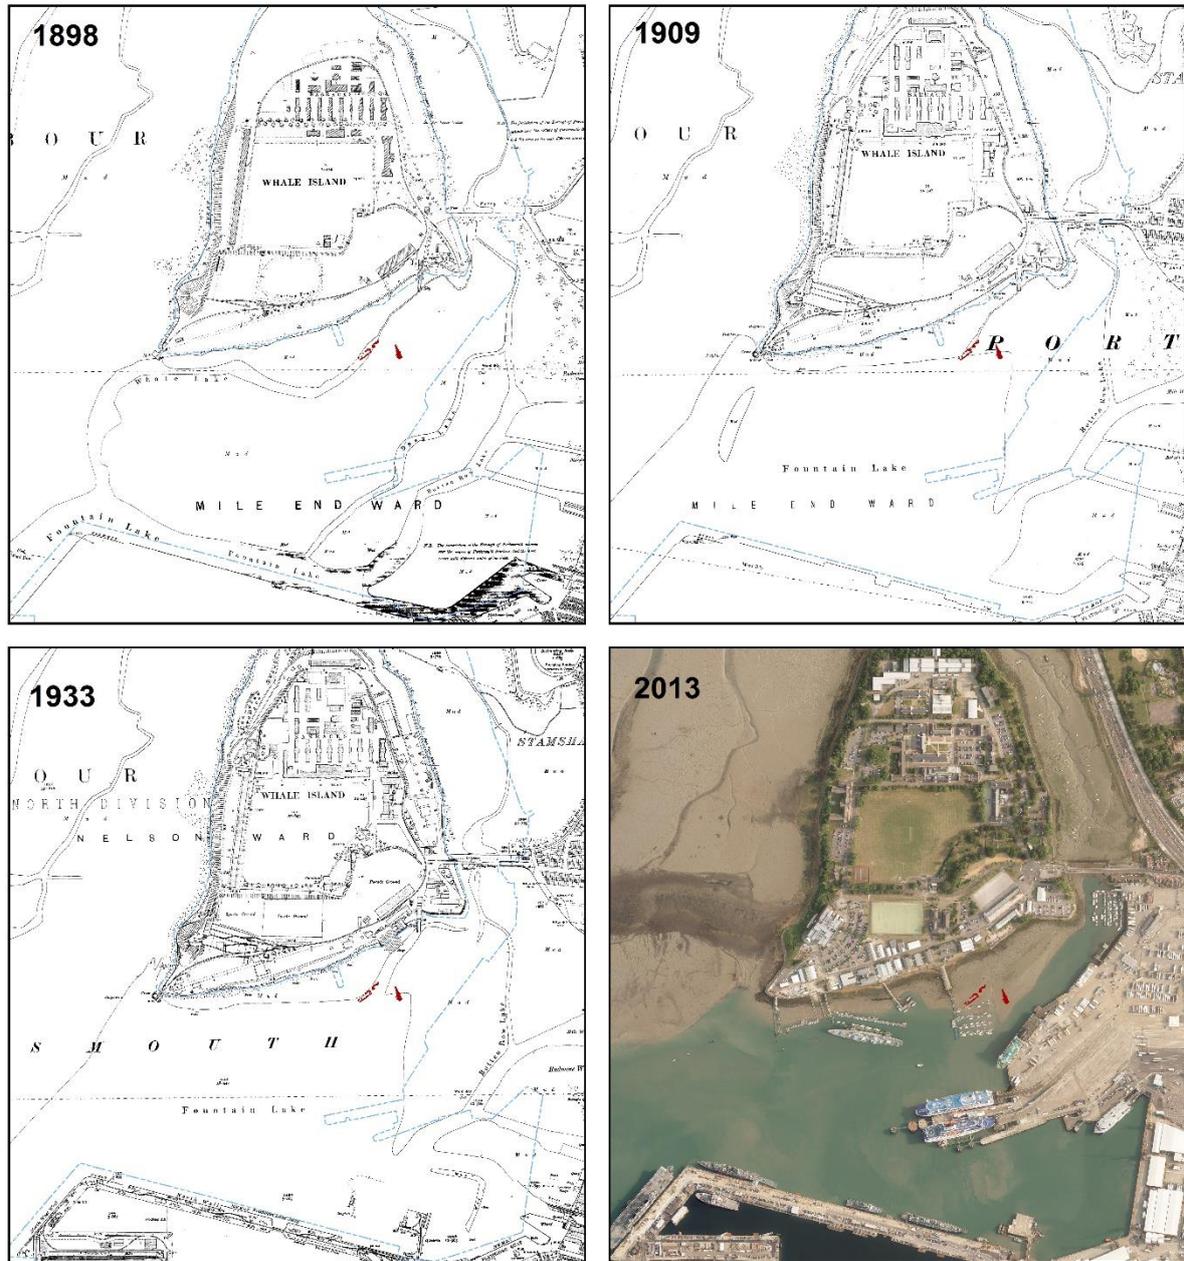
Figure 4. Historical map progression of Fountain Lake and the southern shore of Whale Island, 1898-1933, illustrating the dredging of Fountain Lake post 1908 and the extent of the modern ferry port in an aerial photo from 2013. For comparison, the visible remains of V44 and V82 are shown in all images, but were not in place until the 1920's.

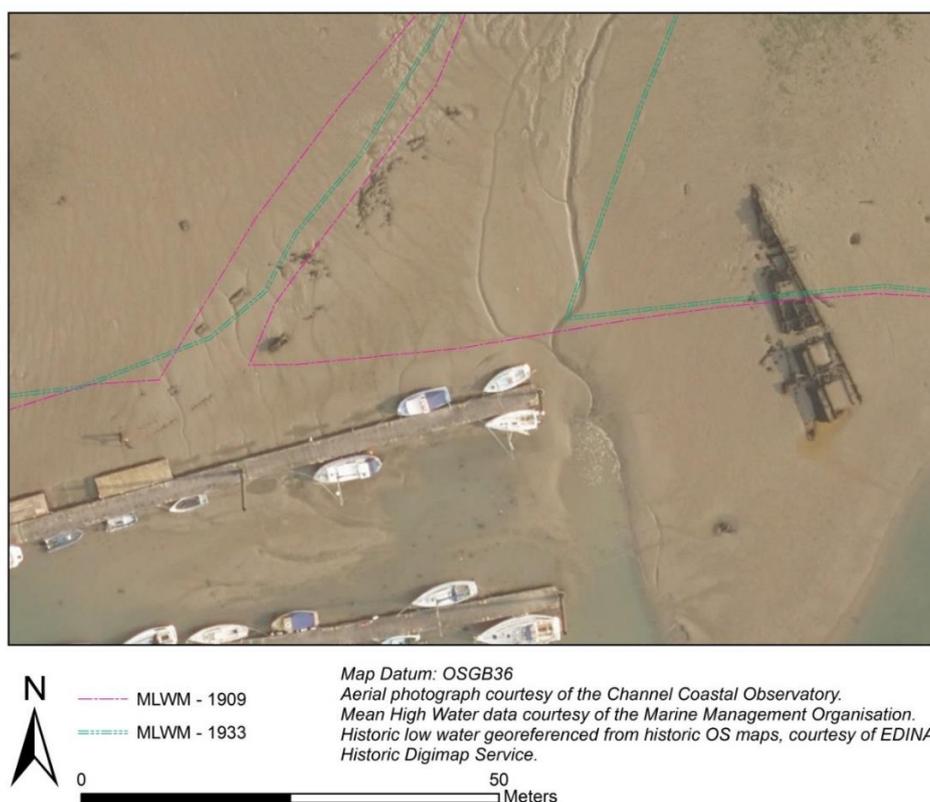
Figure 5. Close up aerial photo of the two vessels taken in 2013. The reduction to mudflat level of the western remains and the cutting in half of the eastern remains are both clearly discernible. The mean low water mark from historic maps is also illustrated to provide further context.

The remains of the eastern vessel are aligned 340°/160° and are currently visible over a length of 30m (98ft). The bow of the vessel clearly lies to the north and it is visibly truncated at the southern end of the remains (Section 4, below). The first UKHO mention of the wreck is on 25th May 1927 (H3360/27) when its position is noted, along with the fact that it was being demolished. As with the western vessel, the full UKHO listing (19224) reports the wreck as a German destroyer, but once again does not use this identity in any survey reports. The current alignment is reported in a UKHO record (H1270/77) from 15th December 1977, which records a comparable length of 80 feet (26m). The same record also contains additional information which records that the vessel is visible in aerial photos (1240/230) dating to 7th July 1976 when it measured 255ft (78m) in length. The date of the removal of the southern half of the vessel would therefore seem to date between the aerial photo in July 1976 and the UKHO record in December 1977, and can probably be correlated with the construction of the ferry terminal and the related dredging of the Rudmore Channel. Cross-referencing of the visible vessel remains with historic OS maps (Figure 4) indicates that the vessel was run ashore perpendicular to the edge of the mudflats, with the bow towards Whale Island, straddling the mean low water mark.

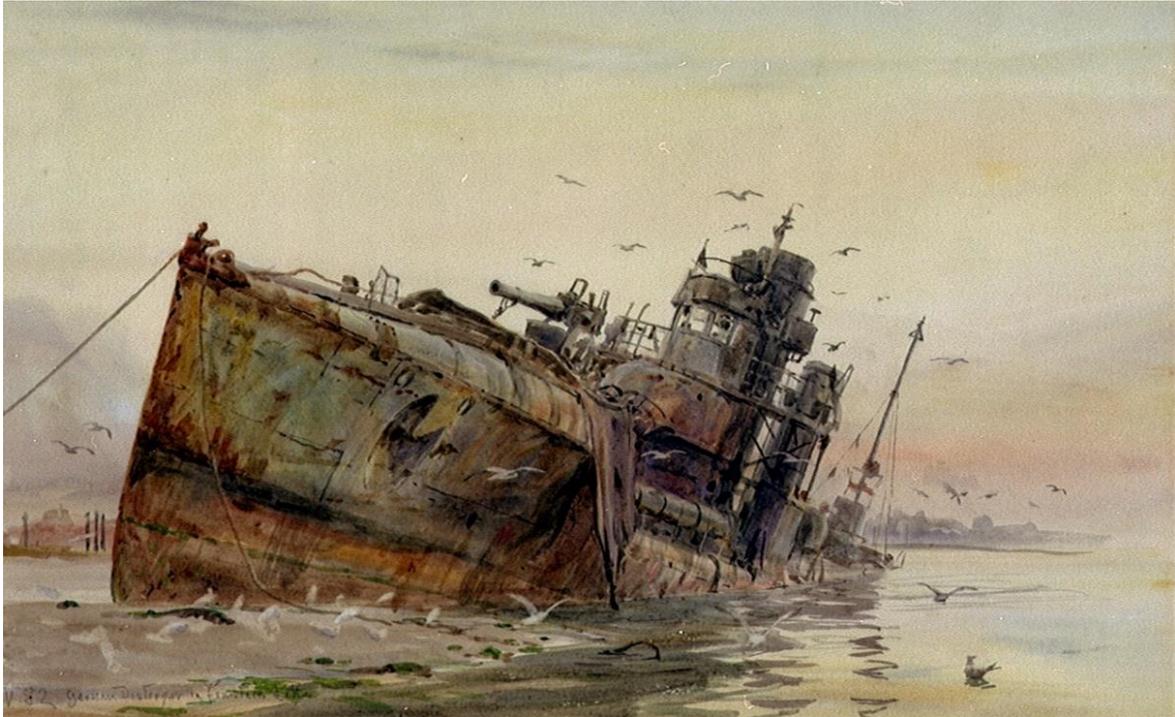
Figure 8. Painting by William Wylie titled 'V82 German Destroyer in Fountain Lake' dated to 1920-22 (copyright: National Maritime Museum PAF2085).

same prominent trunking is also visible on the contemporary painting titled 'German destroyer in Fountain Lake', attributed as V82 by William Wylie (Figure 8). The correlation between that technical detail and the painting also serves to confirm the identity of the vessel in the painting as V82, rather than V44.

The disposition of V82 in Wylie's painting also offers an initial possible means to distinguish between two otherwise very similar vessels. Wylie shows V82 as being beached bow first, with the bow resting on the mud at low water and the vessel generally aligned perpendicular to the foreshore. This bears a clear correlation with the alignment of the eastern vessel as plotted against the mudflat alignment between 1909 and 1933 (Figure 4 & 5), especially when compared to the alignment of the western vessel *along* the foreshore. It also correlates with the current understanding of the forward section of the eastern vessel being relatively extant (Section 5.1) when compared to the western vessel. An initial assessment of the broader evidence would therefore suggest that on the basis of contemporary records, in conjunction with the alignment of the archaeological remains, the eastern vessel is V82, and by extension the western vessel is V44.

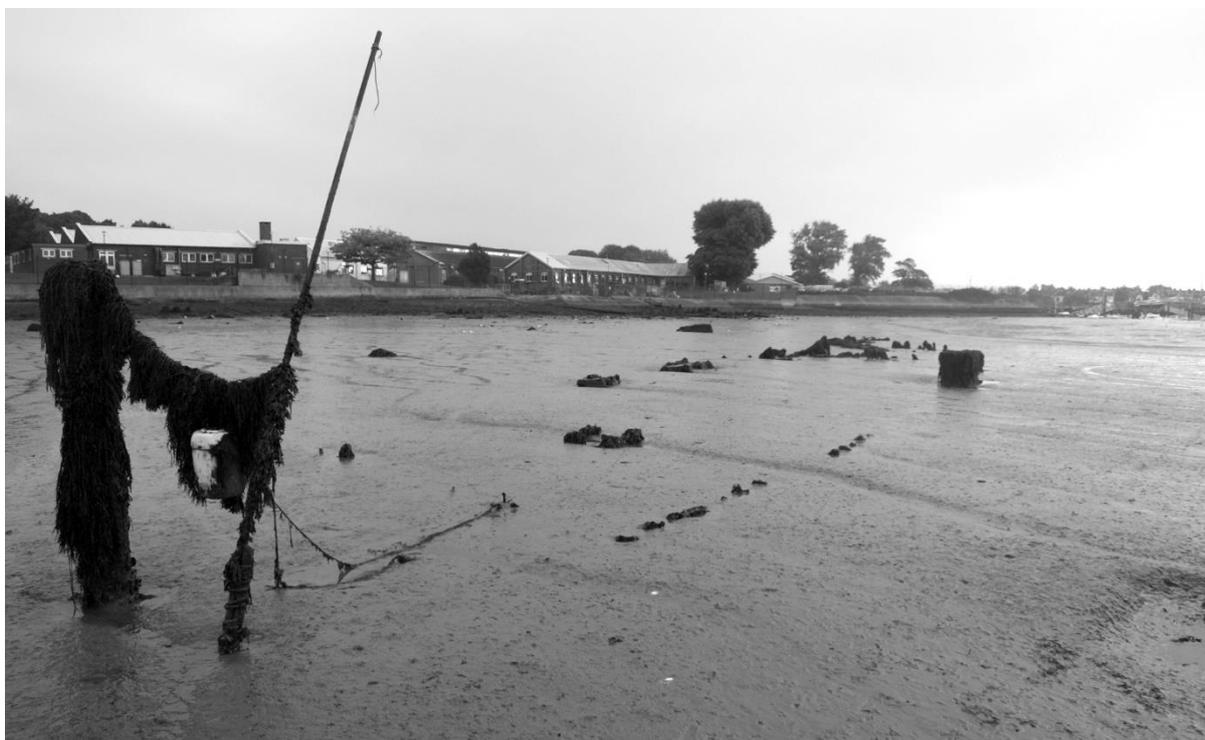
The remains of the western vessel (Figure 9) are aligned 45° (bow)/225° (stern) and at present, the remains are visible over a length of 56m (183ft). The surviving structure is truncated at the level of the mudflat with only a small number of unidentifiable elements protruding through the mud surface. A combination of UKHO and historic aerial photos indicate that the main period of salvage of the vessel seems to have taken place in the late 1920s, and certainly before 1939. The width of the remains can be ascertained from modern aerial photos at a point where sections of outer hull survive on either side of the vessel in the same part of the hull, 23m forward of the stern. The breadth of the original vessel can therefore be estimated as 8.1m, which correlates with historically recorded breadth dimensions of the class as 8.3m in the same area. Very few other diagnostic features are visible, other than a square structure that is clear of the mud and located c. 8m from the stern of the vessel and which measures 800mm on each side. The original function of this can probably only be determined through reference to original internal construction plans. Further forward, an ovoid shaped structure on the centreline of the vessel protrudes from the mud c.40m from the stern, measuring 3.6m fore-and-aft and 2.5m athwartships. The shape, size and location of this feature correspond with the generally expected location of the aft funnel, according to the class plans.

Figure 9. The eastern vessel, looking NNE, the hull has been truncated at the level of the surrounding mud-flat. The stern is located immediately to the right of the vertical upright structure to the left of the image, which is a former mooring post and not part of the ship.

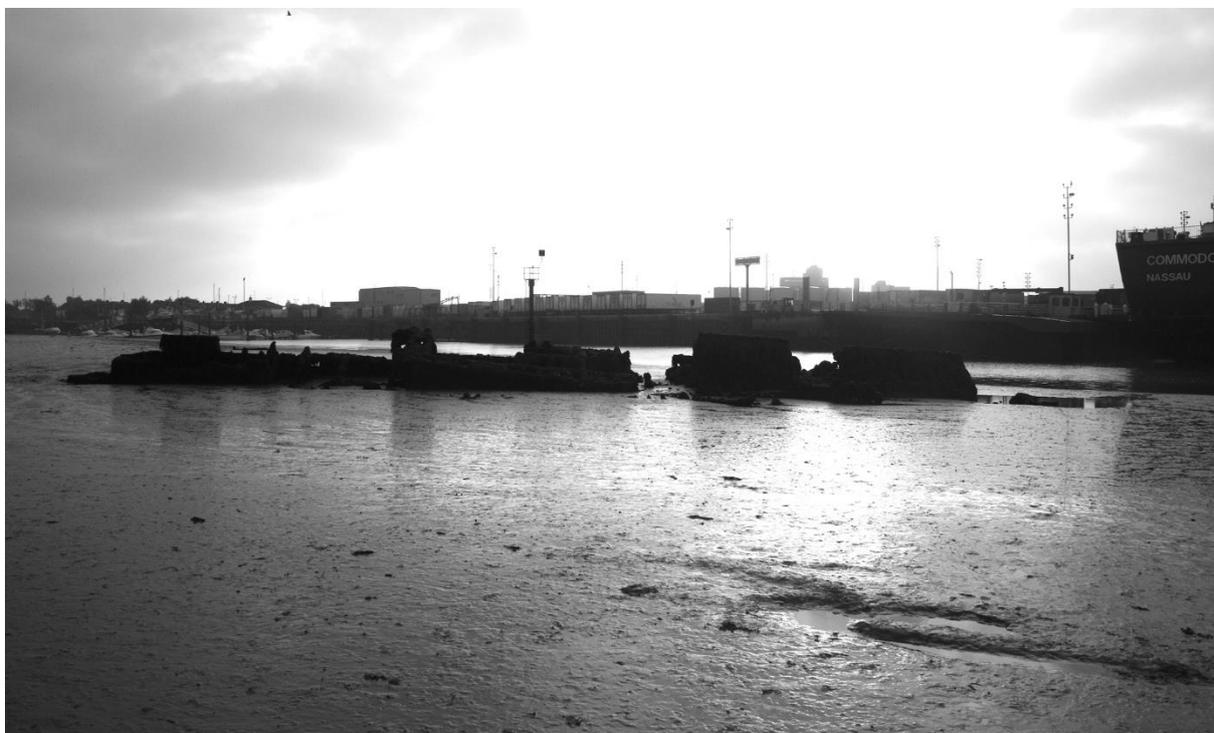
The remains of the eastern vessel (Figure 10) are aligned 340° (bow)/160° and are currently visible over a length of 30m (98ft). The nature of the surviving southern end of the ship, in conjunction with the current surviving length and historic records all indicate that the vessel was cut in half in the late 1970s, but was relatively complete in terms of its overall length before that (Section 3.2). Although truncated amidships, the surviving remains protrude significantly above the mudflats to a height of c.1.5m, and despite a covering of seaweed it is possible to identify the vessel's bow and forecastle to the north, with at least two boilers to the south. The surviving forecastle structure extends for 18.4m from the northern end of the remains and their narrowness at the bow suggests they are relatively complete. Historical plans also illustrate the forecastle along the vessel centreline extending for 18.4m. On the basis of modern aerial photos the breadth of the vessel remains between the two surviving boilers, c. 24m aft of the bow, can be estimated as 6.6m, which roughly correlates with historically recorded breadth dimensions of the class as 7.4m maximum breadth at the same location, but higher up the hull.

The surviving boilers are both offset on the port-side of the vessel, rather than being on the centreline. The forward boiler is 3.2m in length (fore-and-aft) and 2.3m athwartships, the aft boiler is 4.3m in length (fore-and-aft) and also 2.3m athwartships. Historical records indicate that pairs of boilers and engines would have originally been set side-by-side within the hull, and accordingly, there is a rectangular void for the engines to starboard of each boiler, of the same length and c.2m athwartships. The boilers themselves appear to have survived relatively intact as indicated by visible surviving water tubes on the port side of both boilers, although this in turn indicates that some of the outer wall of the boilers have degraded.

Figure 10. The eastern vessel, looking east, the hull has been severed at the right hand (southern) end. The bow and lower elements of the forecastle are located to the left, the two upstanding rectangular structures to the right are the vessel's surviving boilers.

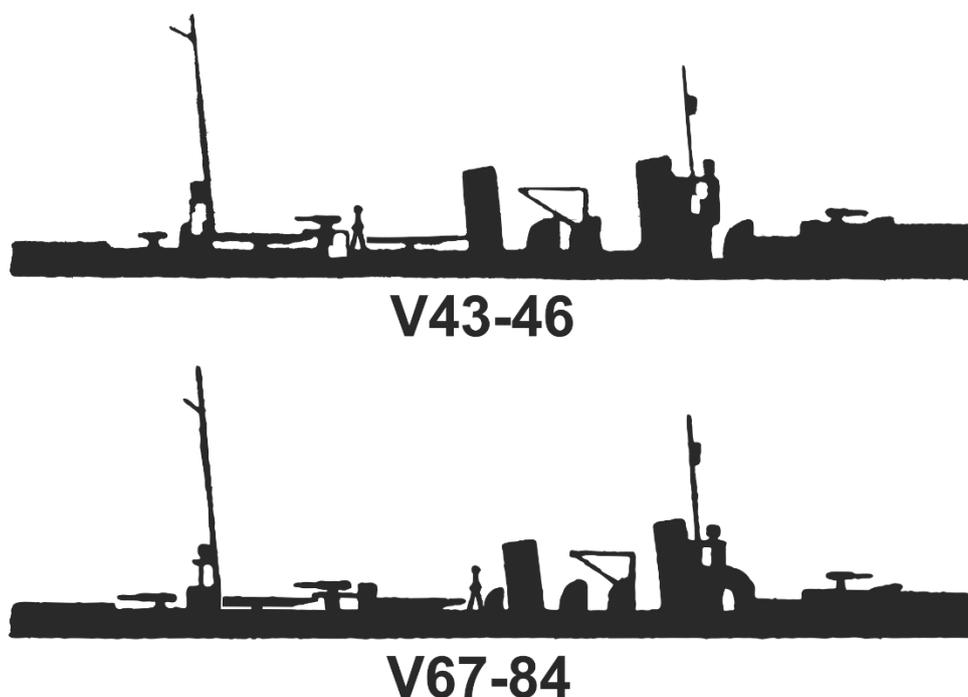
Figure 11. Comparative profiles for the two classes of vessel represented by the remains at Whale Island, V44 top, V82 bottom. The prominent aft-facing curved ventilation trunking can be noted forward of the bridge structure on the V67-84 group of ships. (source ADM 116/1992).

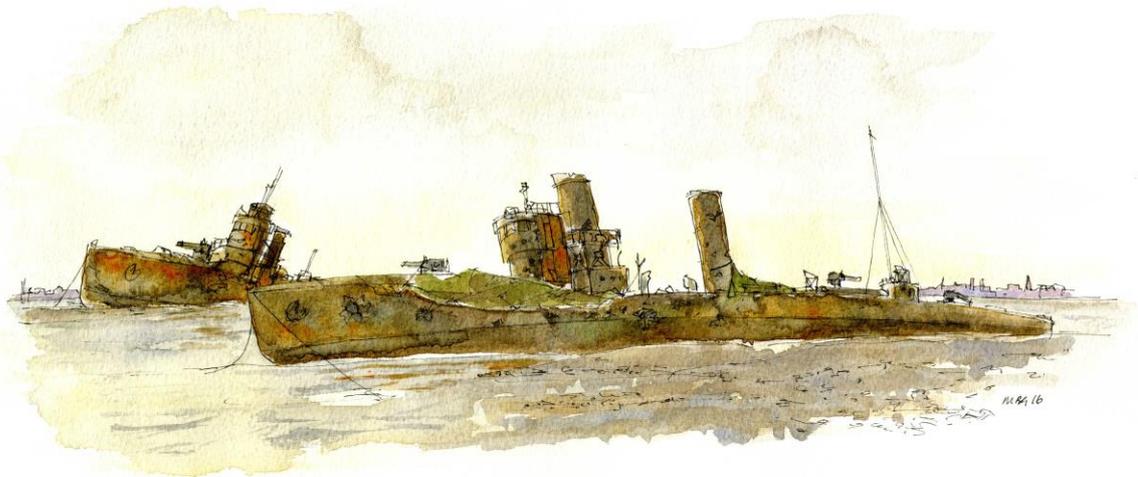
Figure 12. Artistic impression of V44 and V82, shortly after beaching at Whale Island, and before significant salvage activity occurred (Reproduced with the permission of Mike Greaves, ASGFA, www.greaves2connections.com).

FIGURE 12. ARTISTIC IMPRESSION OF V44 AND V82, SHORTLY AFTER BEACHING AT WHALE ISLAND, AND BEFORE SIGNIFICANT SALVAGE ACTIVITY OCCURRED (REPRODUCED WITH THE PERMISSION OF MIKE GREAVES, ASGFA, WWW.GREAVES2CONNECTIONS.COM).
