Forgotten Wrecks
of the
First World War

SS Maine

Site Report

SS MAINE
(Sunk 23 March 1917)
SITE REPORT

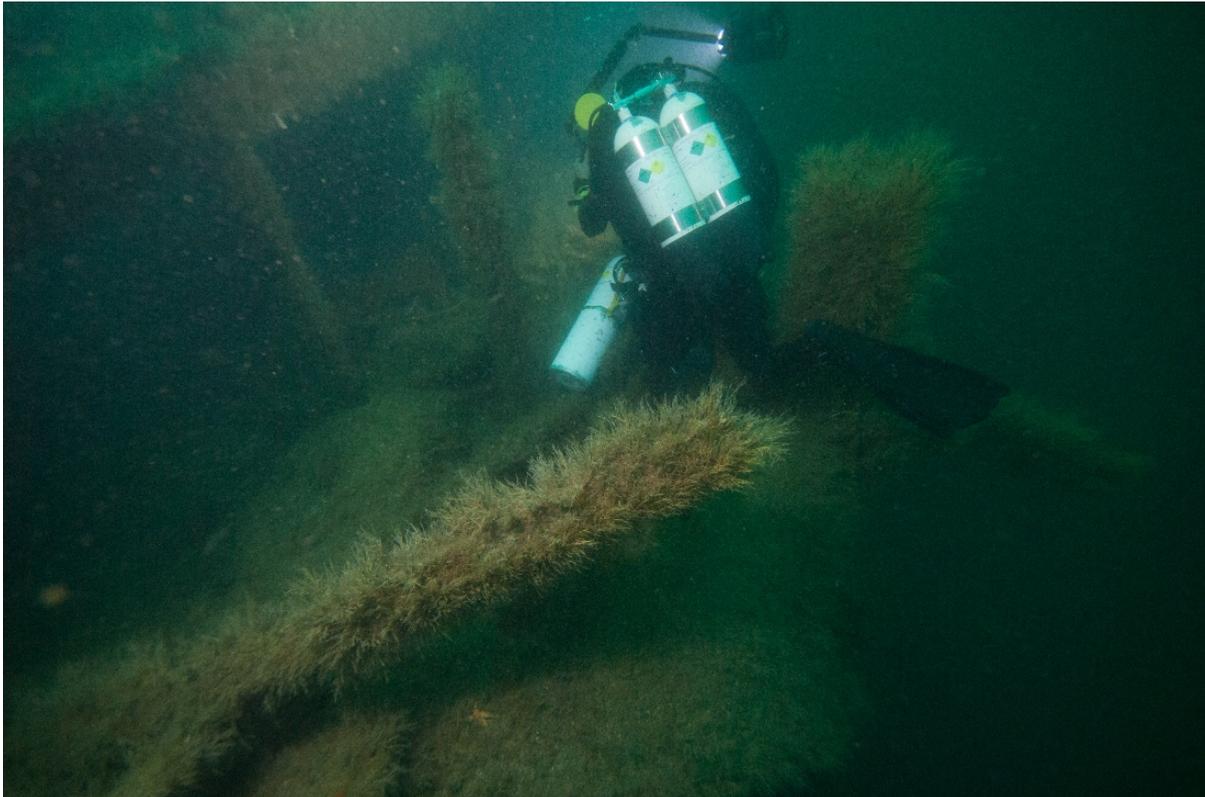
To obtain this, two divers took an overlapping series of photographs, one diver using a Nikon D7000 and the other a Nikon D200 held within underwater camera housings. They each carried an Orca 3000 Lumin light each to illuminate the wreck as much as possible as conditions were fairly dark (Figure 5).

Figure 5: Diver carrying out photogrammetry near the stern of the *Maine*

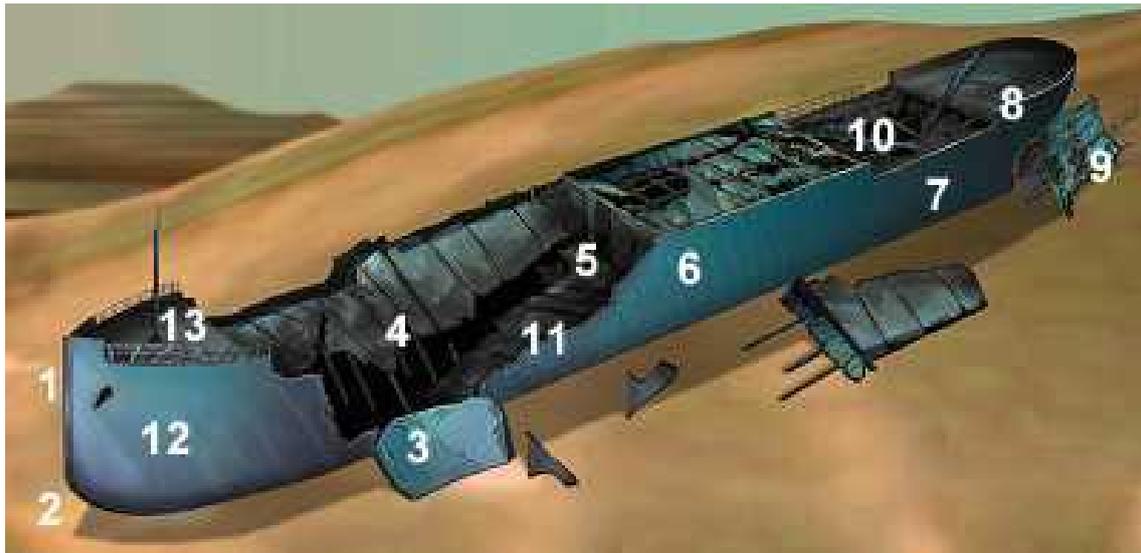
Figure 6: Drawing of SS *Maine* (copyright: John Liddiard and Max Ellis, with permission)

The wreck is broken up where the torpedo hit on the port side of the hull, as seen in Figure 6 which is an image by John Liddiard and Max Ellis created in 1999 (numbers on the image relate to a Diver Tour which can be accessed here: <http://archive.divernet.com/wreck-tours/p301712-wreck%20tour:%201,%20the%20maine.html>), this area gives access to the forward holds amid the remains of the deck and bulkheads where it is collapsing. The starboard side of the hull is more intact, as shown in Figure 7, a drawing by Richard Wood created in 2001 (Totnes BSAC). There is a hole on the starboard side which gives entry to the back of number two hold and there are many places to see inside the wreck (Figure 8). The holds are cavernous which is testament to the ships construction being built to carry substantial cargoes.

Comparison of the images of the site from 1999 (Figure 6) and 2001 (Figure 7), to the site remains as recorded in 2016 it is clear that changes continue to occur. There is now debris around the bow area where the hull plates are breaking down. Because of its popularity with divers, the *Maine* provides interesting potential for its deterioration to be monitored over time if information can be collected from divers.

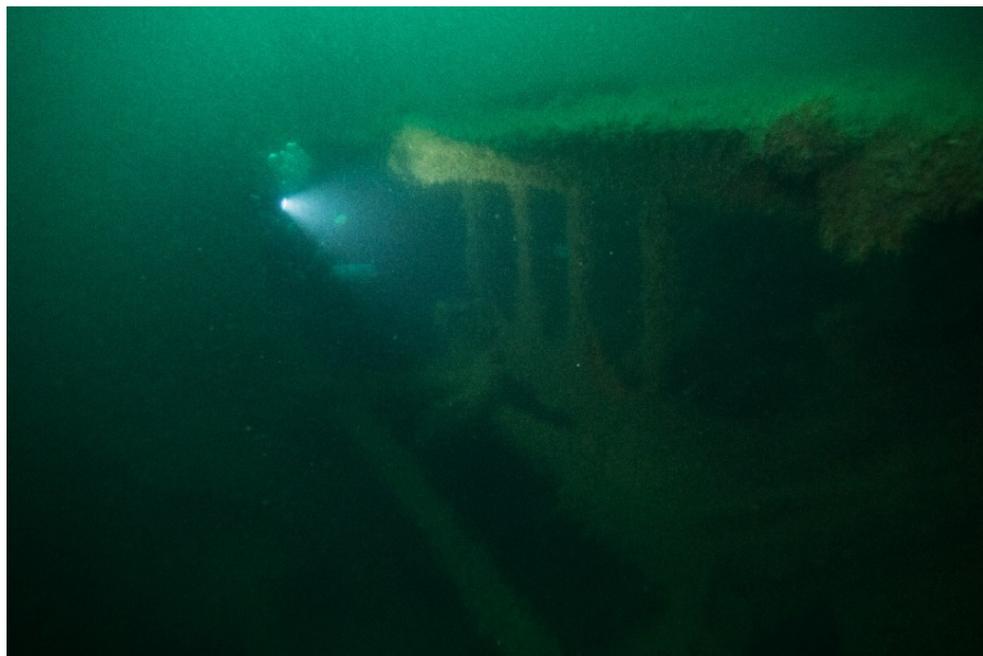
Figure 8: Looking into open girders below the upper deck

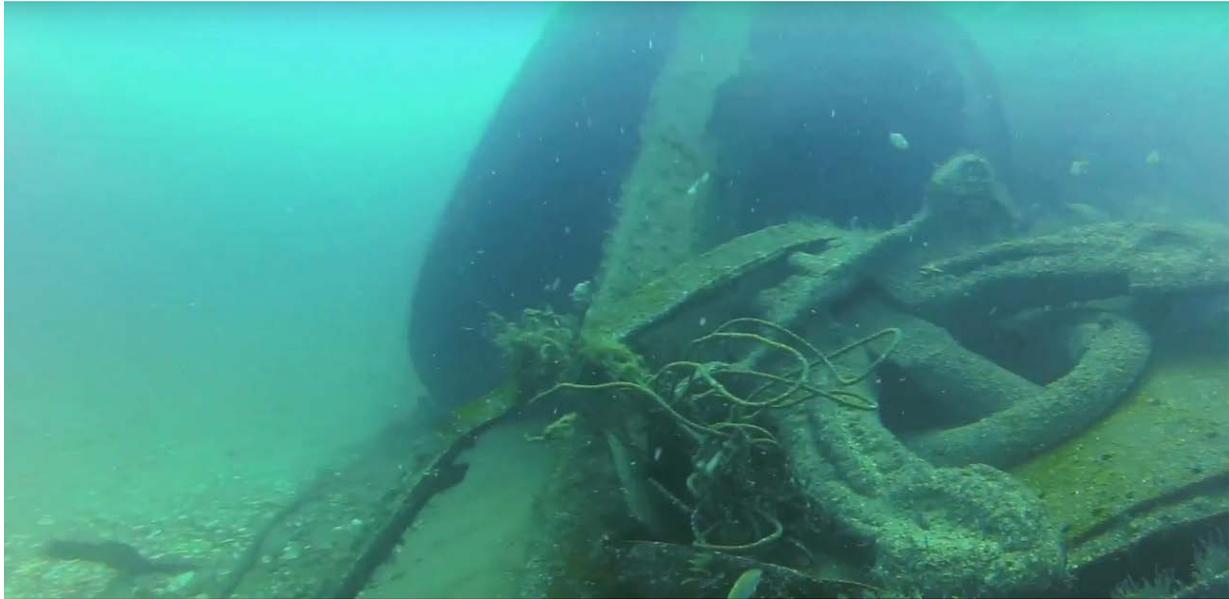
At the bow there is debris on the seabed and nearby the starboard anchor lies amongst collapsed plates (Figure 9).

Figure 9: Anchor amongst hull plates

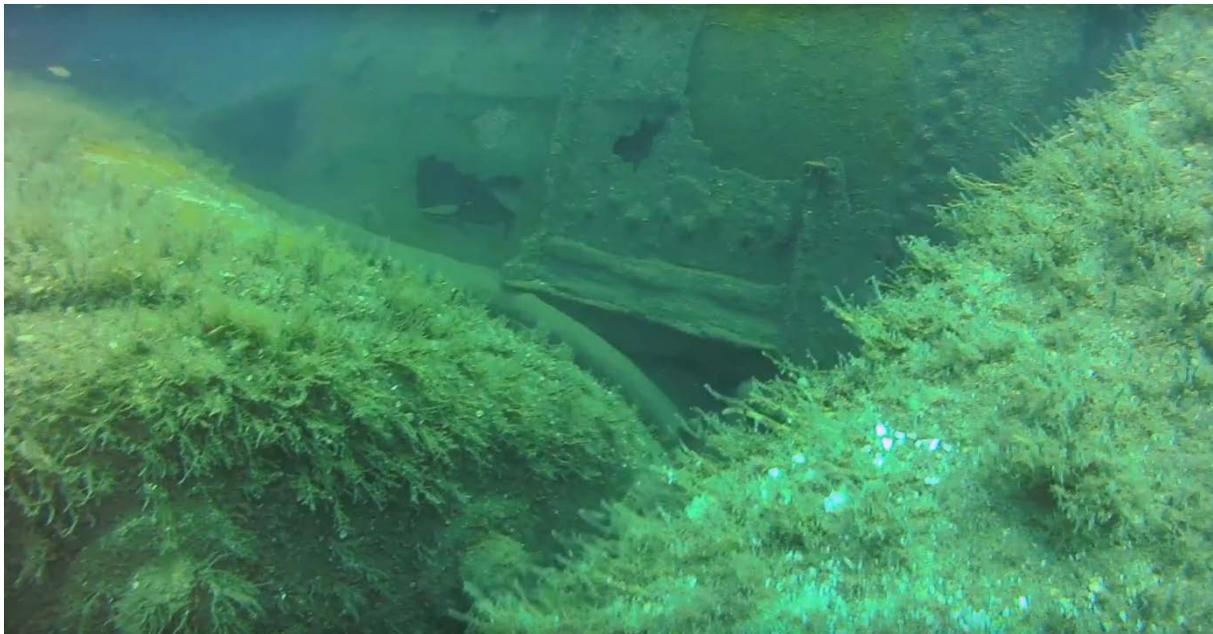
Swimming above the collapsed deck it is possible to swim into the engine room where the two main boilers (Figure 10) and triple expansion engine are sitting in the midships section, in front of these is the third boiler. The length of the main boilers is 350cm, the engine block measures 666cm from the front edge to the rear edge (Figure 11).

Figure 10: Two main boilers (Courtesy Richard Knights <https://www.youtube.com/watch?v=o4yTy5ZTXSc>)

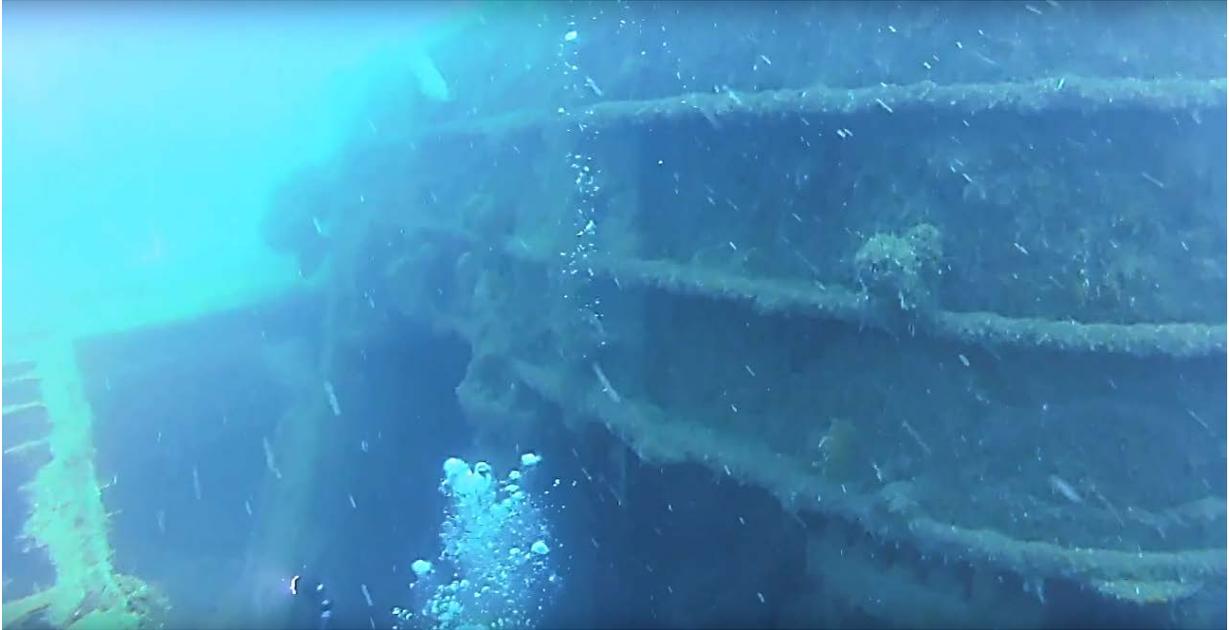
Figure 11: Triple expansion engine (Courtesy Richard Knights <https://www.youtube.com/watch?v=o4yTy5ZTXSc>)

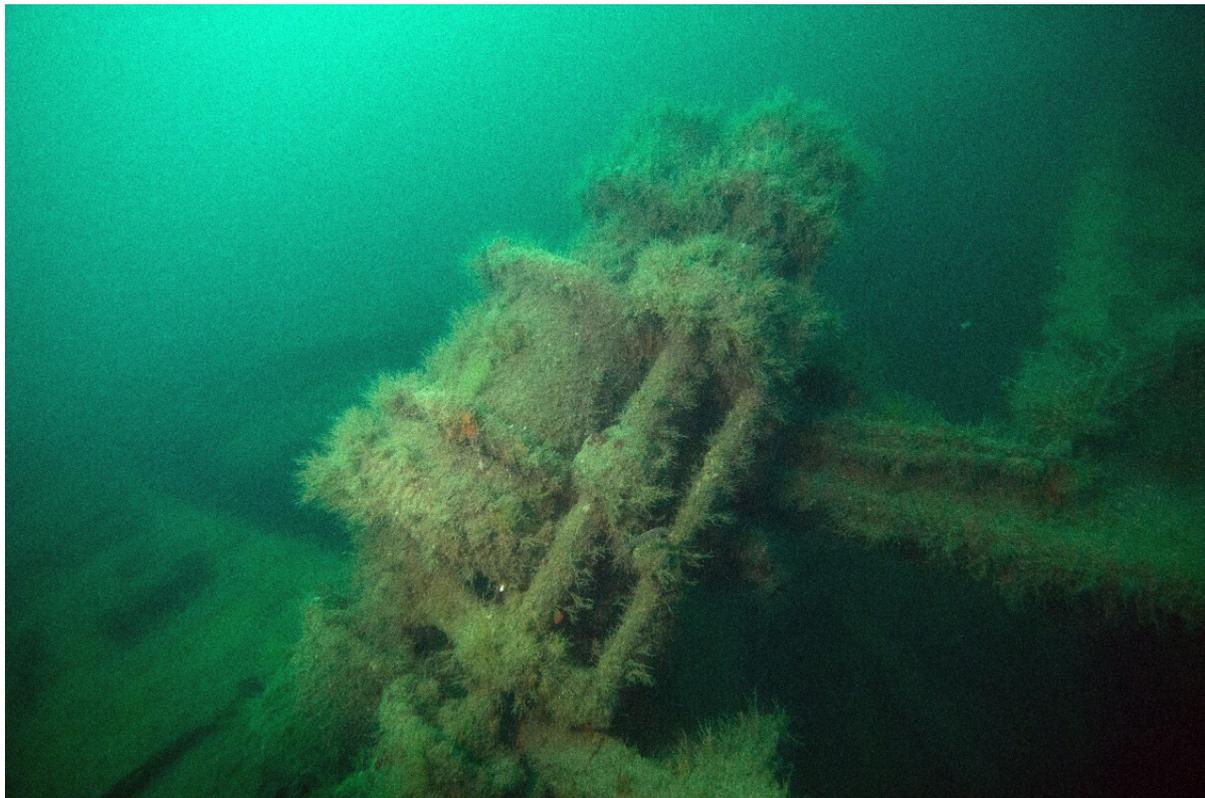
Moving further aft along the deck a winch is present with the drum and warp ends (Figure 12) before reaching the hold with the hatch coaming which measures 680cm. A ladder leading down into the hold is still in place (Figure 13).

Figure 12: Deck winch near the stern

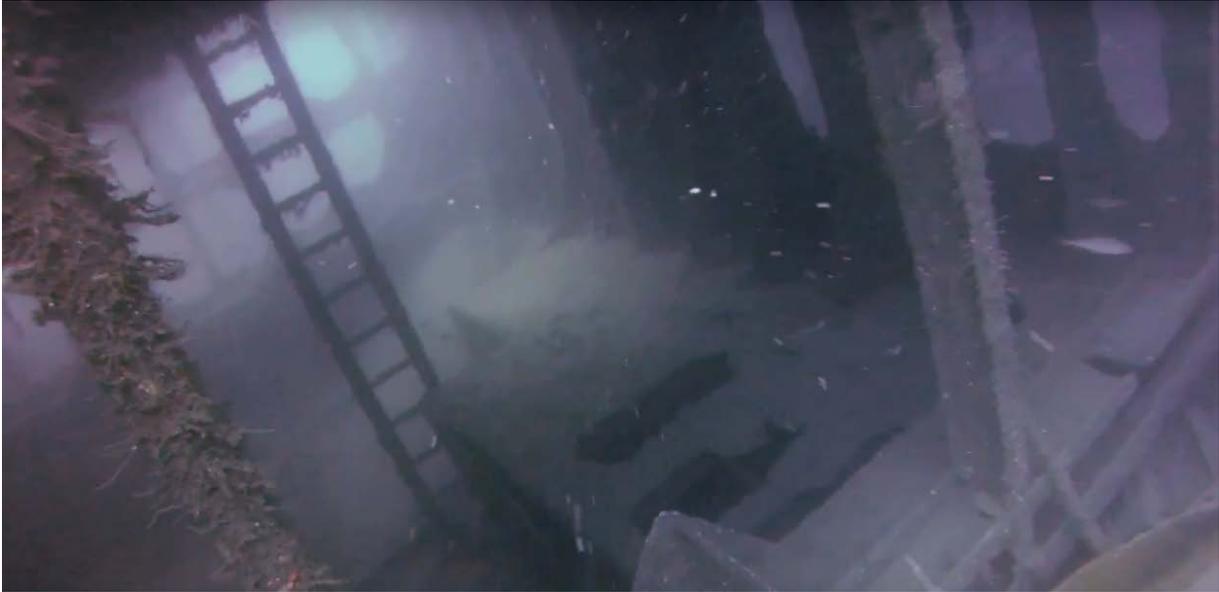
Figure 13: Ladder still in place in hold no 3 (Courtesy Richard Knights <https://www.youtube.com/watch?v=o4yTy5ZTXSc>)

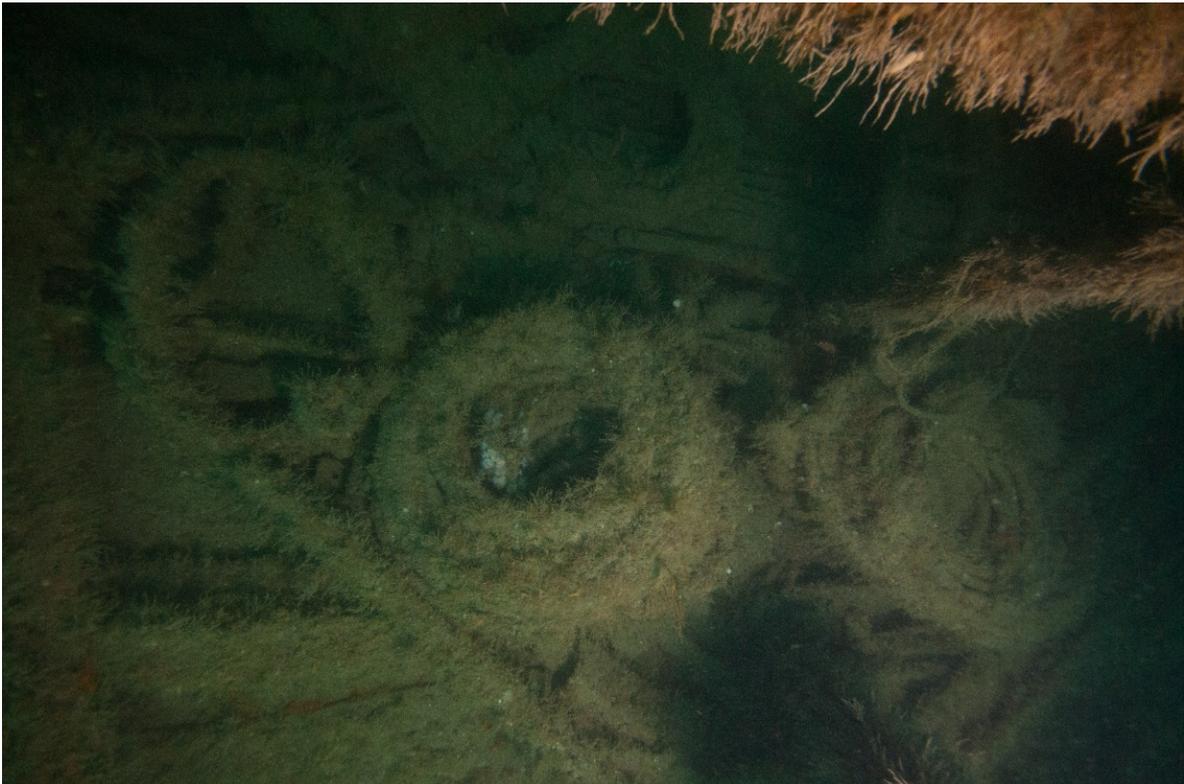
Rope is still coiled on the back deck amongst metal fittings and debris (Figure 14) and the after mast, thought to have been flattened during a wire-sweep, lays across the deck (15).

Figure 14: Coiled rope on the stern deck

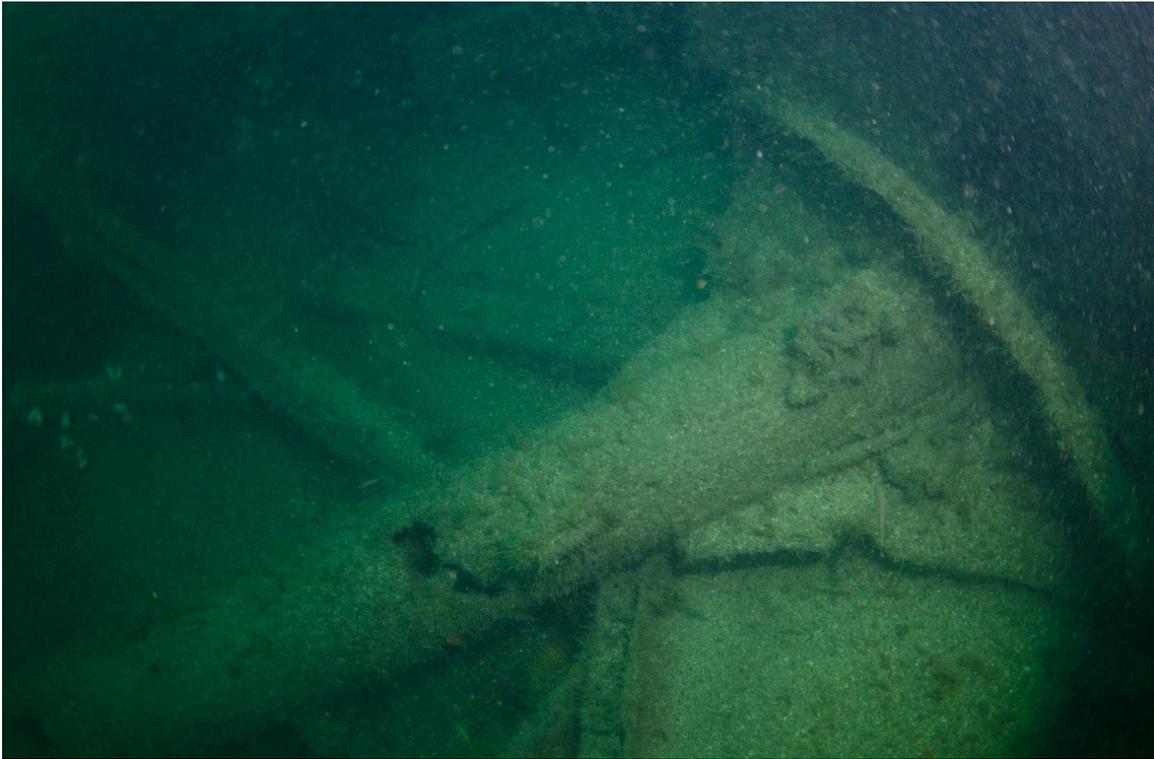
Figure 15: Remains of fallen after mast lying across the deck

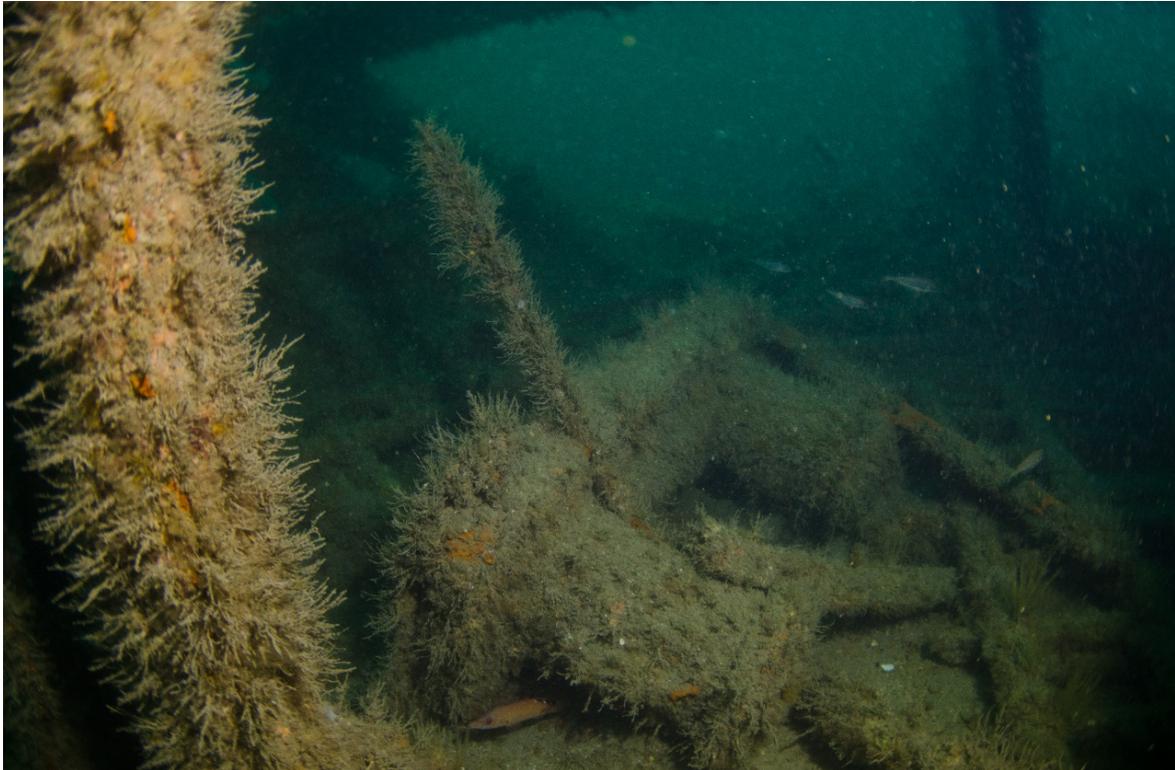
Reaching the poop deck at the stern end of the ship bollards can be seen fallen from their mounts with a ladder lying nearby (Figures 16 and 17).

Figure 16: Bollards fallen from their mounts

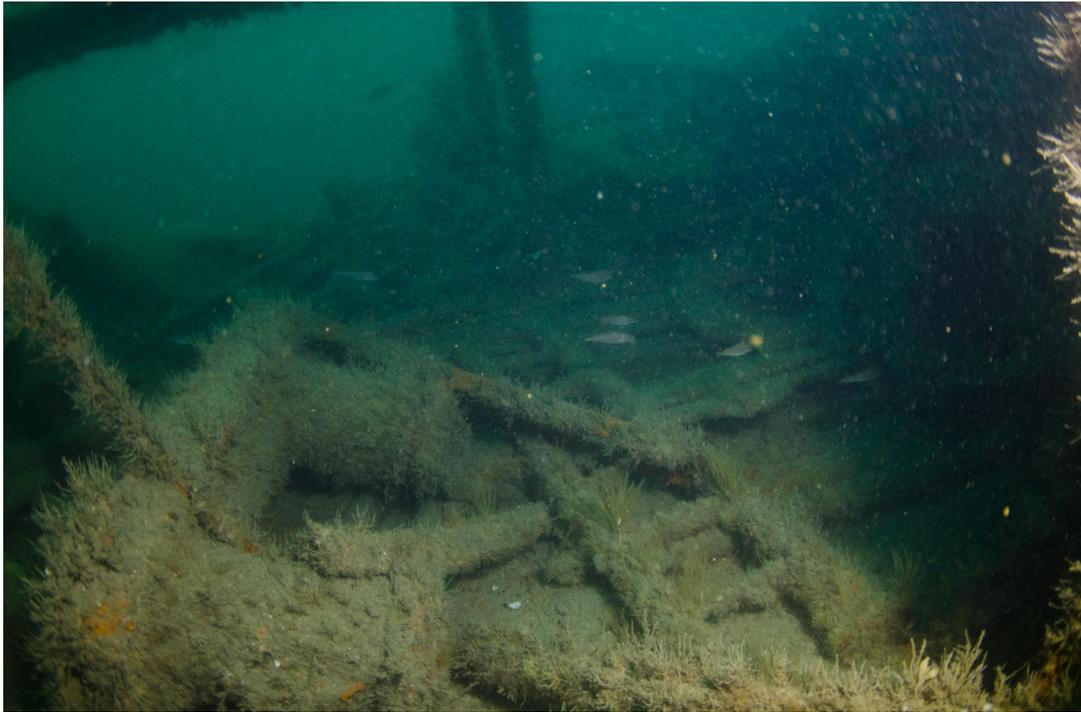
Figure 17: A ladder lies on the poop deck nearby the bollards

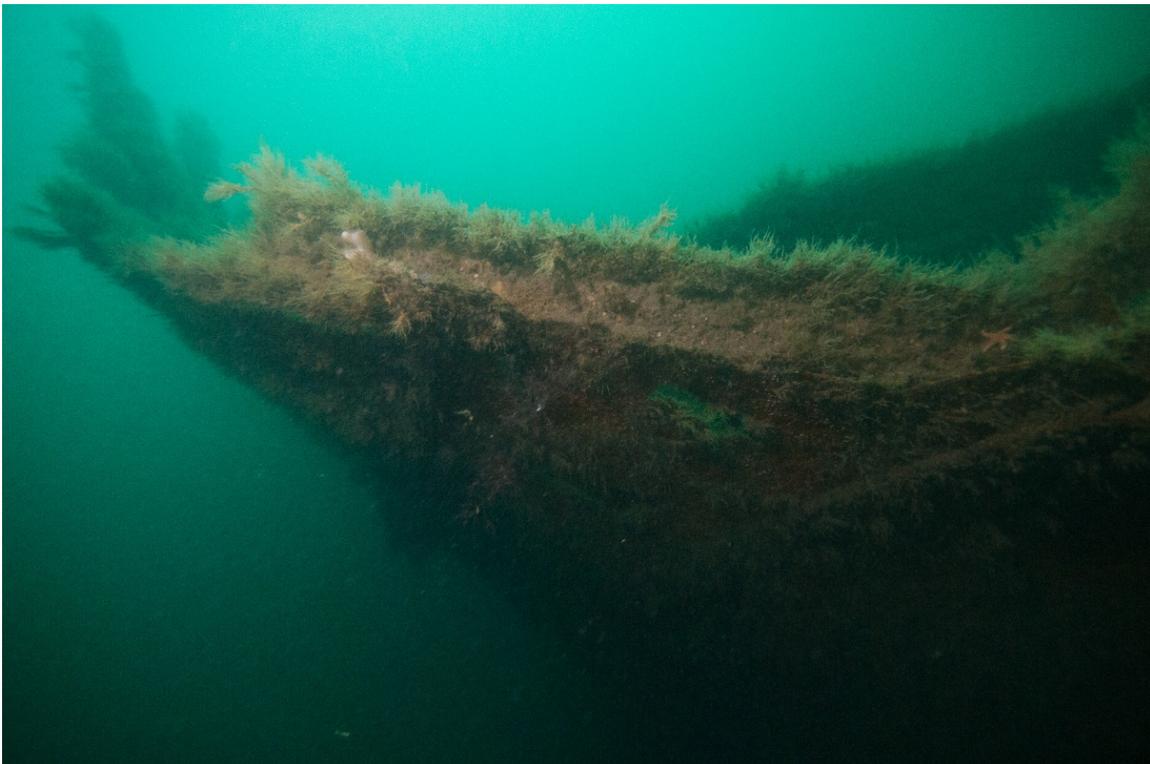
Continuing to the stern of the ship, the once graceful counter stern is still discernible (Figure 18) and looking down from here the fixture for the rudder post is still recognisable (Figure 19).

Figure 18: Counter stern

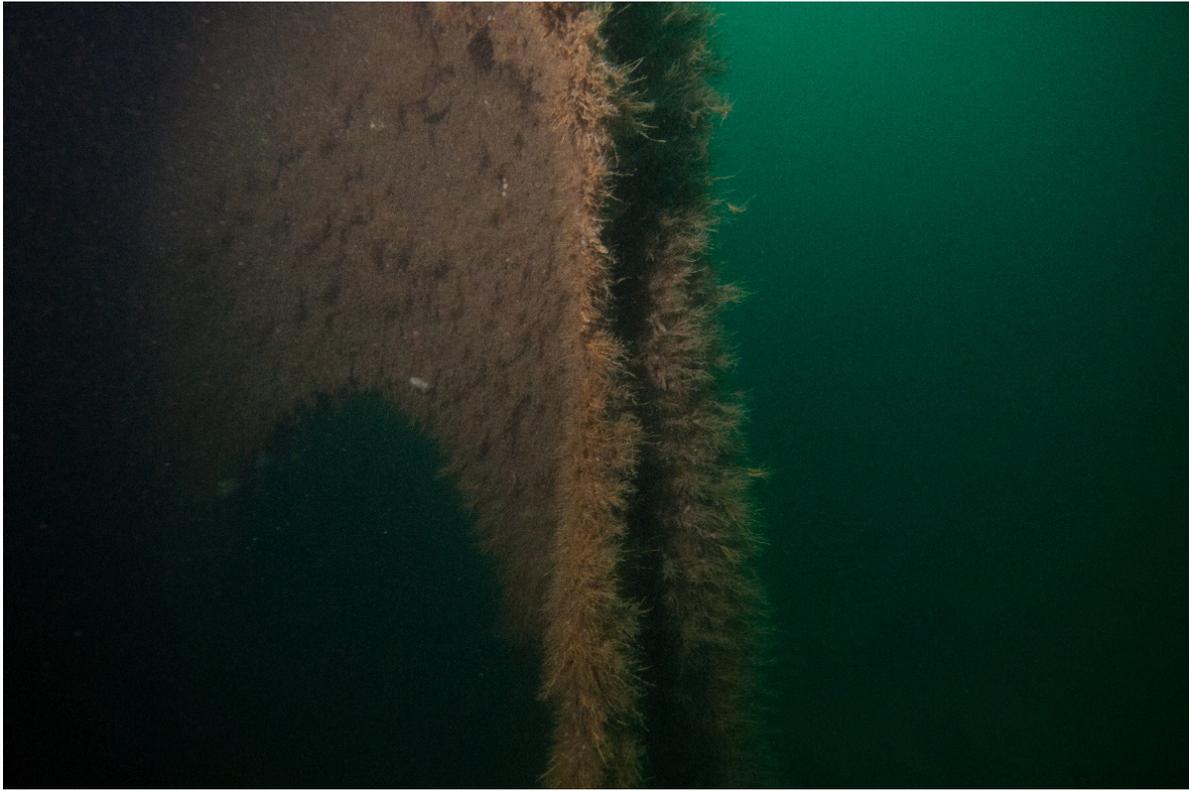
Figure 19: Rudder post fixture

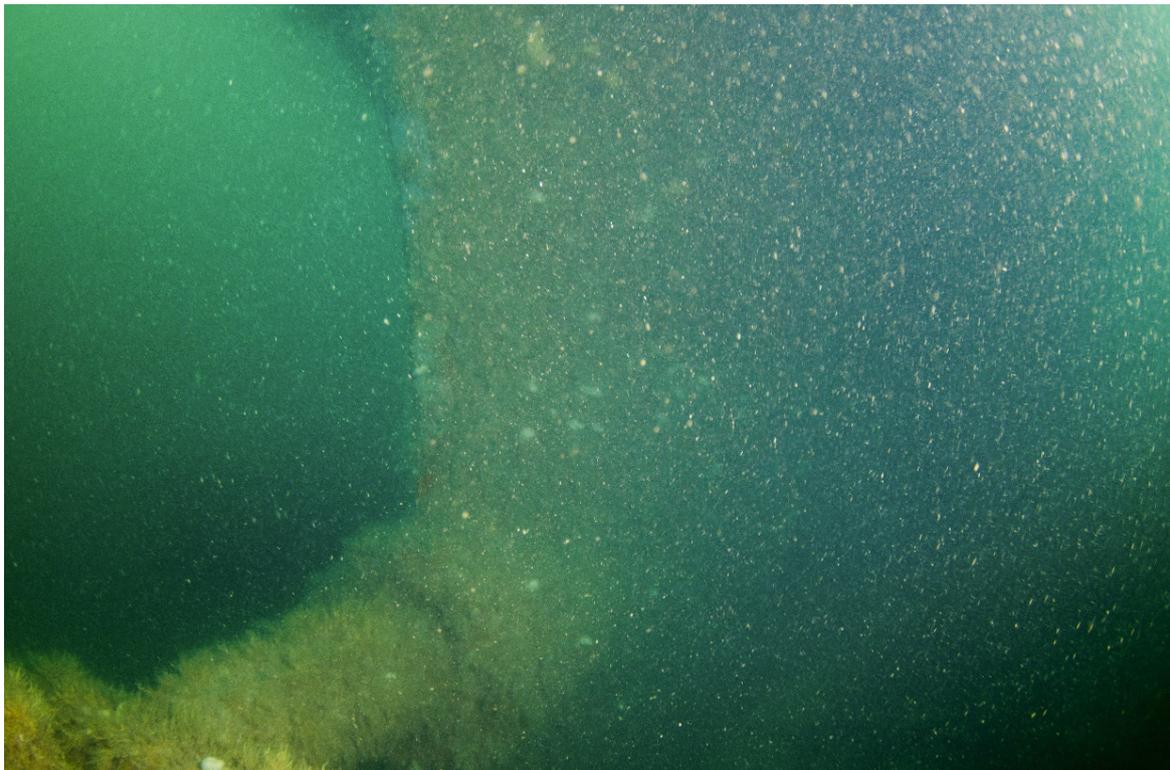
Figure 20: End of prop shaft

At the bottom of the hull, the end of the prop shaft protrudes (Figure 20) where the ship's bronze propeller was once fixed and on the seabed next to the prop lies the gun platform which has fallen from the stern (Figure 22).

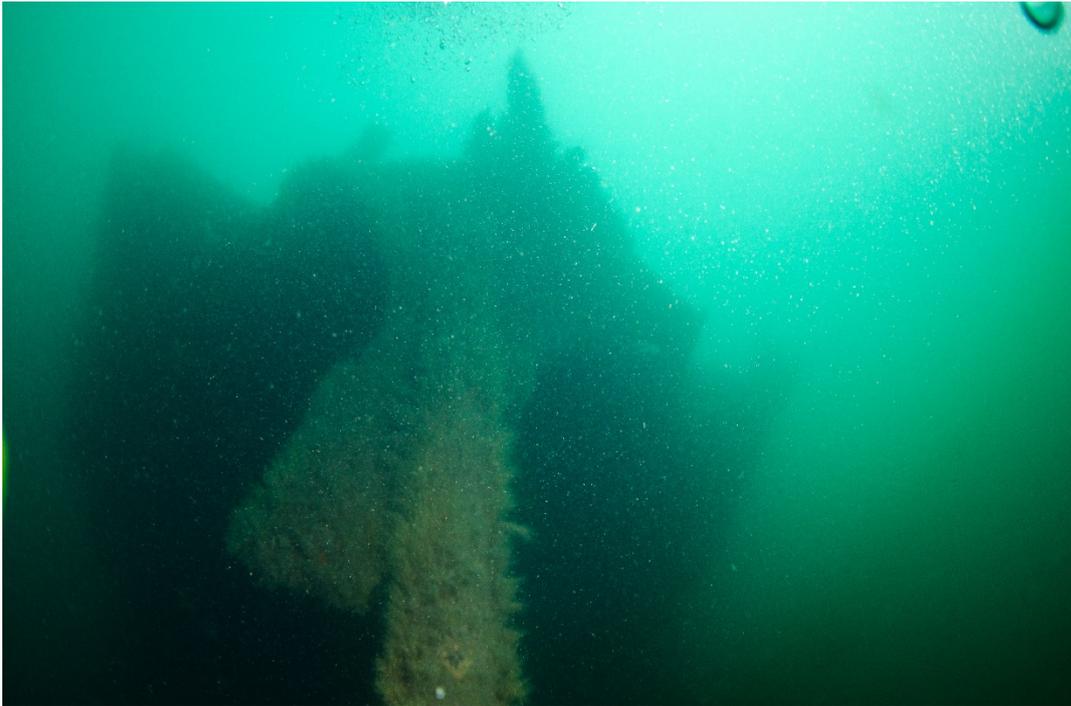
Figure 21: View looking up underneath stern

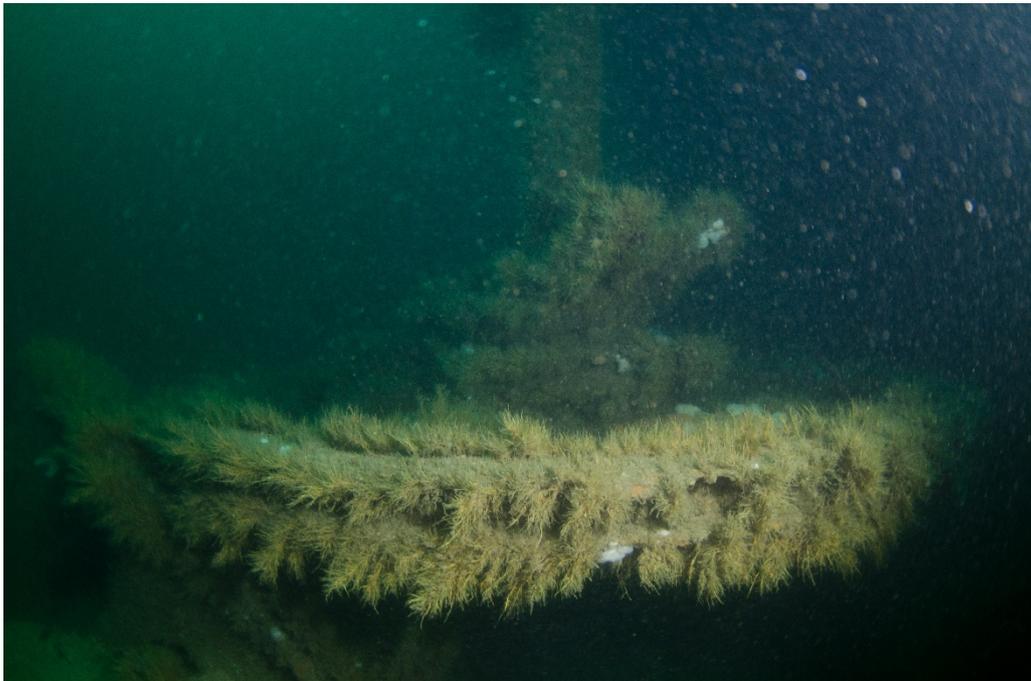
Figure 22: Gun mount now on the seabed

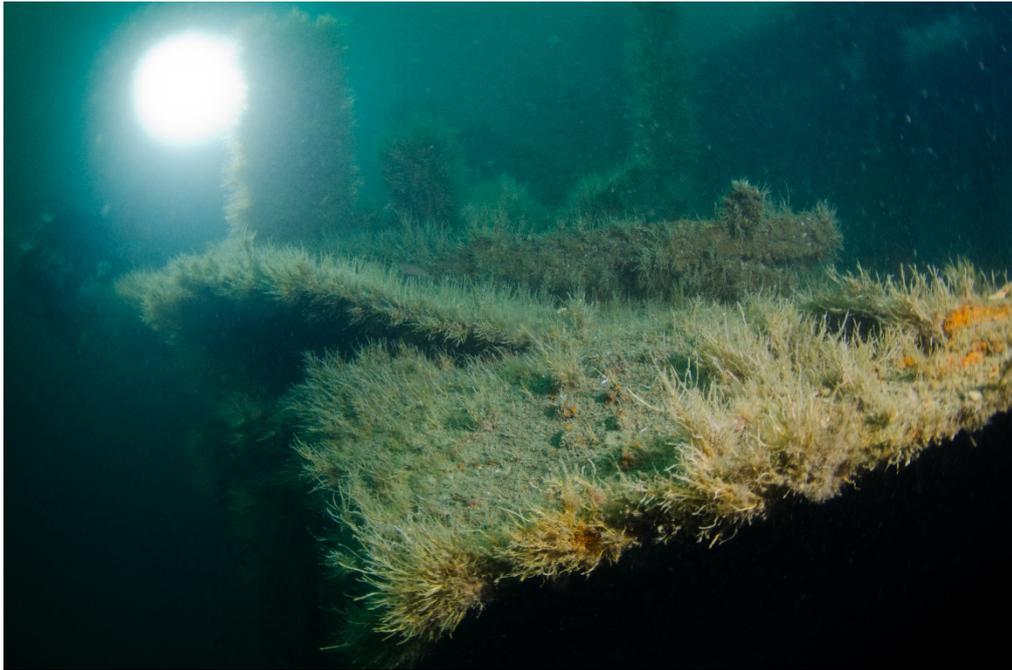
The hull plates are coherent in some areas but broken down in others, the starboard side of the hull is fairly intact but partially collapsed at the back of no 2 hold, whereas there is a large gap where the hull has collapsed and broken down on the port side which is where the torpedo hit. Marine growth is heavy on many parts of the hull plating and plumose anemone and hydroids are in abundance (Figure 23).

Figure 23: Marine growth covers plates

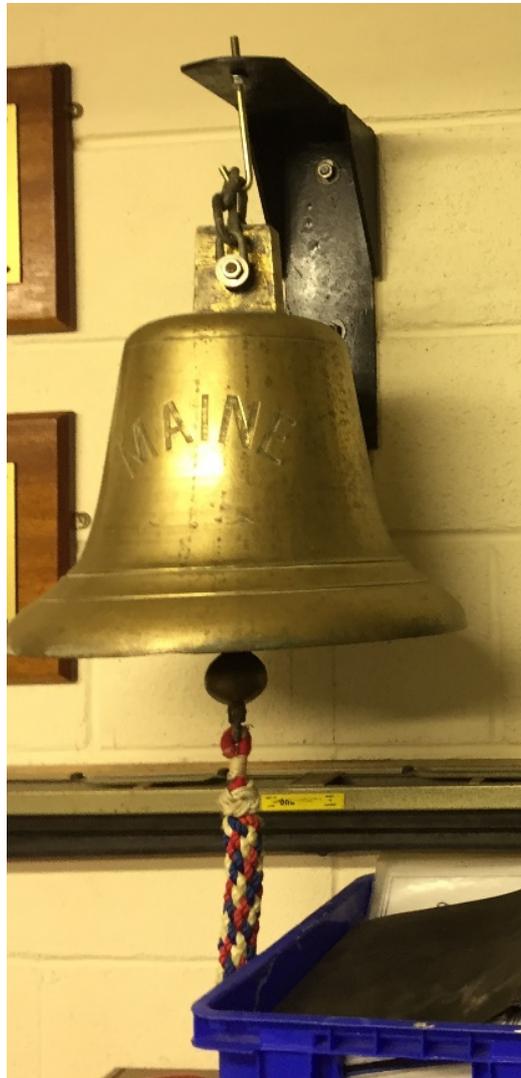
The ships bell was recovered in 1987 and presented to Torbay BSAC. The two-foot high brass bell now hangs in Torbay Sub Aqua Club's compressor building at Torquay harbour (Figure 24).

Figure 24: Ships bell from the *Maine* (photo and permission Richard Wood, Torbay Sub Aqua Club)
