Forgotten Wrecks  
of the  
First World War

*SS South  
Western*

Site Report

***SS South Western*  
SITE REPORT**

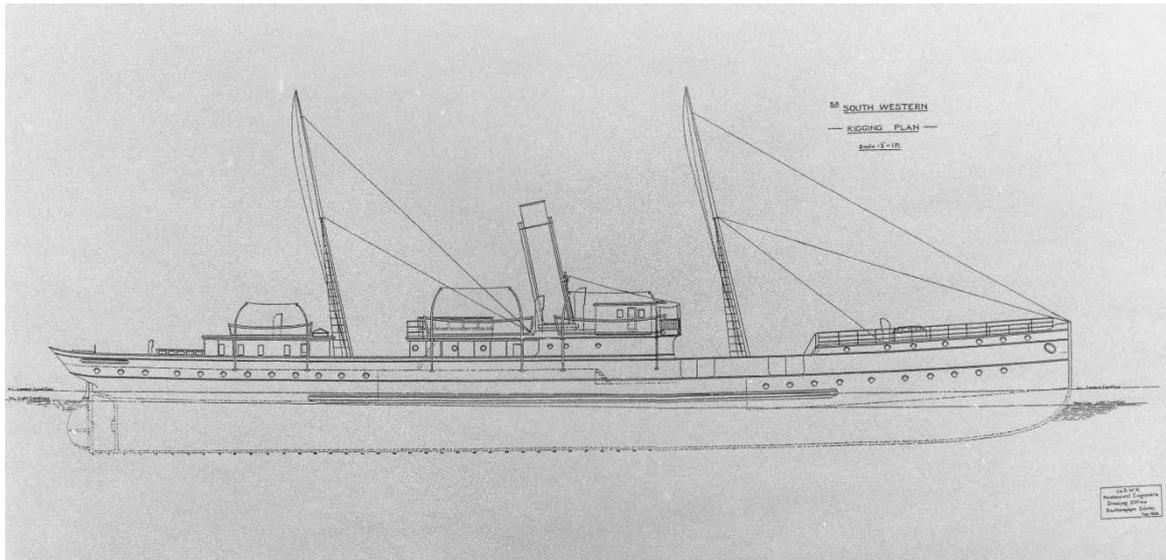
Figure 2: Rigging plan for the *South Western*  
(Dave Wendes collection with permission from The National Archives).

*SS South Western* was built in 1874 by J & W Dudgeon in London. The ship was a single screw, schooner rigged steamer with a gross tonnage of 657 (Figure 2). The 67.7m (222ft) long ship had a beam of 8.26m (27.1ft) and draught of 3.96m (13.5ft). It was powered by a triple expansion engine with 225 nominal horse power and a speed of 13 knots. Its official number was 72341. It was armed with one 13-pounder stern gun.

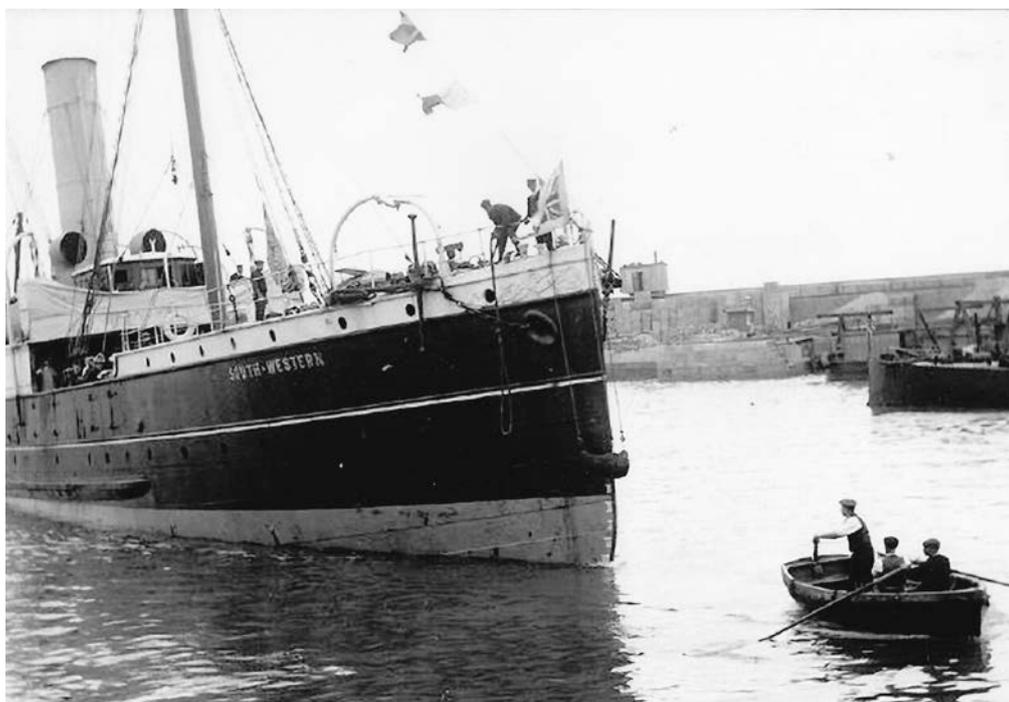
The *South Western* (Figure 3) was built for travelling between Southampton and St Malo and the Channel Islands and began a trial period of use in March of 1875. Later, when bigger ships took over this route, the *South Western* served as a relief ship on other routes and wintered on the St Malo route.

Figure 3: The *South Western* (courtesy of Dave Wendes collection, copyright unknown)

In 1890 the ship had a major overhaul, when the efficiency of steam had finally overtaken sail – it was during this time that a new triple expansion engine and new boilers were fitted. Later, in 1906, electric light was fitted and the deck-house was enlarged. *South Western* operated these routes until 1913 (Le Scelleur, 1985), when a replacement was planned, but with the outbreak of the war the *South Western* was kept on (Masterson, n.d).

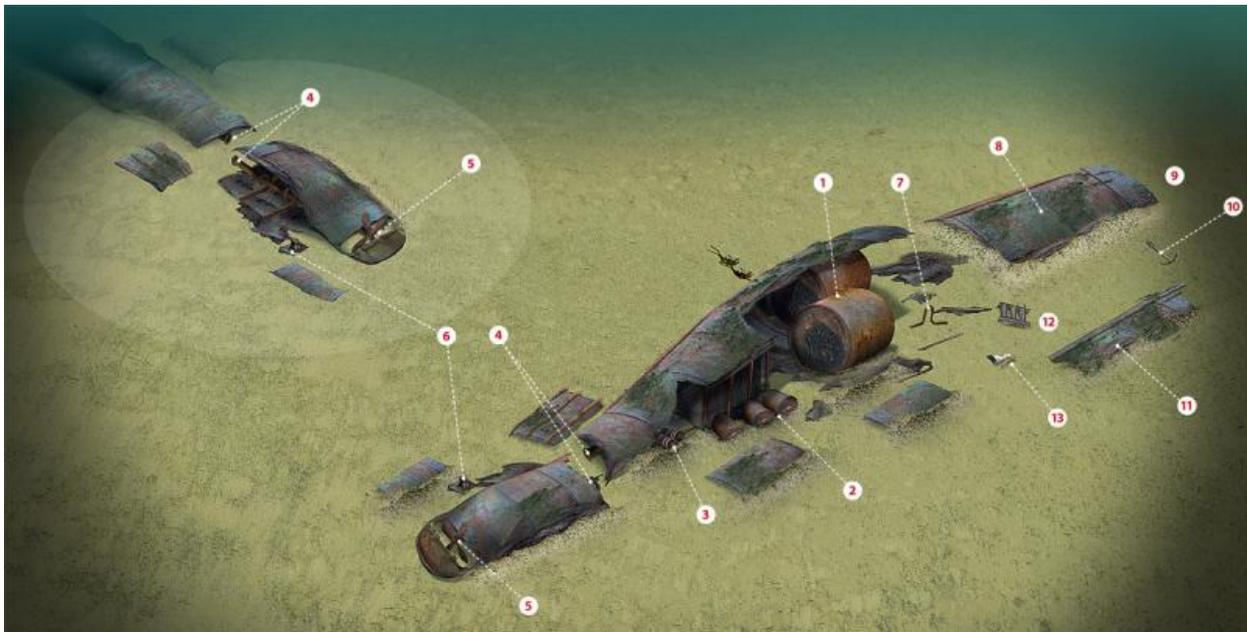
Figure 7: Plan of the *South Western* (Copyright John Liddiard and Max Ellis, with permission)

The wreck tour image generated by John Liddiard and Max Ellis (Figure 8) proved a helpful addition to the photogrammetry survey of the wreck, and it was not apparent that there had been any noticeable deterioration of the remains since this survey (four years earlier).

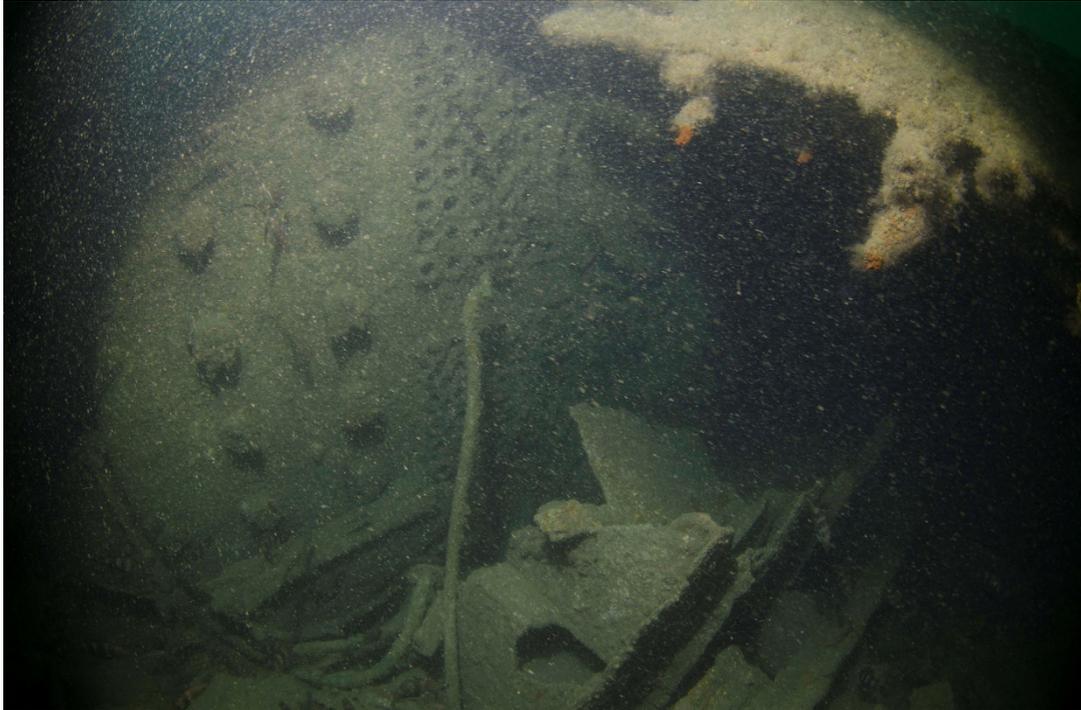
Figure 8: Boiler with hull plating resting on it

The wreck is lying over towards its starboard side and is collapsing further with items of structure moving from their original position. Amidships the two boilers are found with sections of the port side of the hull in that area having collapsed and leaning on one of them shadowing the boiler beneath it (Figure 9). The second boiler, presumably the starboard one, sits beside it, the fire tubes are exposed through the casing (Figure 10). The fireboxes are also evident at what would be the forward end of the boiler (Figure 11).

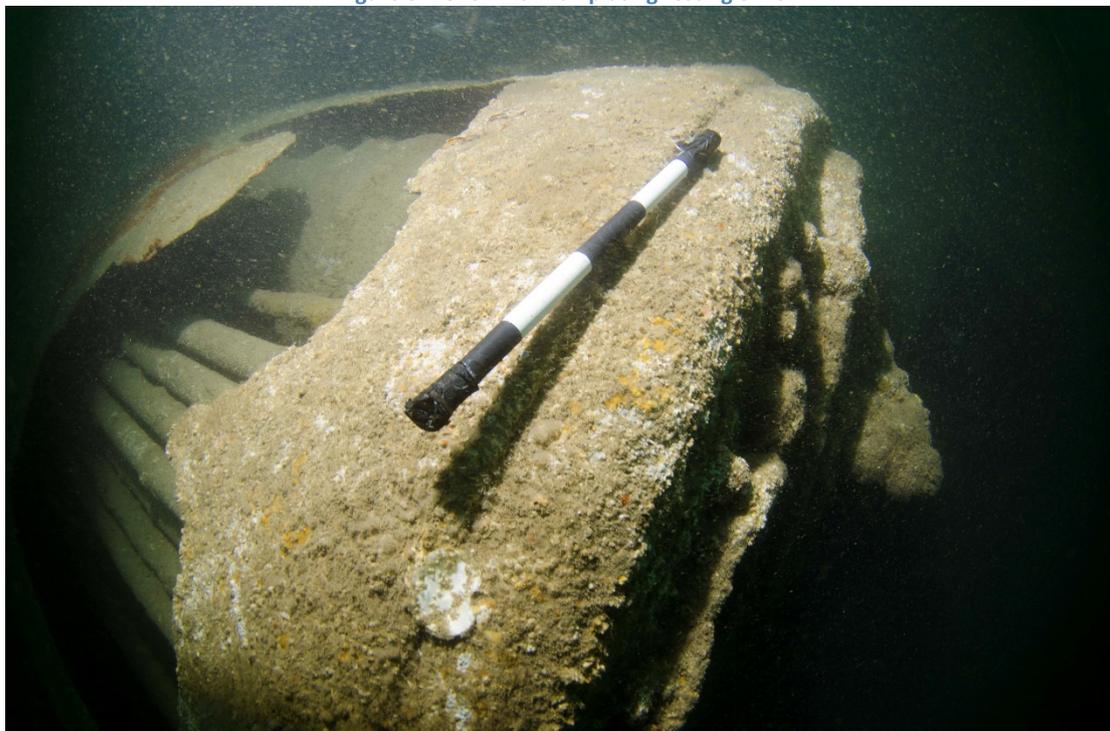
Figure 9: Fire tubes evident through casing

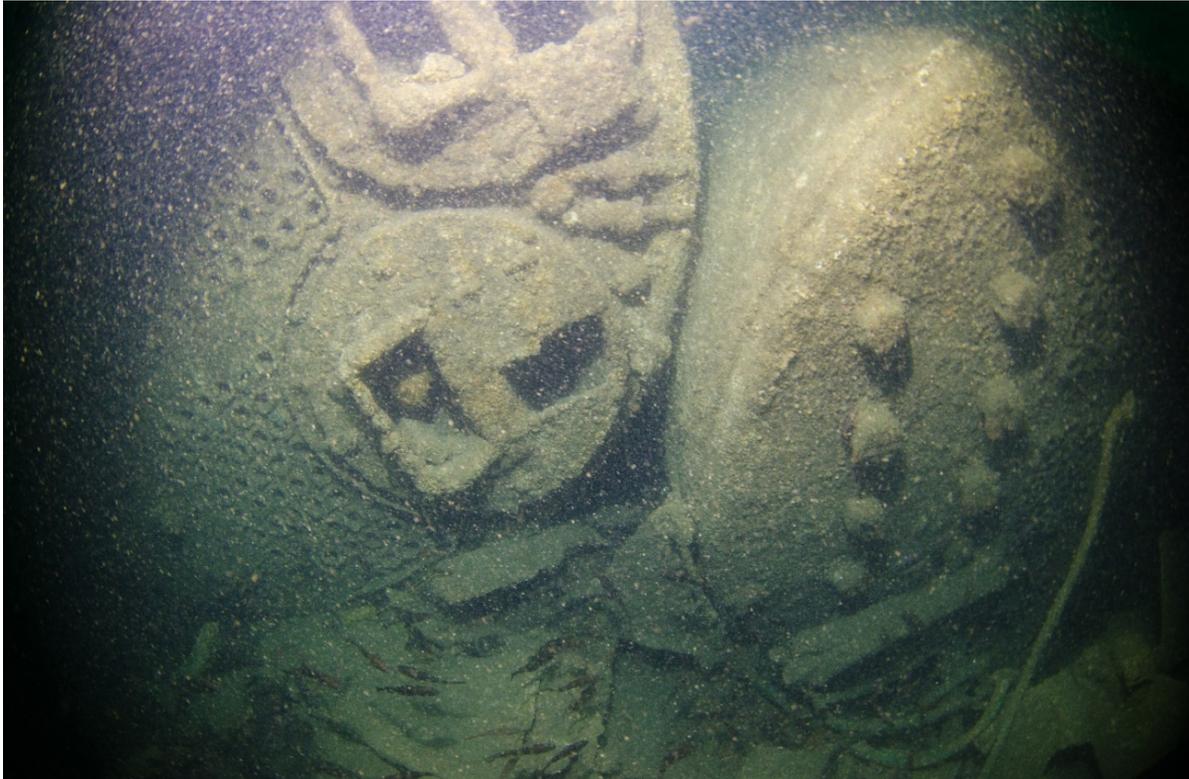
**Figure 10: Fireboxes on boiler**

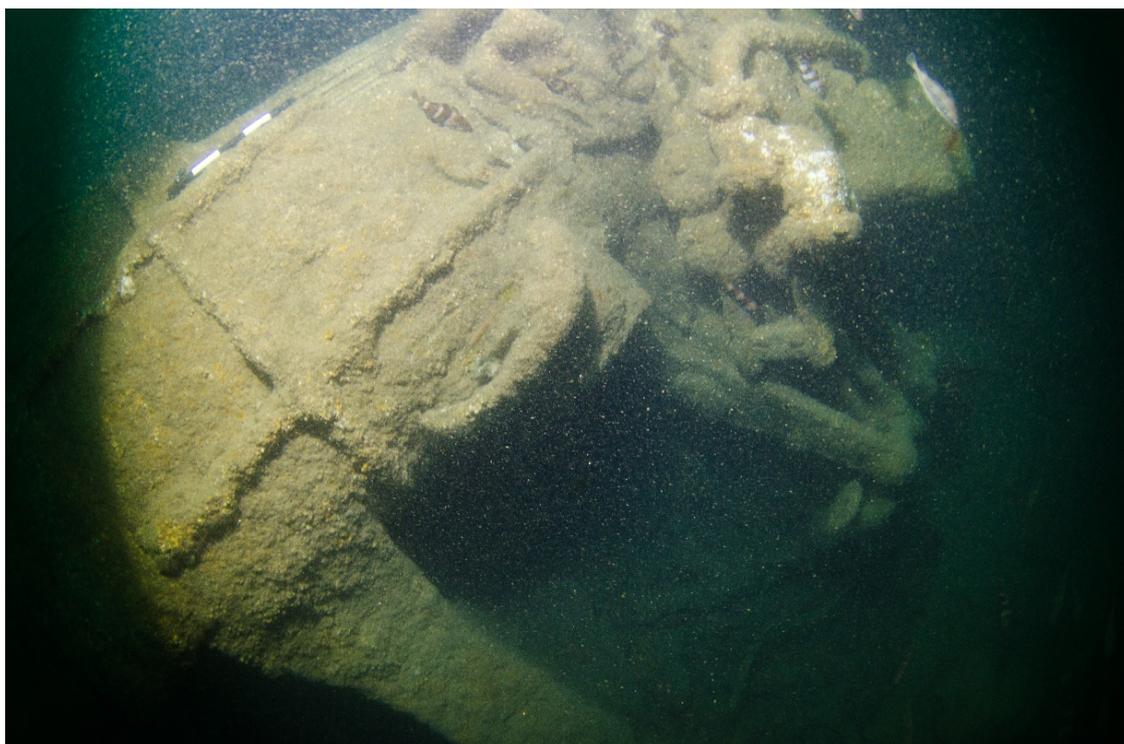
Figure 11: The triple expansion engine

Just aft of the boilers the triple expansion steam engine lies on the seabed having fallen upside down (Figure 12). The pistons protrude from the engine along the seabed. Part of the engine is under collapsed plates of the hull (Figure 13 and 14).

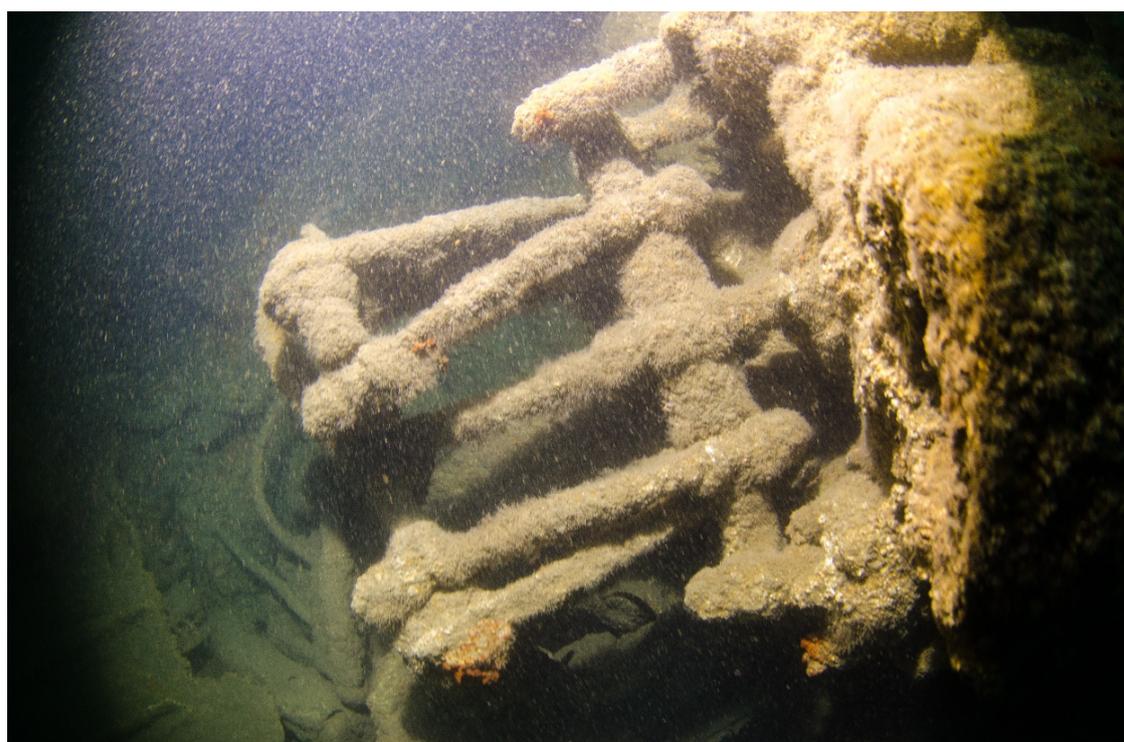
Figure 12: Piston rods beneath the engine

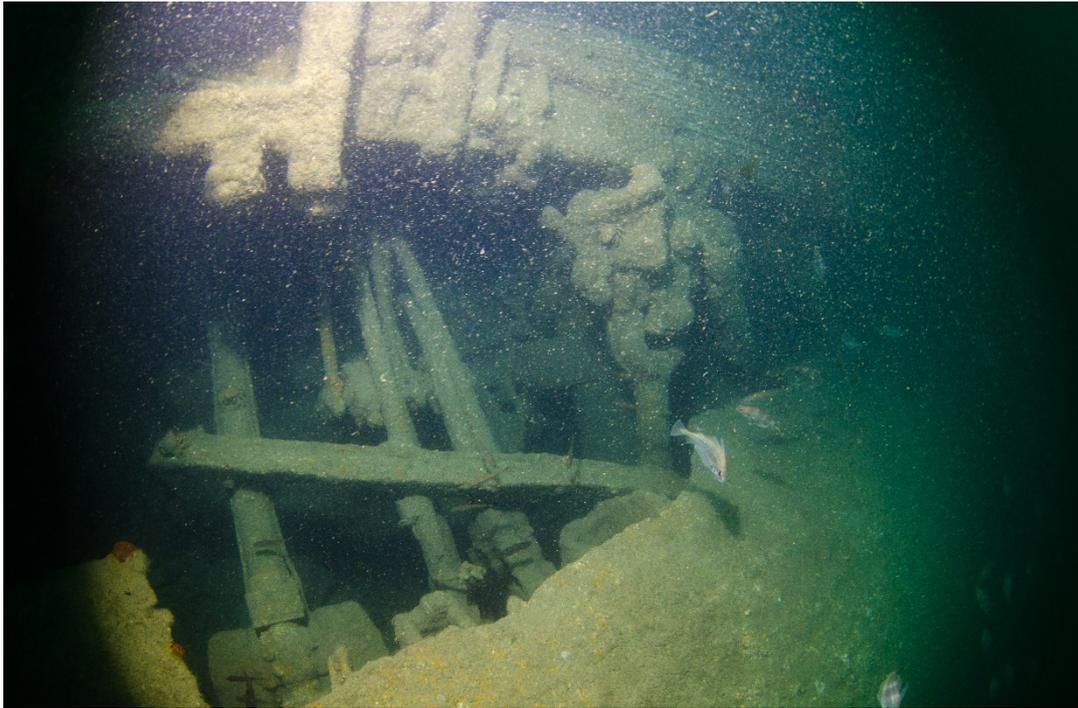
Figure 13: Part of the hull plating is resting on the engine

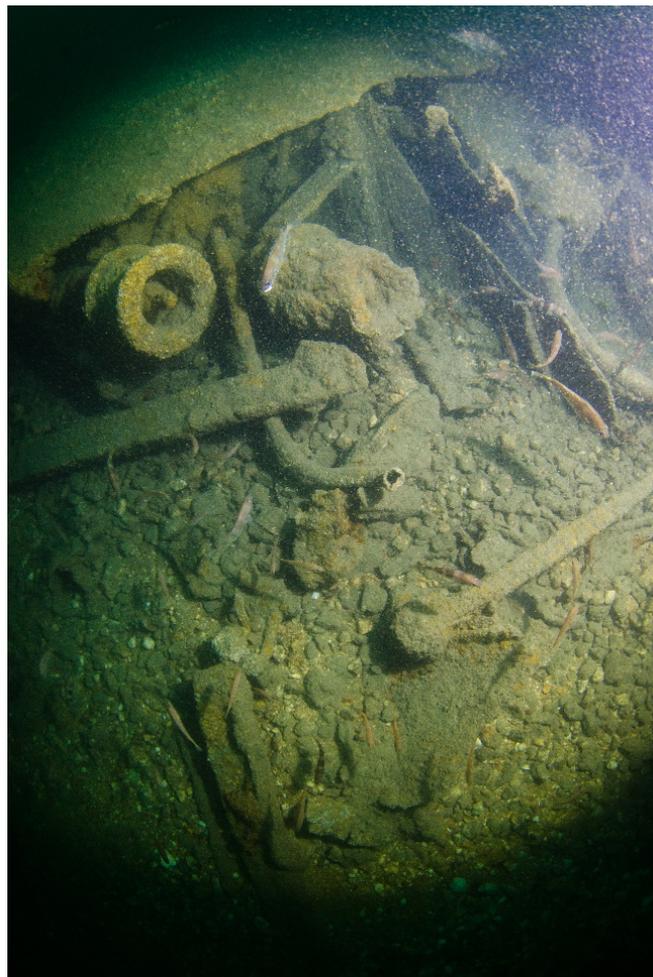
Figure 14: Winch just under the plating

Just near to and just behind the collapsed engine a winch, which was likely a cargo winch, lies slightly under the hull plating (Figure 15). A broken piston rod lies nearby.

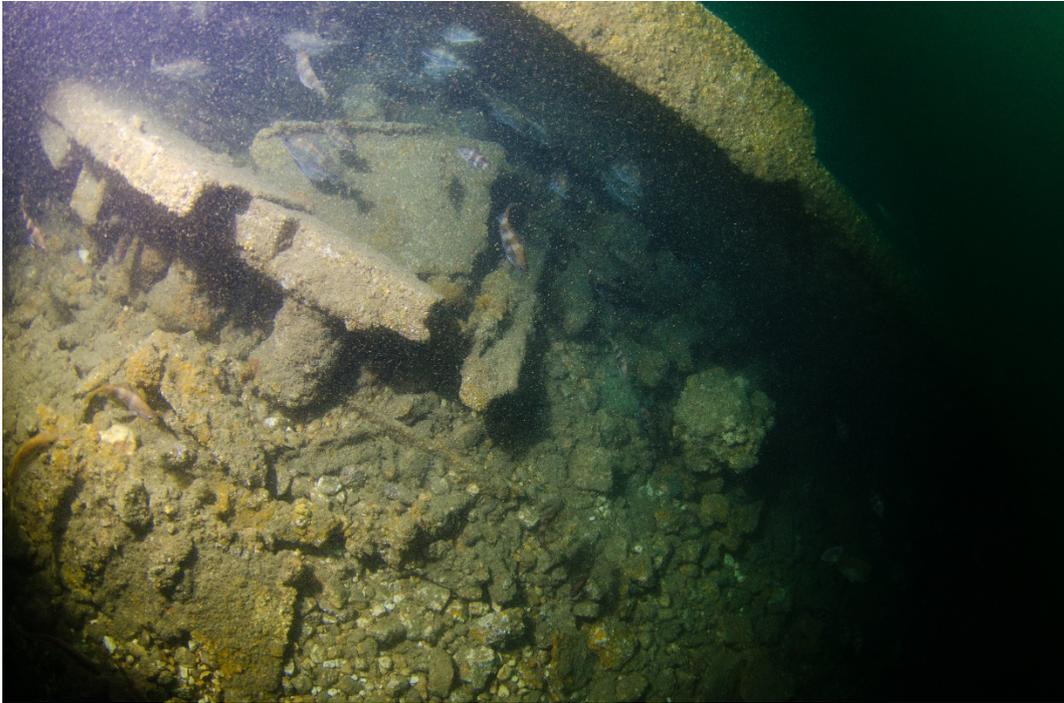
Figure 15: Bollards fallen from deck

Moving further aft the hull is broken apart, a set of bollards have fallen from the deck and lay amongst the debris next to metal plating (Figure 16). Crossing this area amongst broken metal structure, a mangled shell case and what appears to be a complete cod bottle are detected, probably some evidence of the general cargo the ship was carrying (Figure 17).

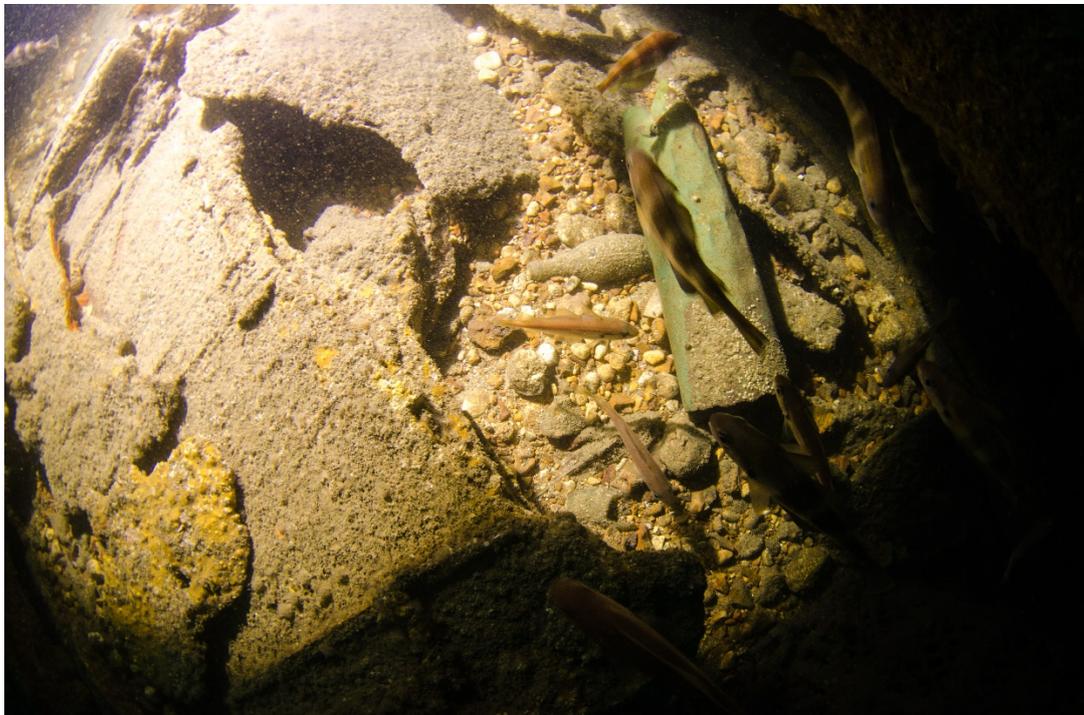
Figure 16: Evidence of cargo, a shell case and cod bottle (middle left of image)

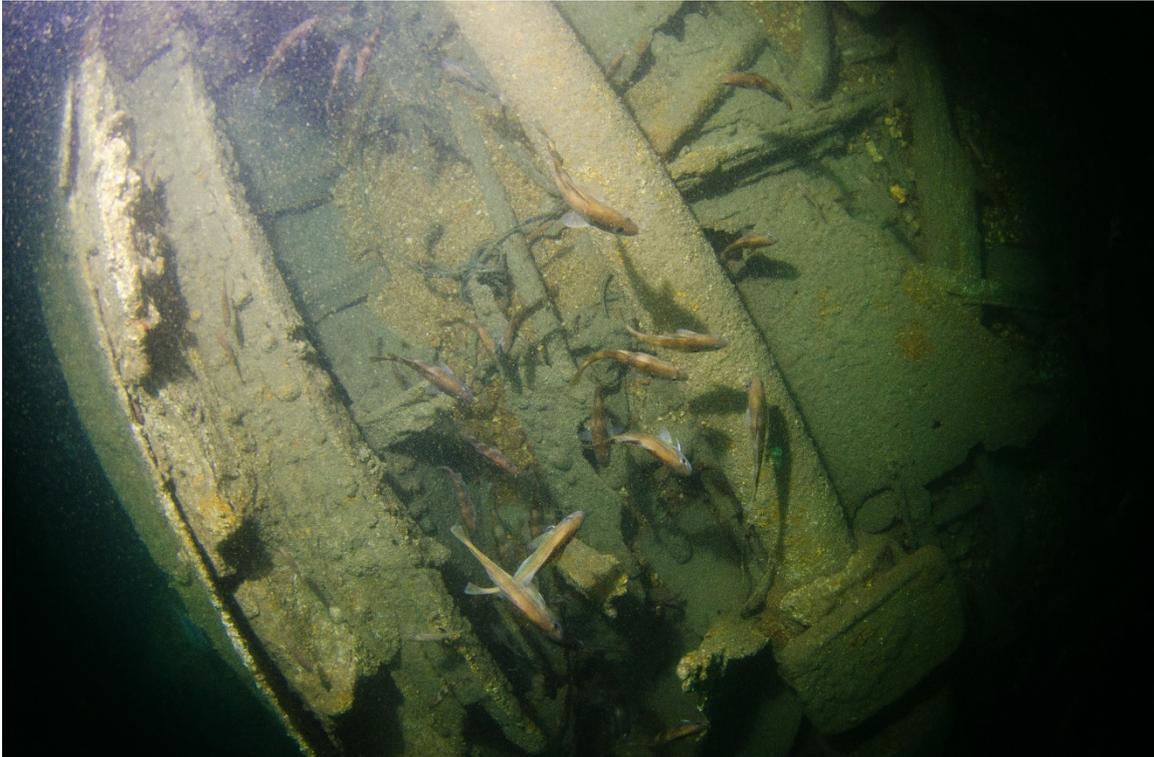
**Figure 17: Propeller shaft complete with one of the flanges**

Towards the stern where the hull has collapsed and the keel has split, the propeller shaft can be traced all the way to the stern (Figure 18) where it can be followed to where the rudder post and propeller are present.

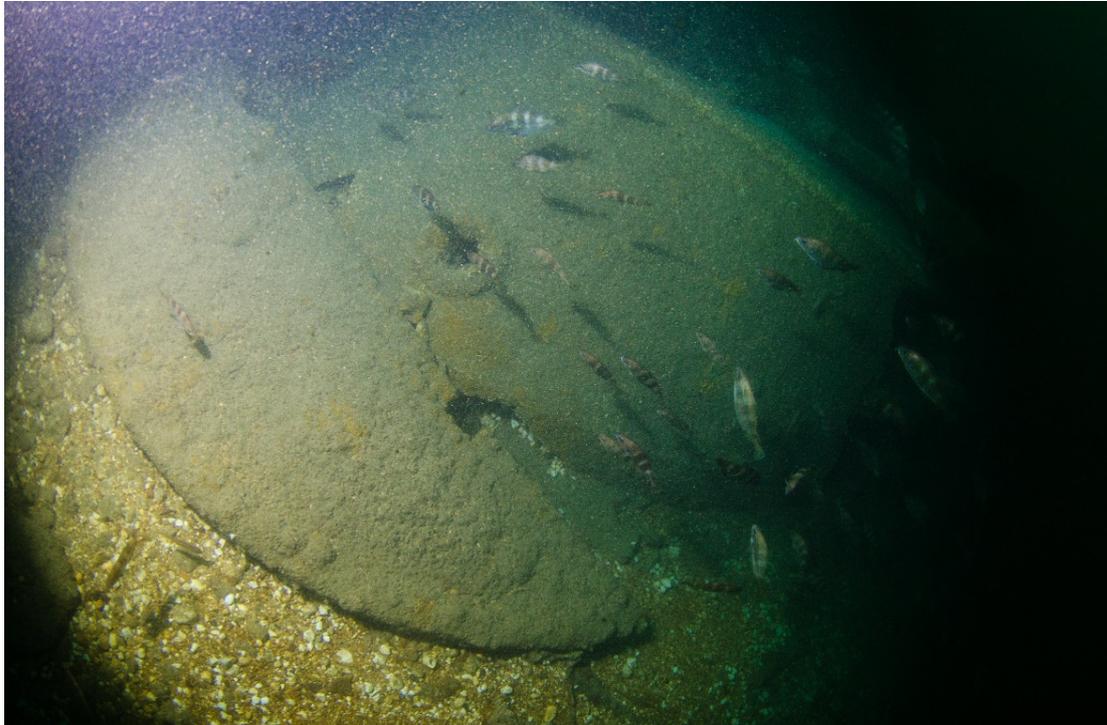
**Figure 18: Collapsed rudder**

At the stern end the rudder is still complete (Figure 19) and has fallen to the seabed with the propeller still attached to its post (Figure 20 and 21).

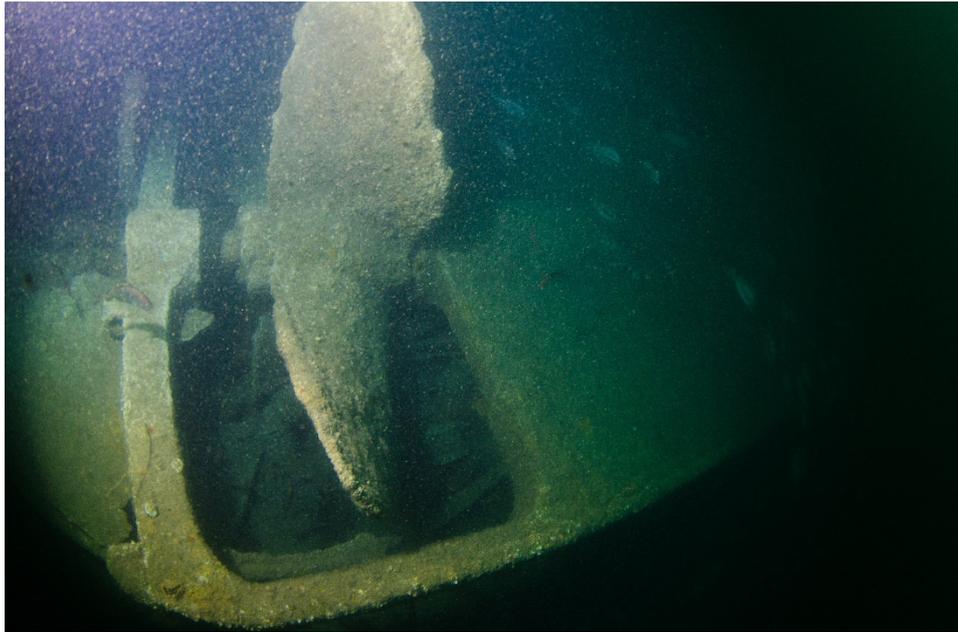
Figure 19: Propeller still in place

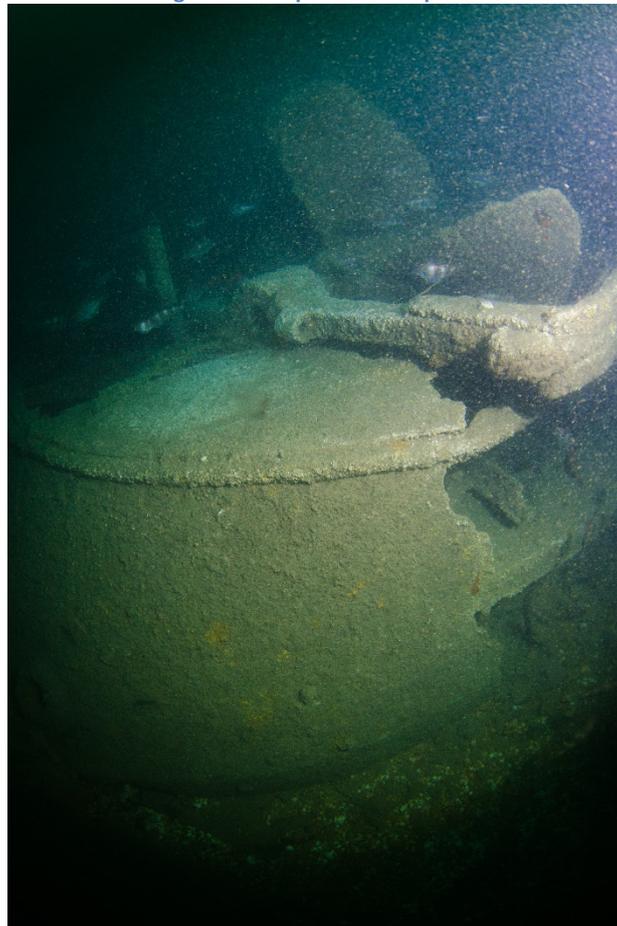
Figure 20: Propeller and rudder stock

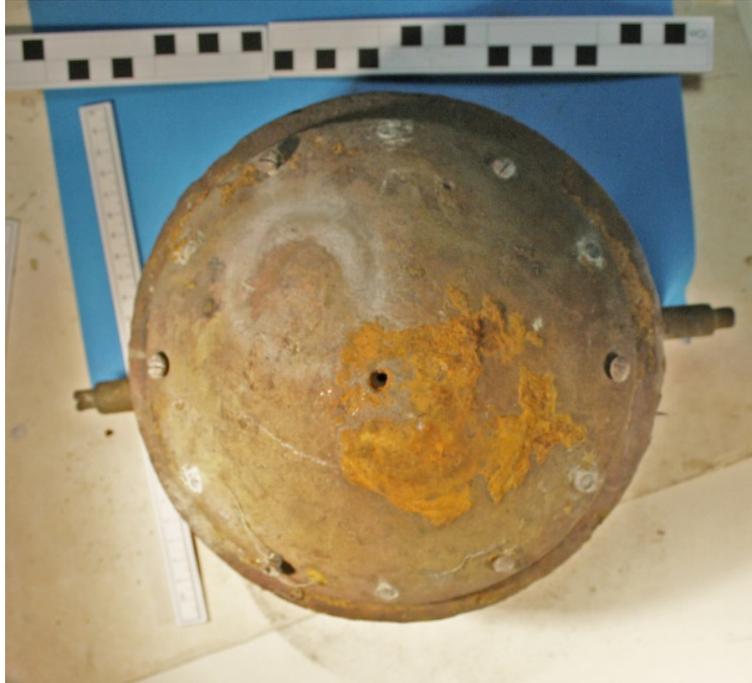
Figure 21: Brass compass bowl from the *South Western* (courtesy of Dave Wendes)

The project identified the following artefacts from the *South Western* which are owned by historian and dive skipper Dave Wendes. They are all from the artefact class 'fixtures and fittings'; they are a brass compass bowl (Figure 22), A bridge telegraph (Figure 23) and a steam pressure gauge (Figure 24).

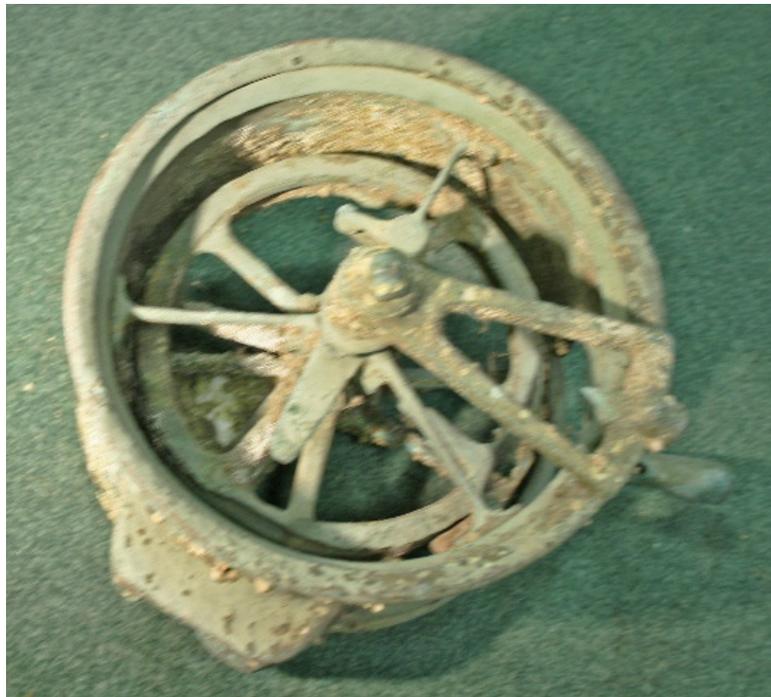
Figure 22: Bridge telegraph from the *South Western* (courtesy of Dave Wendes)

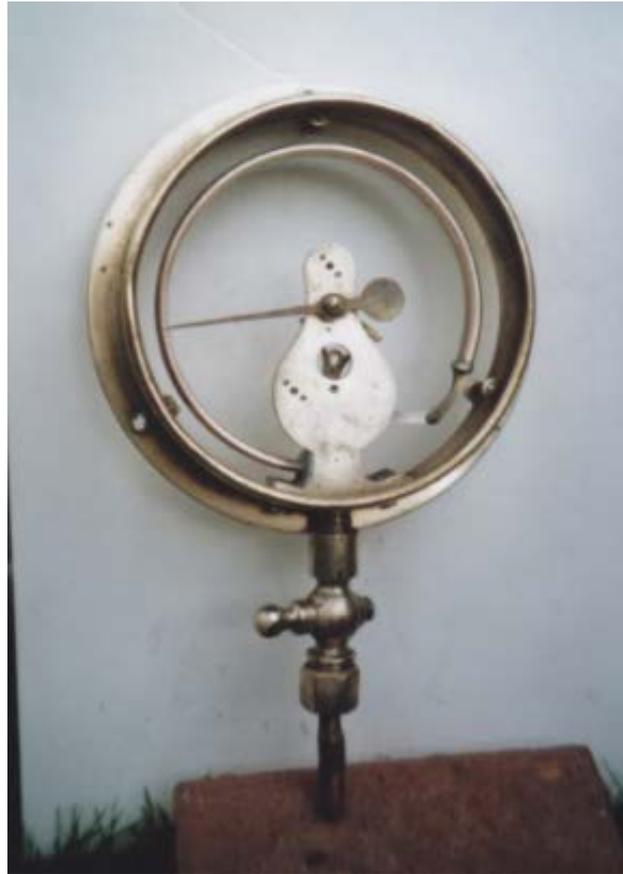
Figure 23: Steam pressure gauge from the *South Western*.
