Forgotten Wrecks  
of the  
First World War

*War Knight*

Site Report

## *SS WAR KNIGHT* SITE REPORT

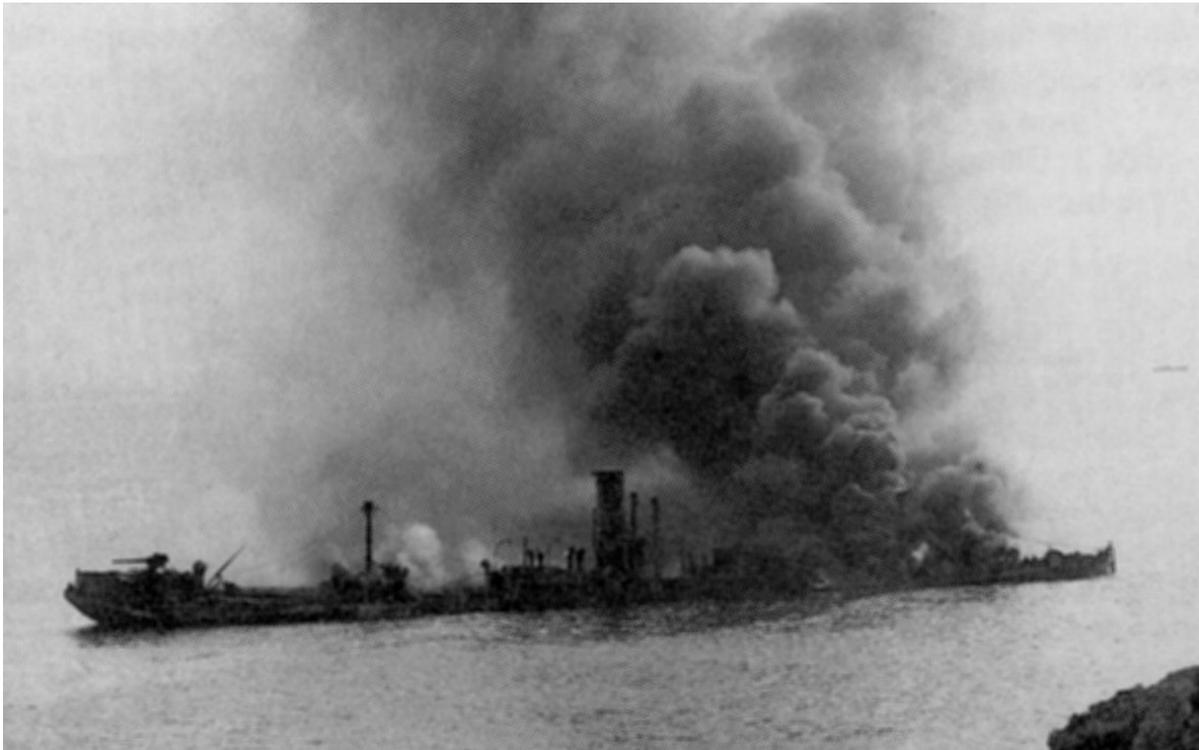
Figure 3: *War Knight* ablaze after the collision  
(Courtesy of the National Maritime Museum and from the Dave Wendes Collection)

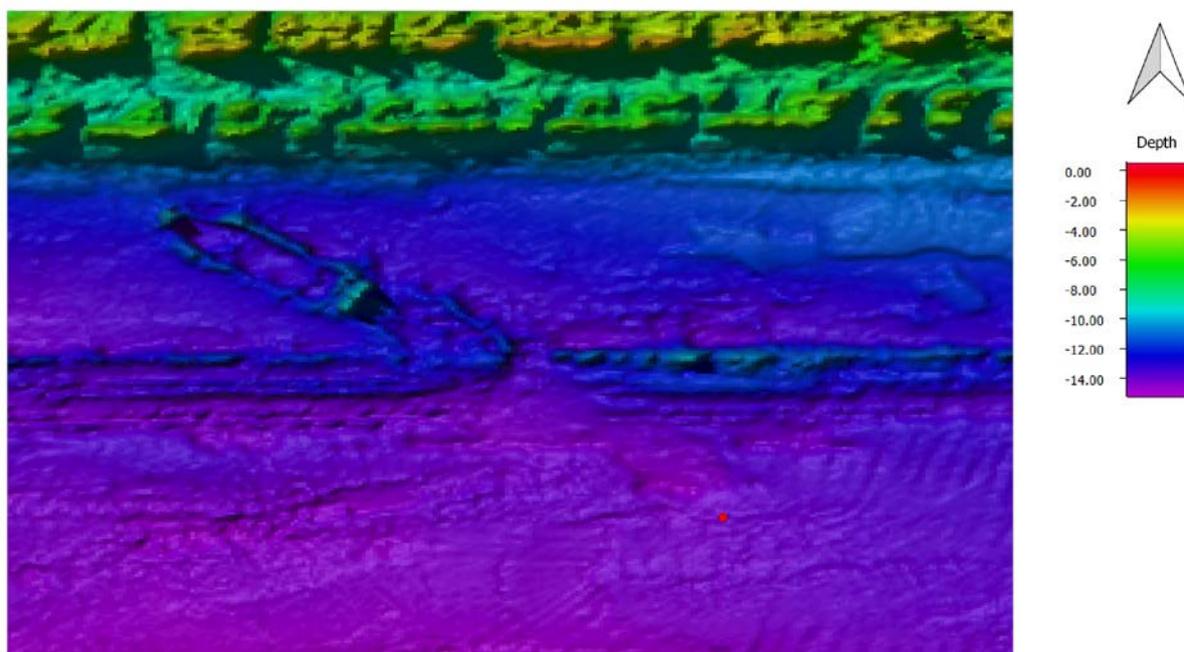
On a clear day it is possible to see the outline of the hull of the *War Knight* sitting upright on the seabed close inshore in a depth of around 13m of water despite being heavily salvaged. The outline of the ship is also visible within geophysical survey data from the Channel Coastal Observatory (Figure 8). The ship's three boilers dominate in the mid-section of the wreck (Figures 8 & 9) standing 3m high with approximately another 1.5m below the level of the seabed. The diameter of each of the three boilers is 4.4m with 0.6m between the middle boiler and the two outer ones.

Figure 8: The *War Knight* site shown within 2011 bathymetry dataset (CCO)

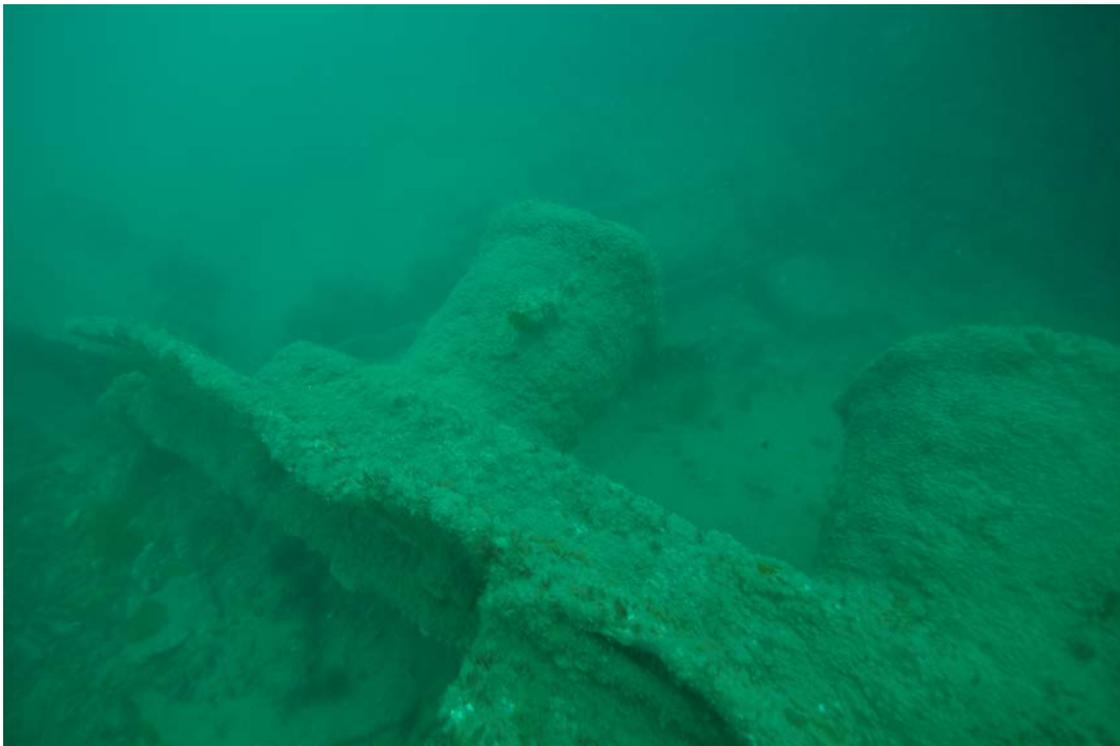
Figure 10: Bollards within the wreckage of the *War Knight* (photo Martin Davies)

Bollards lie within the wreckage (Figure 10) and forward of the boilers there are a series of bulkheads before reaching the chain locker which is still standing upright at the bow. The anchor windlass and hawse pipes lie near the chain locker (Figure 11).

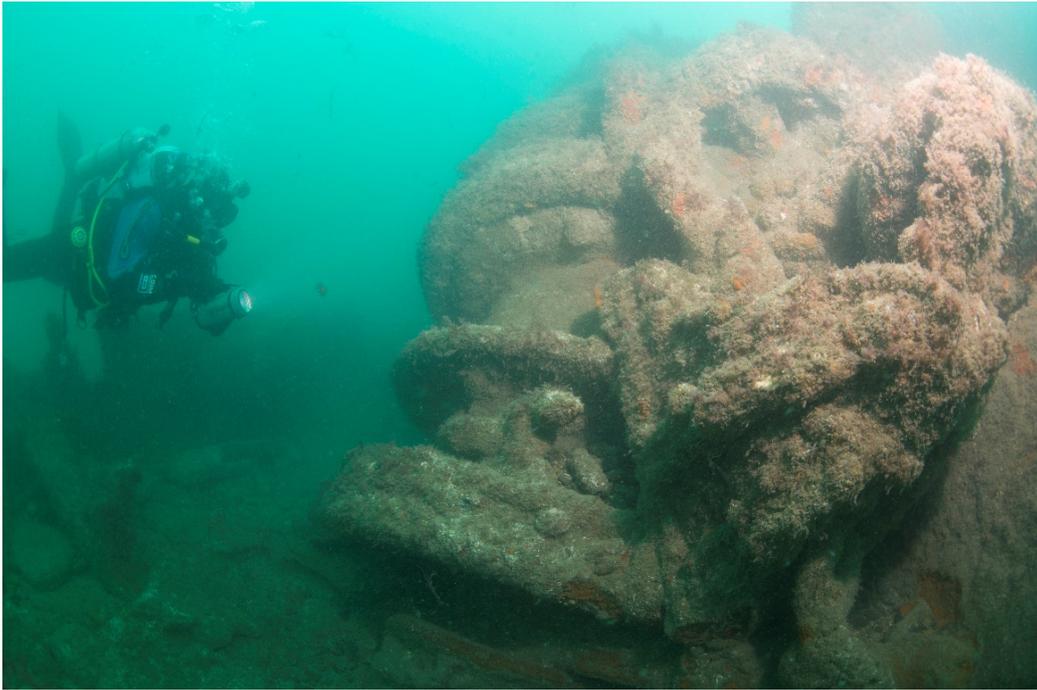
Figure 11: Anchor windlass (courtesy of Michael Pitts)

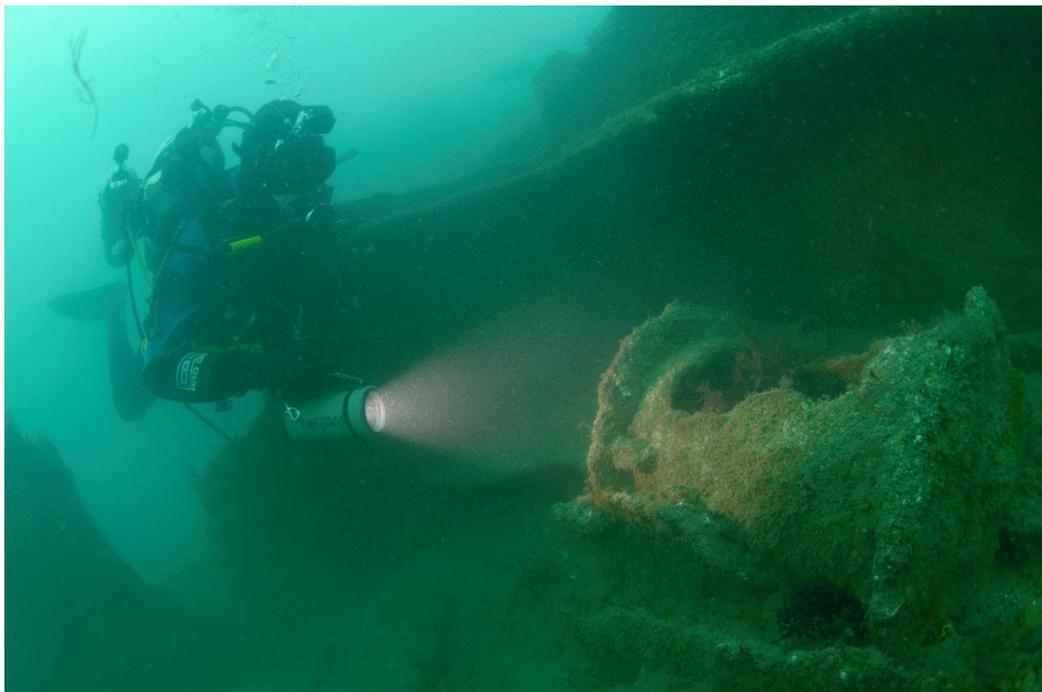
Figure 12: Broken muddled structure (courtesy Michael Pitts)

Sections of the hull still stand high near the forward part of the ship while other sections have collapsed. Structural components are mixed and muddled around the midships to foredeck area, some of which can be seen in Figures 12, 13 and 14.

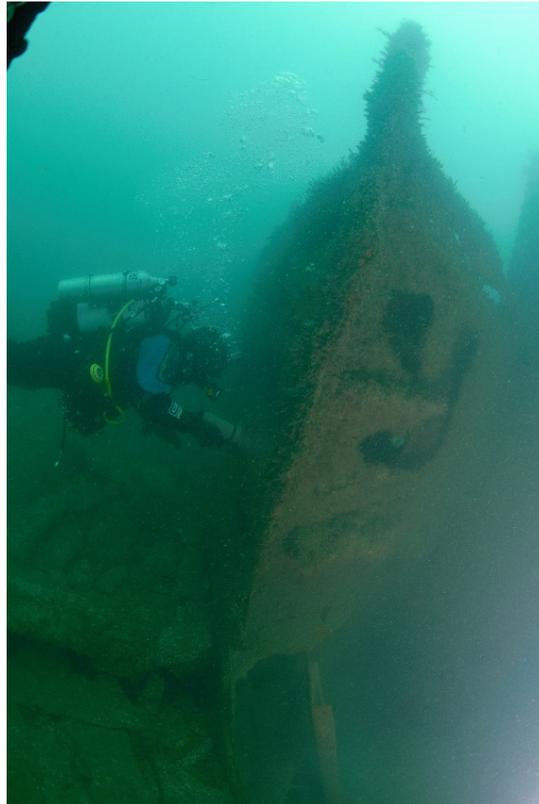
Figure 13: Parts of the hull still stand high (courtesy of Michael Pitts)

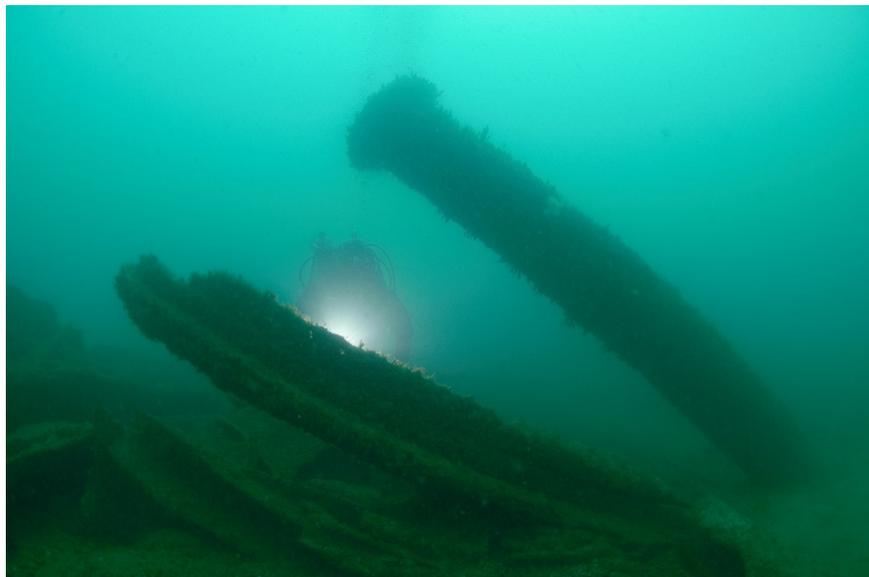
Figure 14: Areas of collapsed hull structure (courtesy of Michael Pitts)

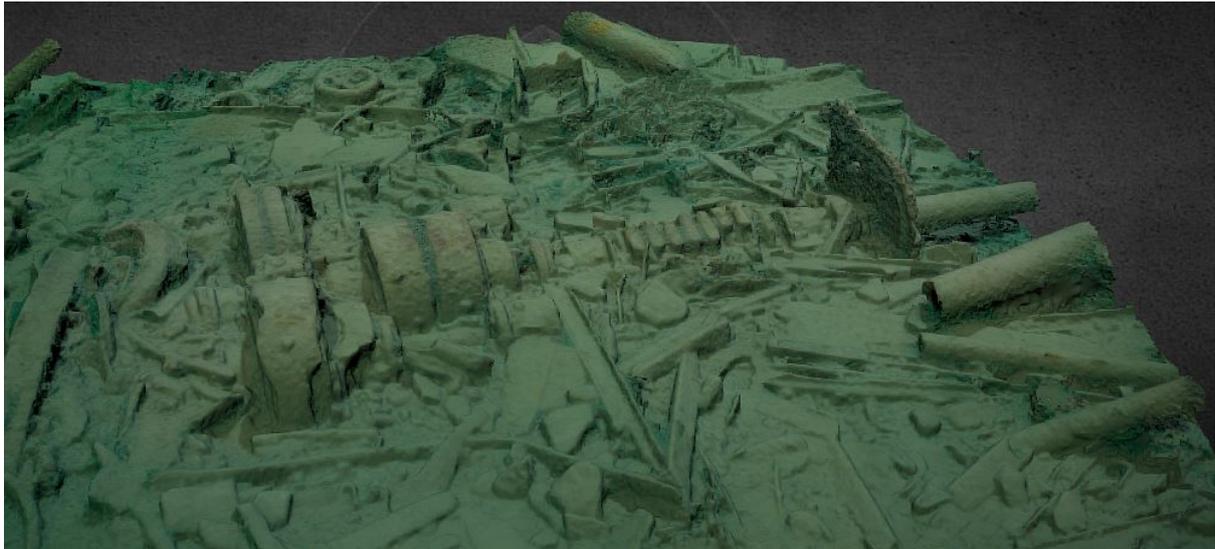
Aft of the boilers are the steam turbines (for more information on these see Section 3.1). A distance of 11.7m was measured between the back surface of the boilers and the beginning of the propeller shaft which measures 30cm in diameter. Photogrammetry was carried out over the aft section of the site by MAT and an interactive 3D computer model of the steam turbine engine (Figure 15) produced which can be seen on the Forgotten Wrecks of the First World War website (Maritime Archaeology Trust, 2015). A detailed measured survey of the steam turbine components was undertaken by Andy Williams, the results of which are shown in Figure 16.

Figure 15: 3D model of the steam Turbine Engine and propeller shaft on the wreck of the *War Knight* the model can be viewed at <https://sketchfab.com/models/e2e26a778cdd4744be357056b8fdad1b>

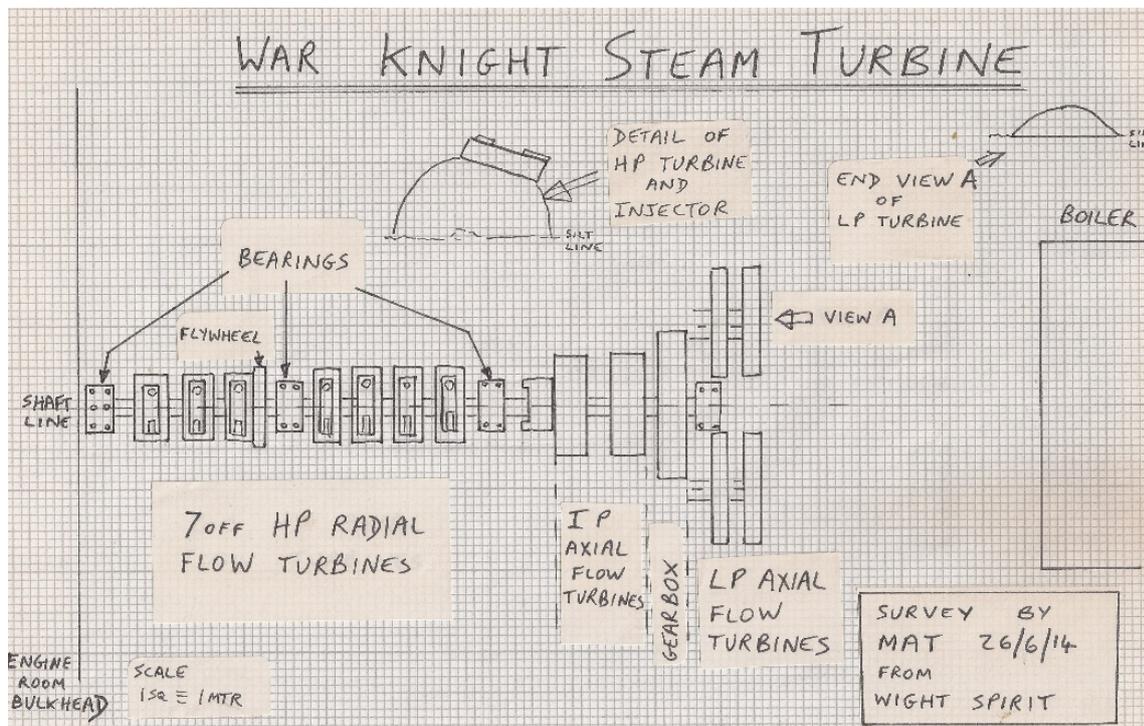
Figure 16: Scale plan of the steam turbine engine on SS *War Knight* (drawing courtesy of Andy Williams)

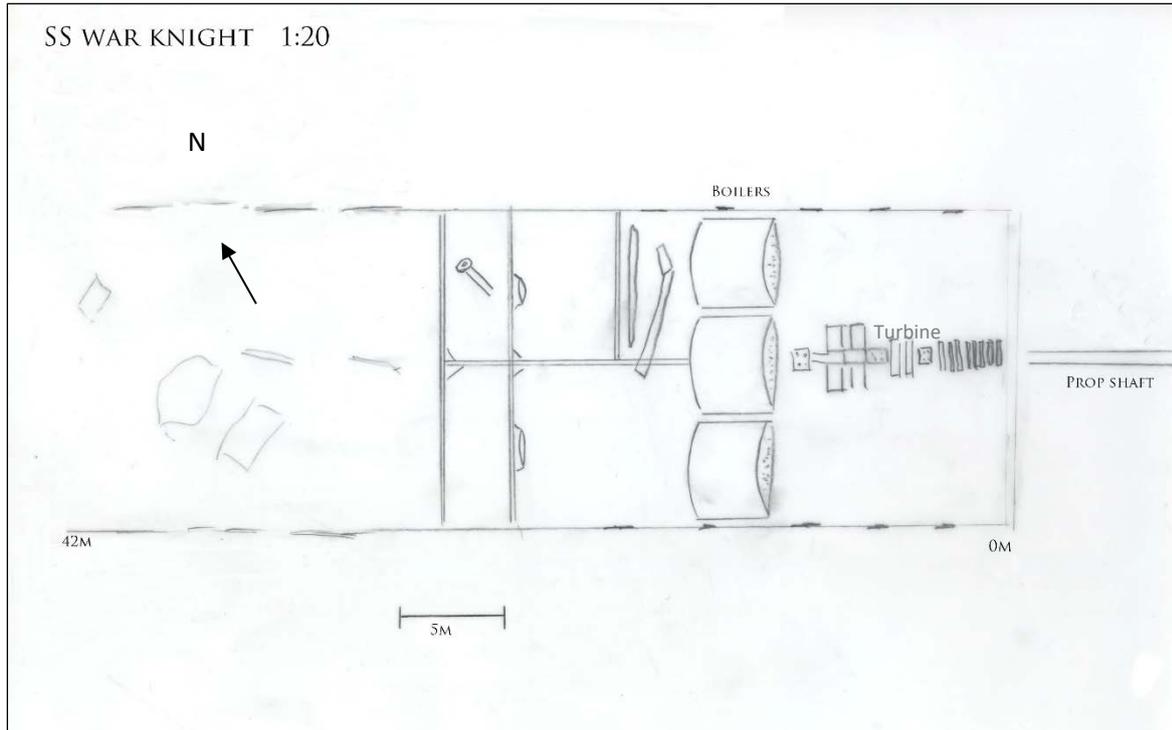
A measured sketch was produced (Figure 17) of the aft of the vessel to the bulkheads just forward of the boilers, the propeller tunnel can be seen in Figure 18 and 19.

Figure 17: Measured sketch of aft-midships section of *War Knight*

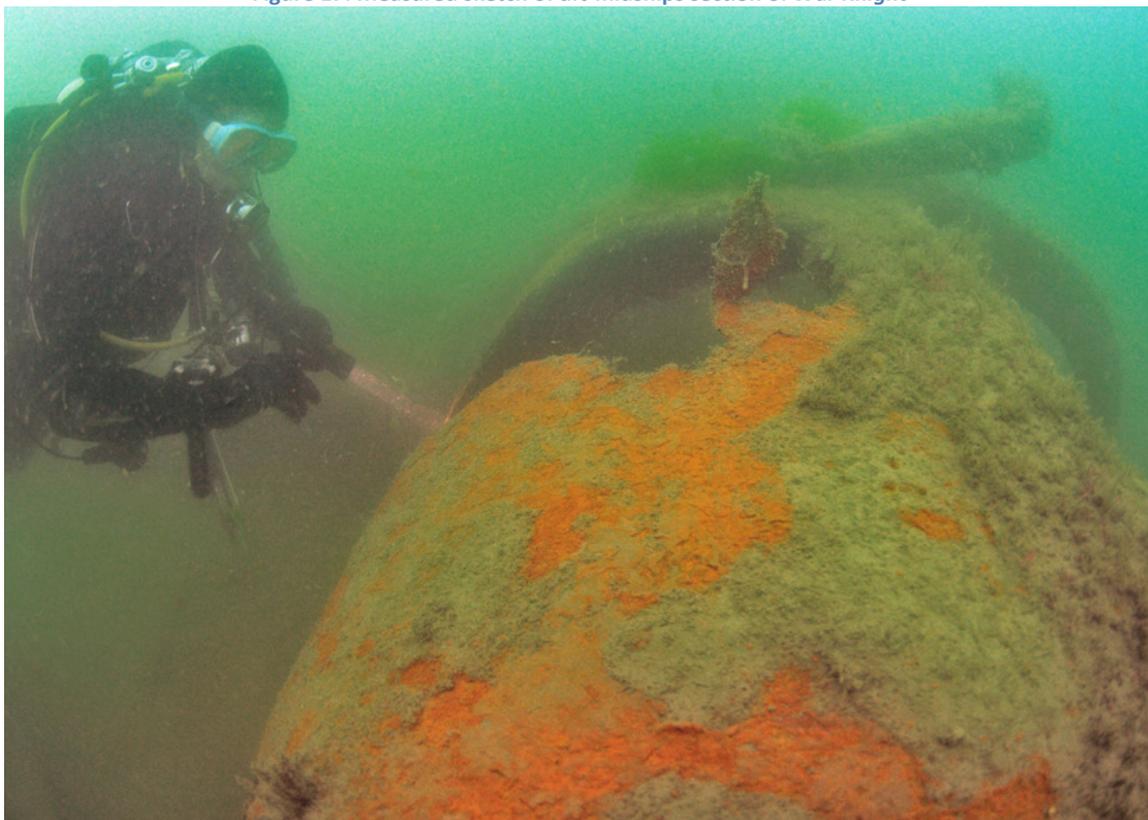
Figure 18: Looking into the propeller tunnel (photo Roland Brookes)

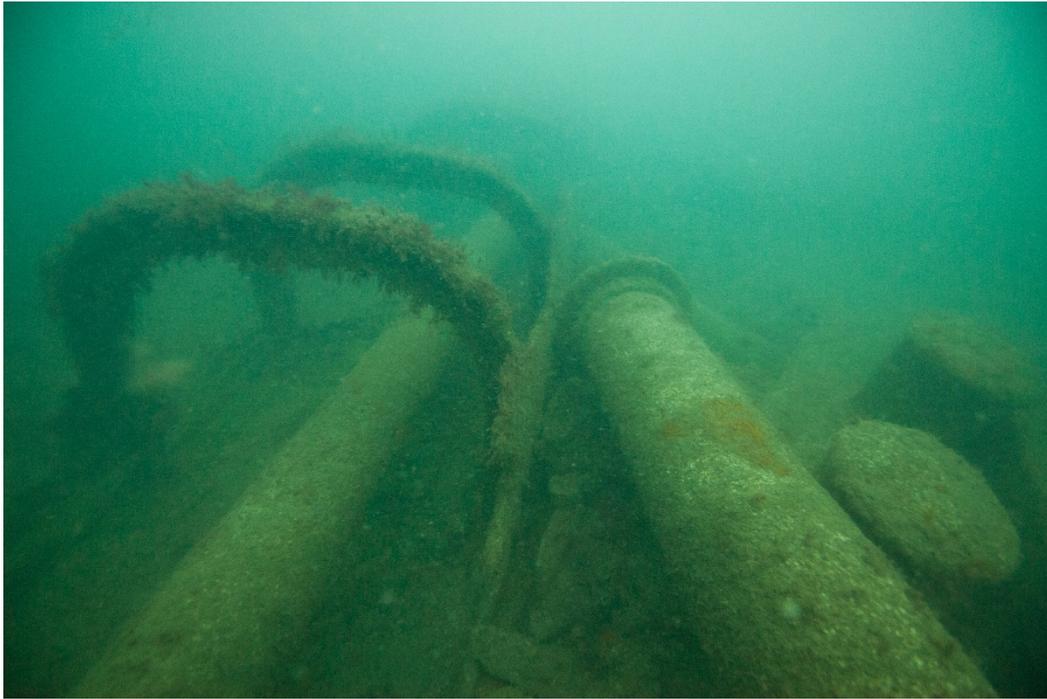
Figure 19: Propeller shaft and tunnel arches

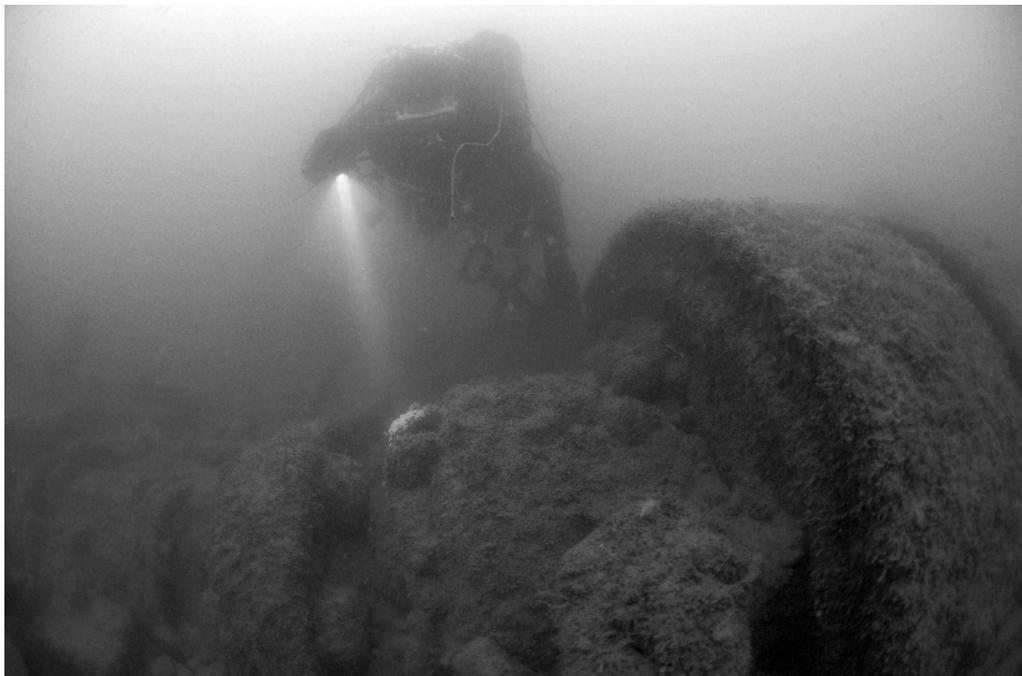
The wreck lies close inshore amongst rocks on the seabed, shingle is interspersed between the rocks. The remains of the *War Knight* are in reasonable condition and the extent remains are still very distinguishable having endured fire, a mine explosion and gunfire sinking. Many features are still identifiable considering the wreck has been heavily salvaged, and the wreck has also survived the natural process of being in an area of shallow water close to shore for 100 years. Some features of the wreck, such as the turbine engine, are still moderately preserved (Figure 20).

Figure 20: Diver inspects the turbine engine (photo Roland Brookes)

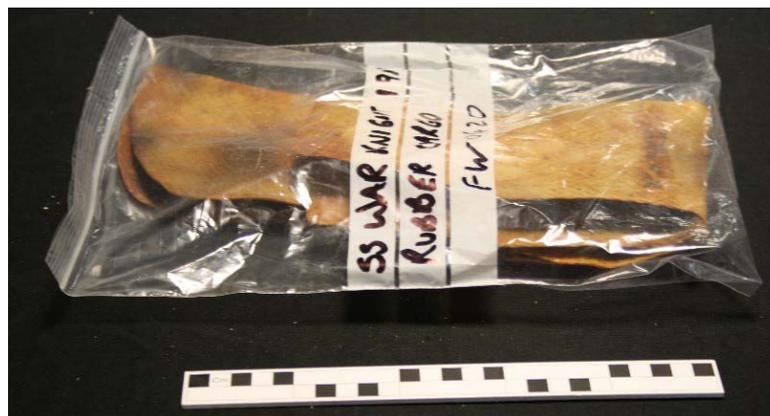
A piece of rubber cargo and a porthole are held in Martin Woodward's collection at the Shipwreck Centre on the Isle of Wight (Figures 21 and 22). An extract from *The Times* on 27 December 1963 (p5) reads 'Freshwater, Isle of Wight Dec 26. Beachcombers in the south-west of the Isle of Wight reaped a rich harvest for Christmas by salvaging scores of bales of raw rubber washed up from the wreck of the cargo vessel *War Knight* which sank off Freshwater Bay in 1918. The finders received a £4 a bale salvage money for the rubber, described as being as perfect as on the day it was shipped'.

Figure 21: Rubber cargo from Martin Woodward's collection

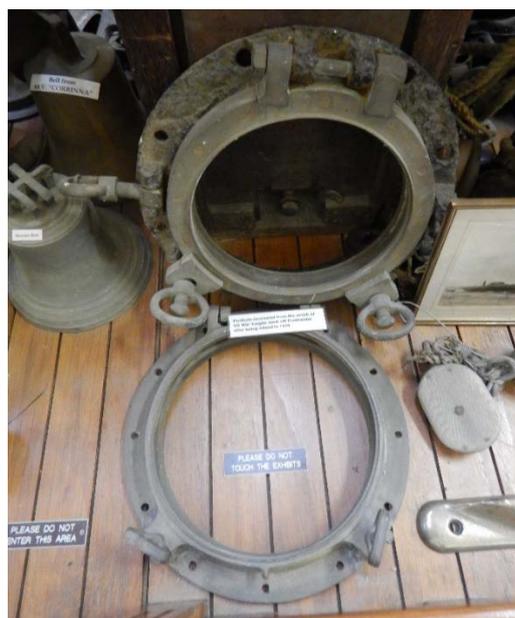
Figure 22: A porthole from the *War Knight* on display at the Shipwreck Centre (Martin Woodward collection)
