Forgotten Wrecks
of the
First World War

SS Molina
Site Report

***SS MOLINA*
SITE REPORT**

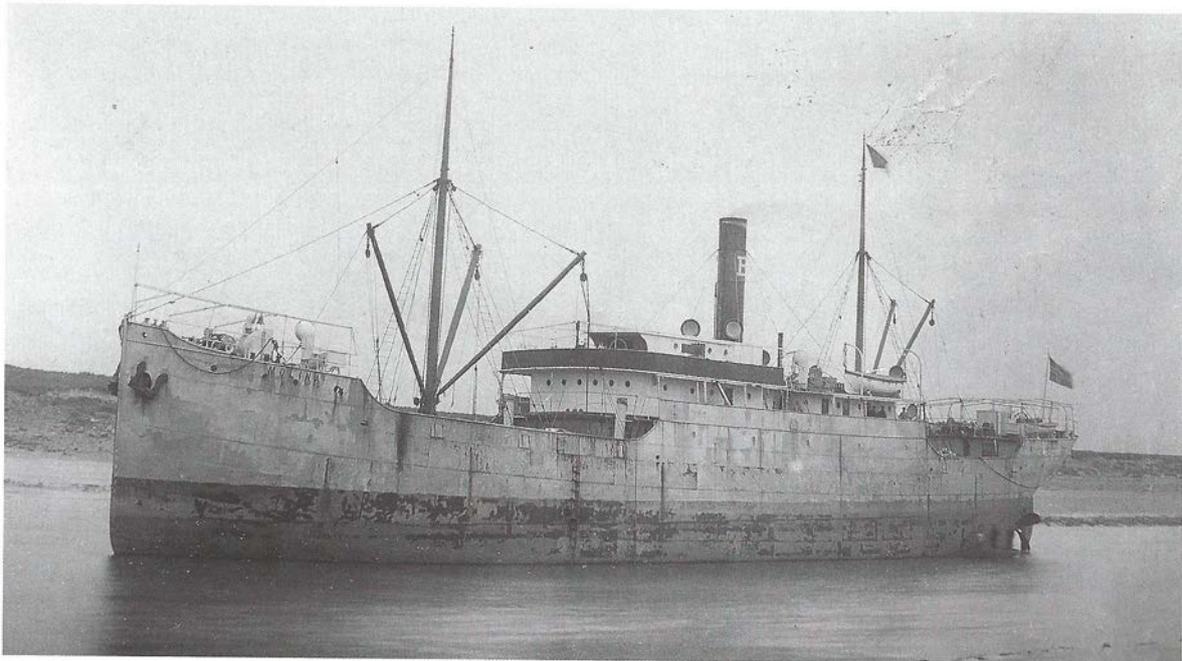
Figure 1: *SS Molina*

SS Molina was chosen as one of the Forgotten Wrecks case study sites because it is an example of a Norwegian Steam Ship (Figure 1). The vessel represents one of a number of ships sunk that were under the flag of a neutral nation during the First World War.

SS Molina was built by Nylands Vaerksted, in Christiania and completed in 1905, the vessel class was DAV1A1. The ship was a steel screw steamer with one deck, it was fitted with electric lights and had a gross tonnage of 1122. The 229 ft (c.70m) long ship had a beam of 36ft (c.11m) and was powered by a three cylinder triple expansion engine with two single ended boilers and 109 nominal horse power (WreckSite EU, 2001-2017; Wendes, 2006).

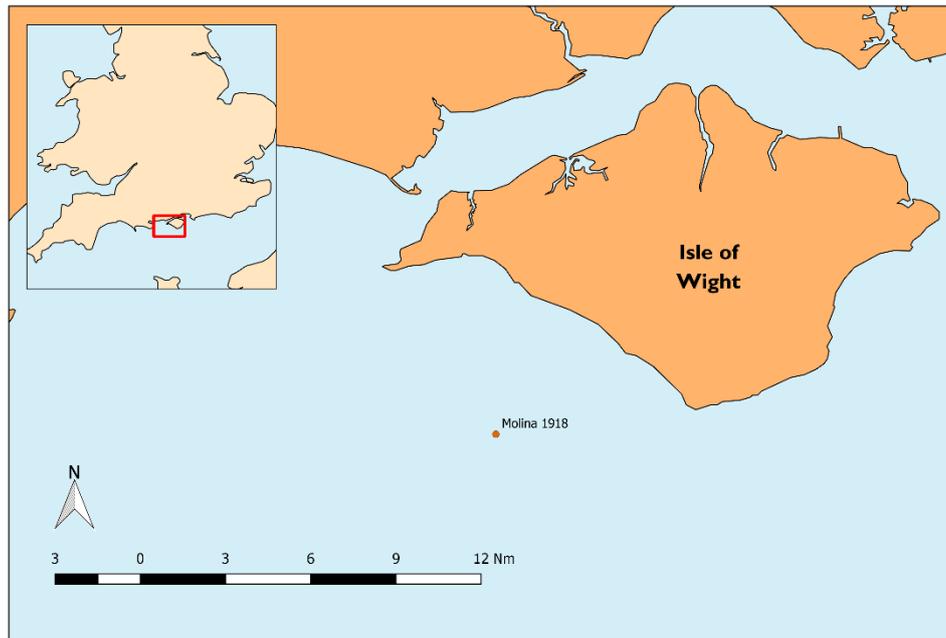
Figure 2 Position of the *Molina* shipwreck

The position the ship was struck is 50.56278 -1.4827 WGS84 (UKHO), three miles west of St Catherine's Point (Figure 2). It rests on a sand and shingle seabed.

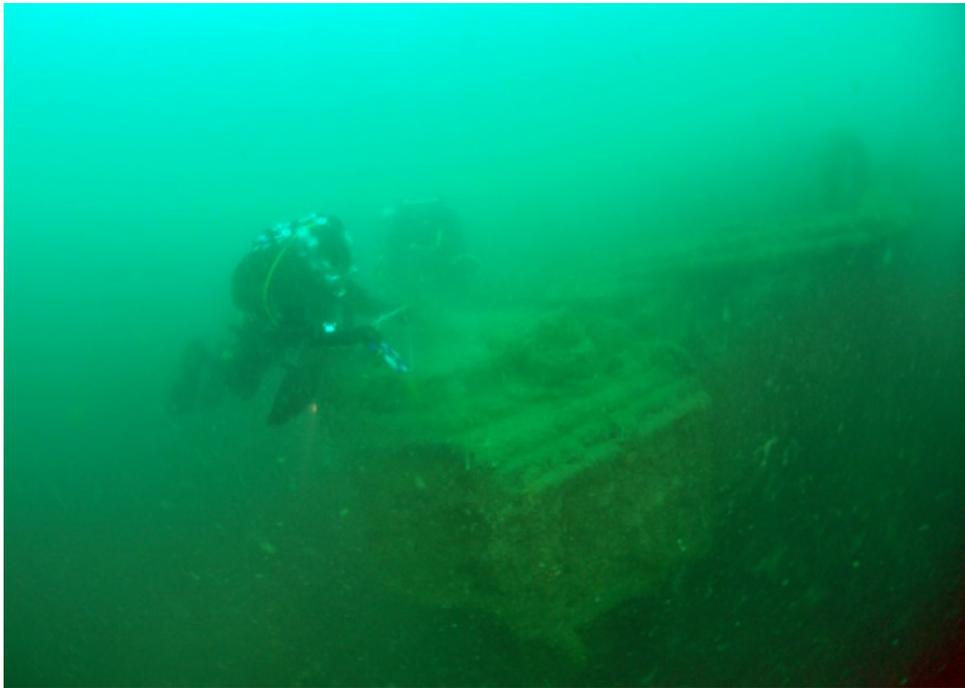
Figure 3: Divers at the triple expansion engine (image Roland Brookes)

The *Molina* sits upright on a seabed of sand and shingle in around 35m of water. It is orientated NE/SW with the bows to the NE. A multibeam survey in January 2012 reported the length of the wreck at 65m and the width 13m, with scour 2.5m deep to the north and south of the wreck (PastScape). The forward end is fairly intact from amidships forward, whilst the aft end of the ship is flattened. The

highest part of the wreck stands around 6m high which is the boiler and the triple expansion engine which can be seen in Figure 3. The approximate measurements of the three pots of the engine (in diameter) are 50cm first pot, 80cm middle pot and 122cm top pot (Figure 4).

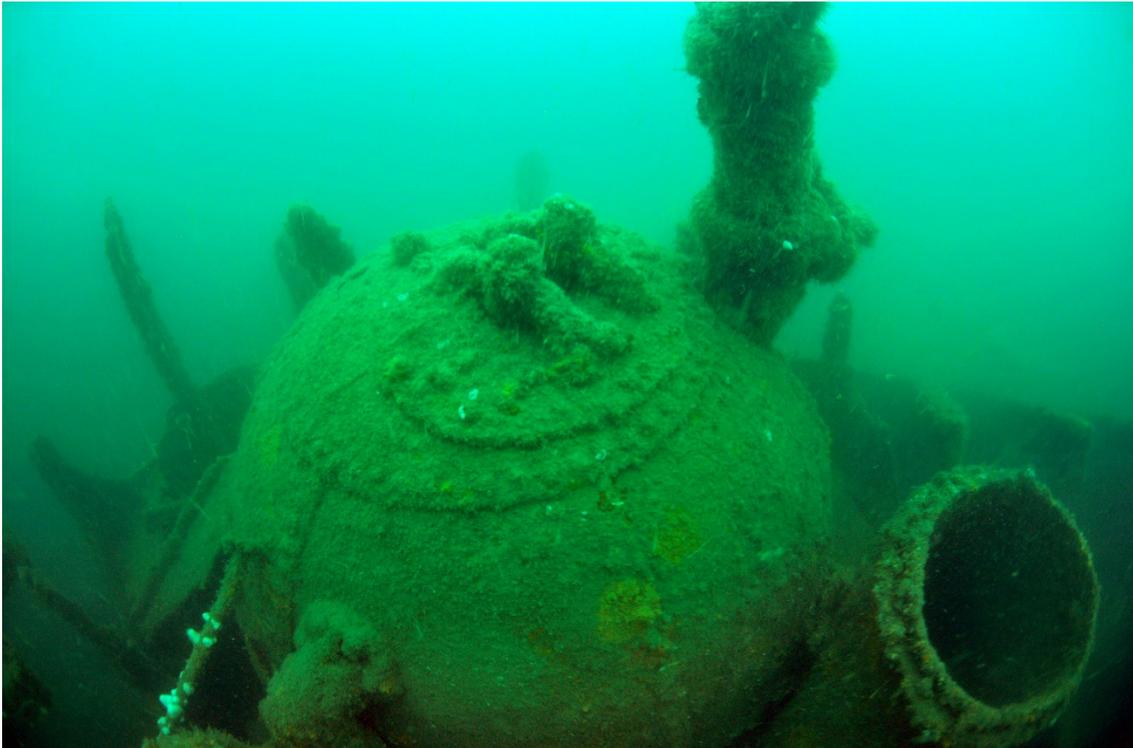
Figure 5: Donkey boiler (image Roland Brookes)

Forward of the engine lie the two boilers and there is also a donkey boiler present (a small boiler which is used to run the ships auxiliary engines when the main boilers are cold) (Figure 5).

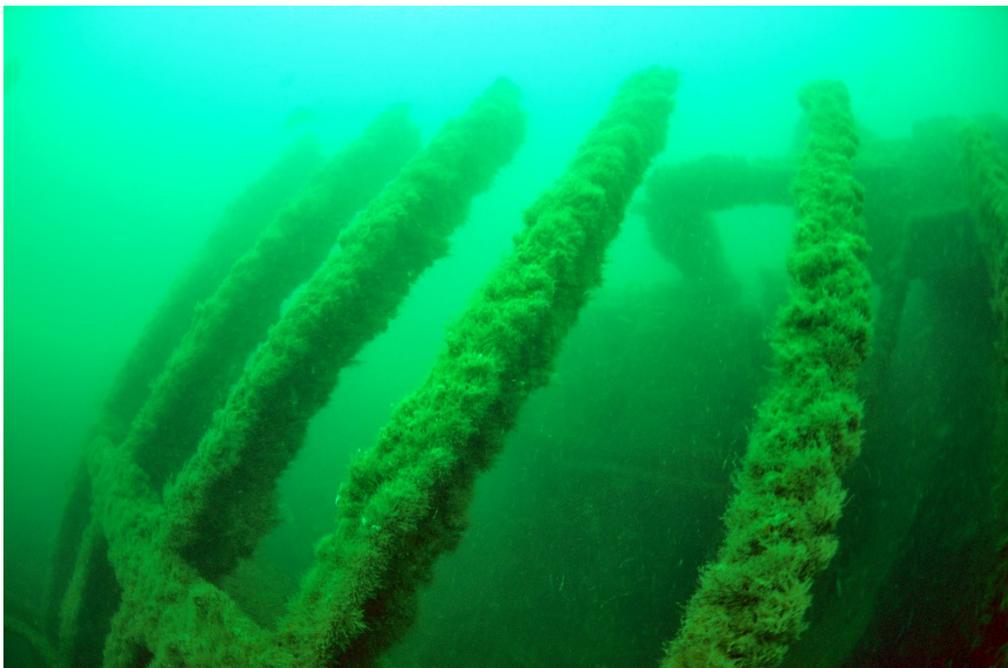
Figure 6: Ribs on Port side (image Roland Brookes)

On travelling towards the stern of the vessel the remains begin to flatten as more ribs become apparent and the sides of the vessel are collapsing (Figure 6). Lots of structure is still recognisable including hatches and combings but further dives would be required to generate a full plan of the vessel. Go pro video footage was taken by divers around the wreck and a short annotated video tour produced and posted on You Tube (Maritime Archaeology Trust, 2017). The deck is evident in many places and its possible to look down amongst the fallen structure into the holds.

The condition of the *Molina* is consistent with what might be expected of a wreck that has survived the natural processes within the area in which it lies for nearly 100 years. Although the remains are partially broken down particular at the stern of the ship which is reported to have been destroyed by the torpedo, some aspects of the ship are still quite well preserved.

The significance of this site is that it is an example of a vessel that was neutral in the First World War being a Norwegian ship. It has a triple expansion engine and is still somewhat intact but it is now just over 100 years old and is beginning to break down. Further diving on this site to obtain a site plan and possible photogrammetry to record it in more detail when conditions allow would be a lasting legacy for the record and future generations, and preserve the ship for historical research and public information.

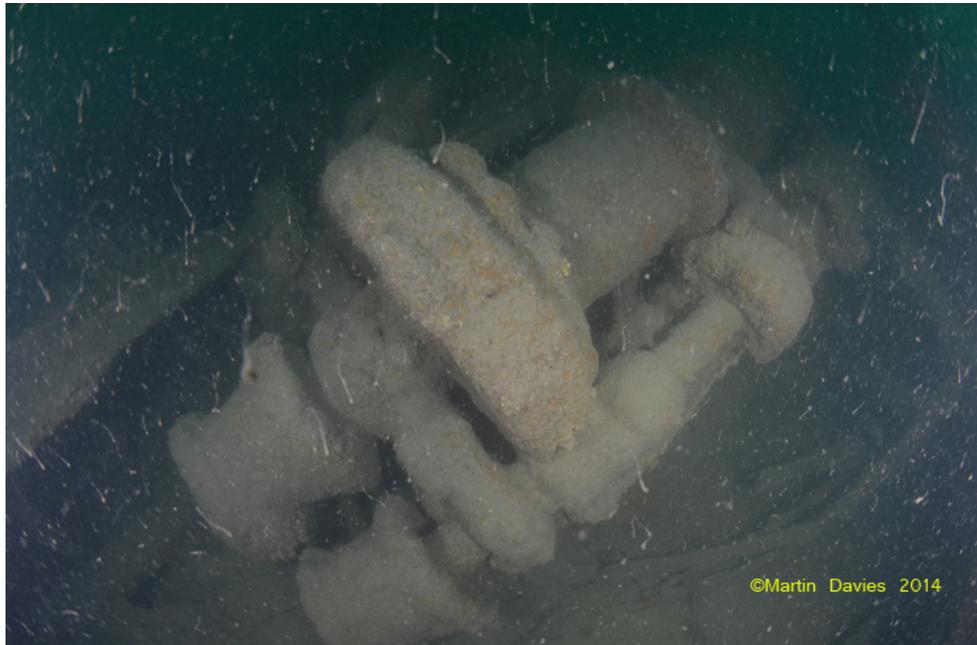
Figure 7: Winch near the stern (image Martin Davies)

Towards the stern a deck winch lies with two bollards nearby (Figure 7). At the stern, the bronze propeller is reported to have been raised by salvage divers and it had two blades missing (Wendes, 2006). No armament is present as *SS Molina* was sailing under the neutral flag of Norway, and therefore, was unarmed.

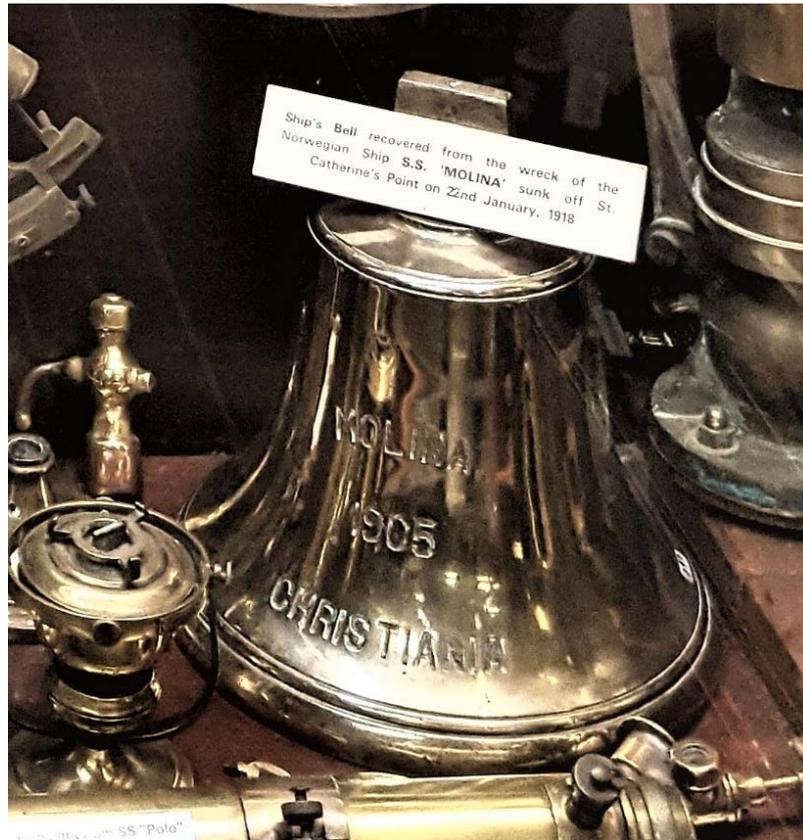
Figure 8: Ship's bell on display at the Shipwreck Centre and Maritime Museum, Isle of Wight

The bell, bearing the ships name, was recovered from the foredeck by Martin Woodwood, this helped to positively identify the wreck. The bell is on display at the Shipwreck Centre and Maritime Museum at Arreton on the Isle of Wight.

- Fixtures and fittings: Brass ships bell bearing the ships name and 'Christiania' (330mm high) and builders nameplate.
