Forgotten Wrecks
of the
First World War

May
2018

SS *Western* *Coast*

Site Report

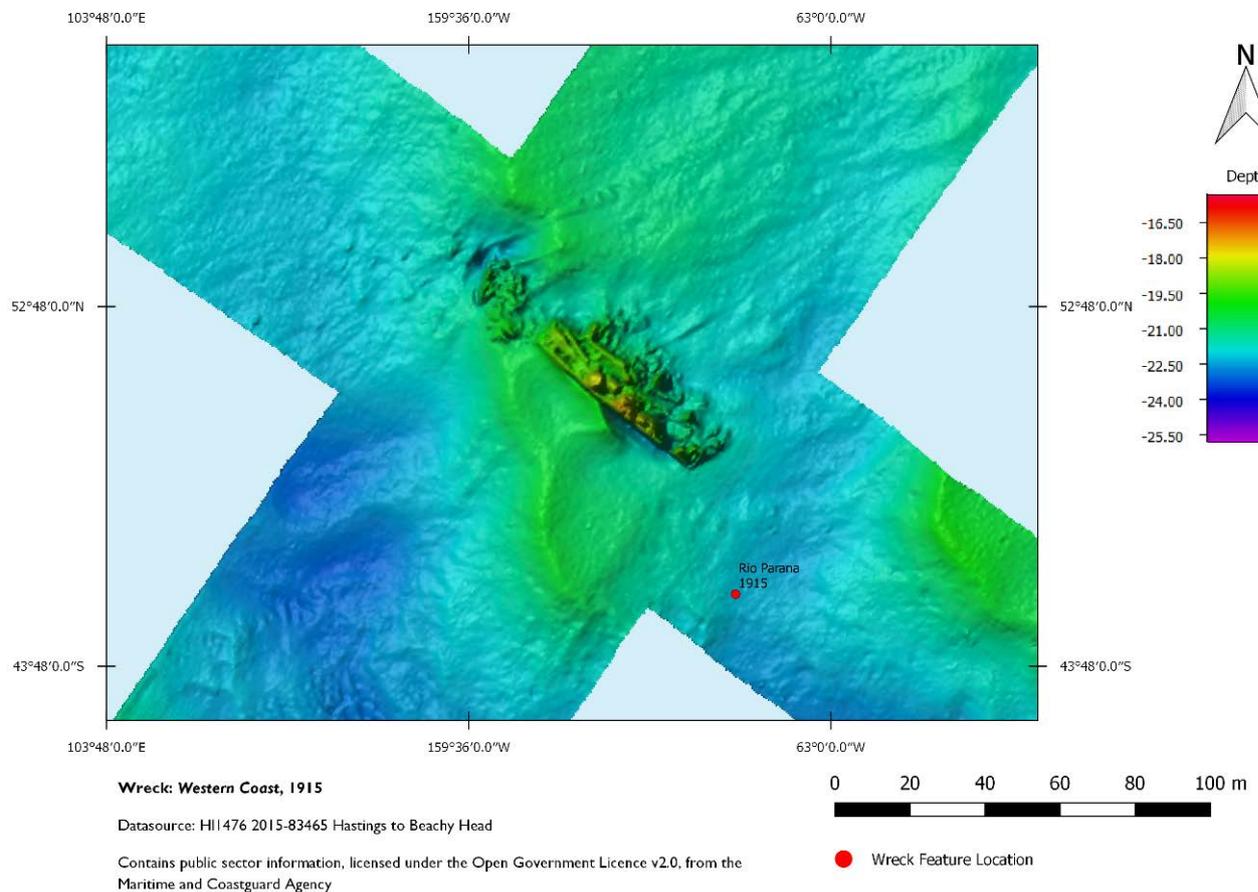
Figure 3: Geophysical image of the *Western Coast* (Maritime and Coastguard Agency' data source: HII476 2015-83465)

The geophysical image of the *Western Coast* shows that the amidships section of the wreckage is fairly intact with the port side of the wreck being quite collapsed (Figure 3). The two boilers can be seen in their orientation in the middle of the wreck site. Scour is apparent from amidships forward on the starboard side of the ship. A closer annotated view is shown in Figure 4.

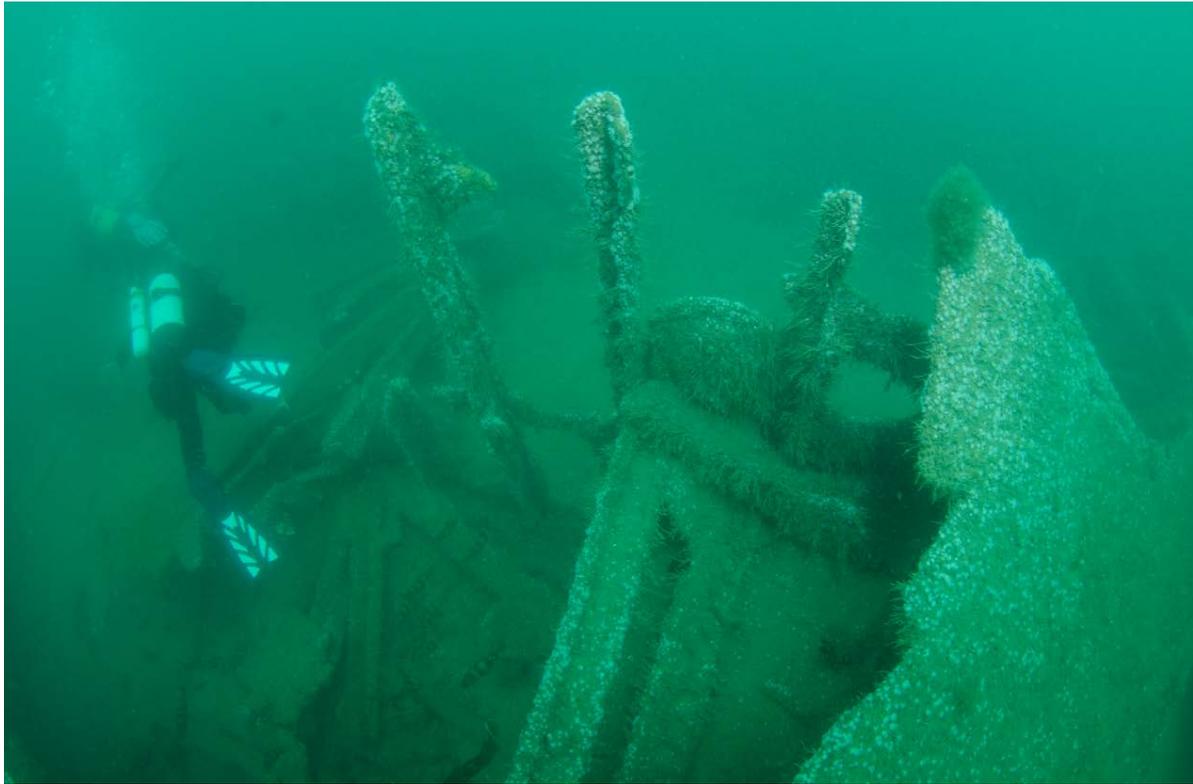
Figure 5: The port side of the ship is breaking down

The starboard side of the ship is quite intact and upstanding whereas the port side has broken down with some upstanding frames visible but other areas considerably collapsed (Figure 5). A measurement taken of the wreck remains is 85m from bow to stern.

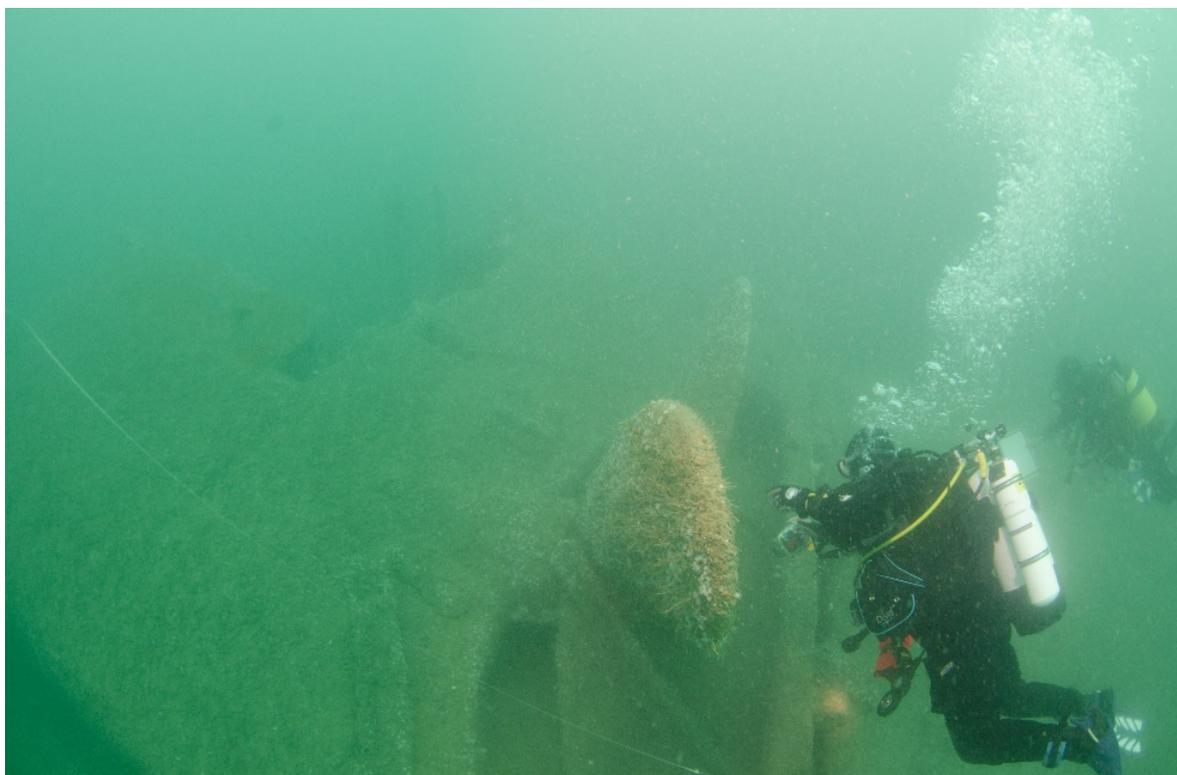
Figure 6: Diver measuring and photographing the propeller

The propeller stands up at the stern with the rudder having collapsed onto the seabed on the port side. The length of each blade of the three bladed propeller is 180cm by 90cm wide with the central section (boss) having a diameter of 65cm (Figure 6 and 7).

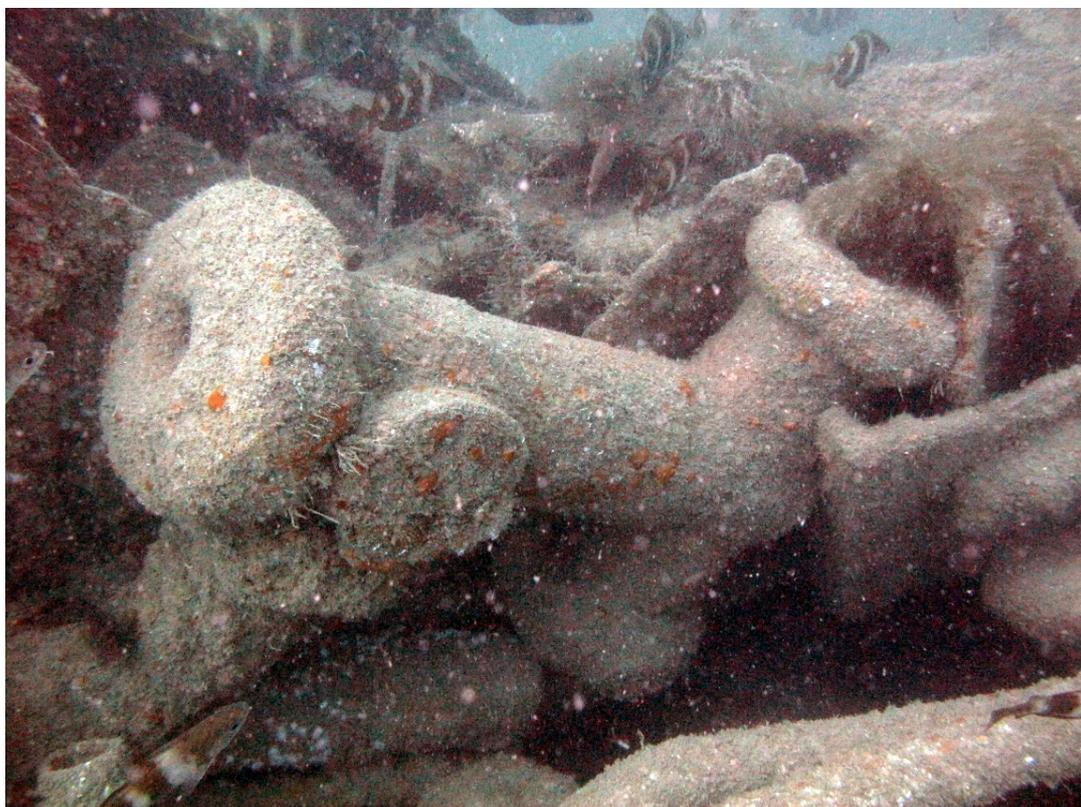
Figure 8: Pipes and structural components

Moving further forward along the wreck, the starboard side is a mixture of plates, pipes and structural remains, divers did not find any evidence of the general cargo the ship was carrying (Figure 8).

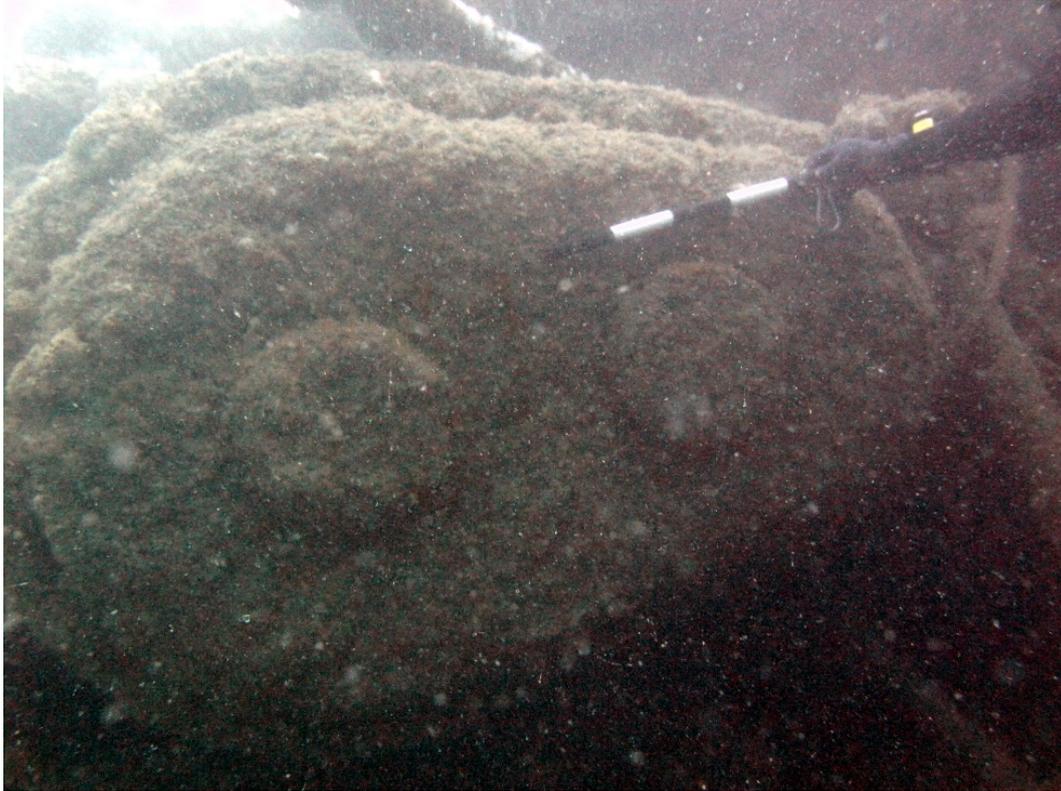
Figure 9: Engine cover

The propeller shaft is present running forwards from the propeller, reaching a muddle of machinery in the centre of the wreck until 25m from the stern where the three cylinder triple expansion engine is located. Two small heads are exposed, the length of the cover of the pistons is 139cm with the diameter of the pistons measuring 27cm. The exhaust steam pipe is present which leads to the condenser (which is missing) (Figure 9).

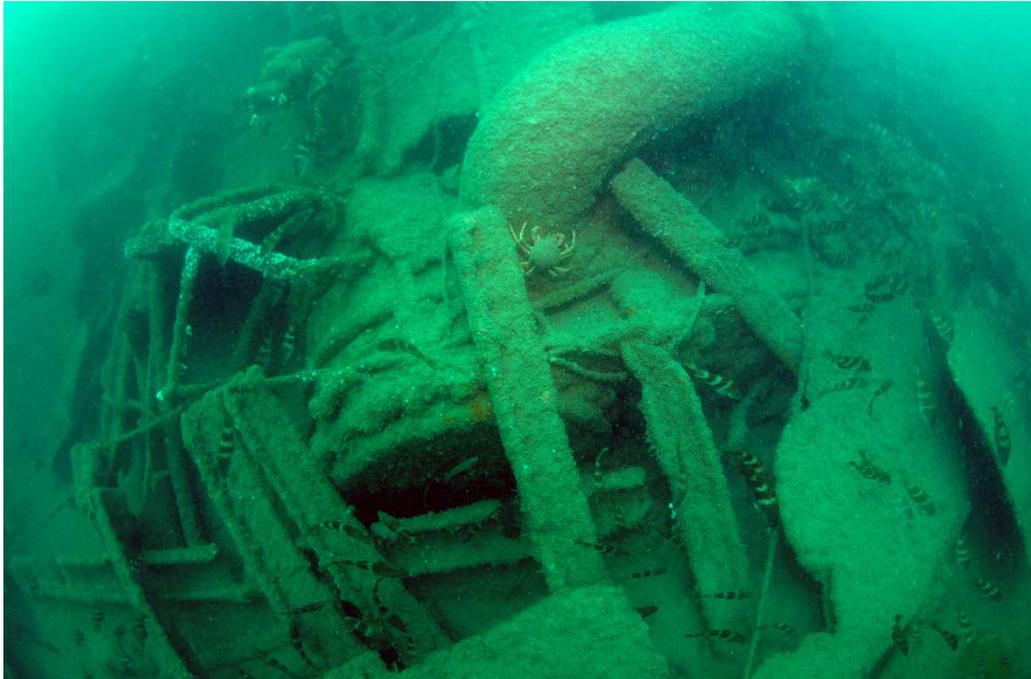
Figure 11: Horizontal boiler amongst broken down structure

Just in front of the engine one of the boilers lays horizontally amongst broken down fittings (Figure 11). The second boiler stands vertically near, and to the side of it measuring 4.26m in diameter and being around 32m from the stern of the vessel.

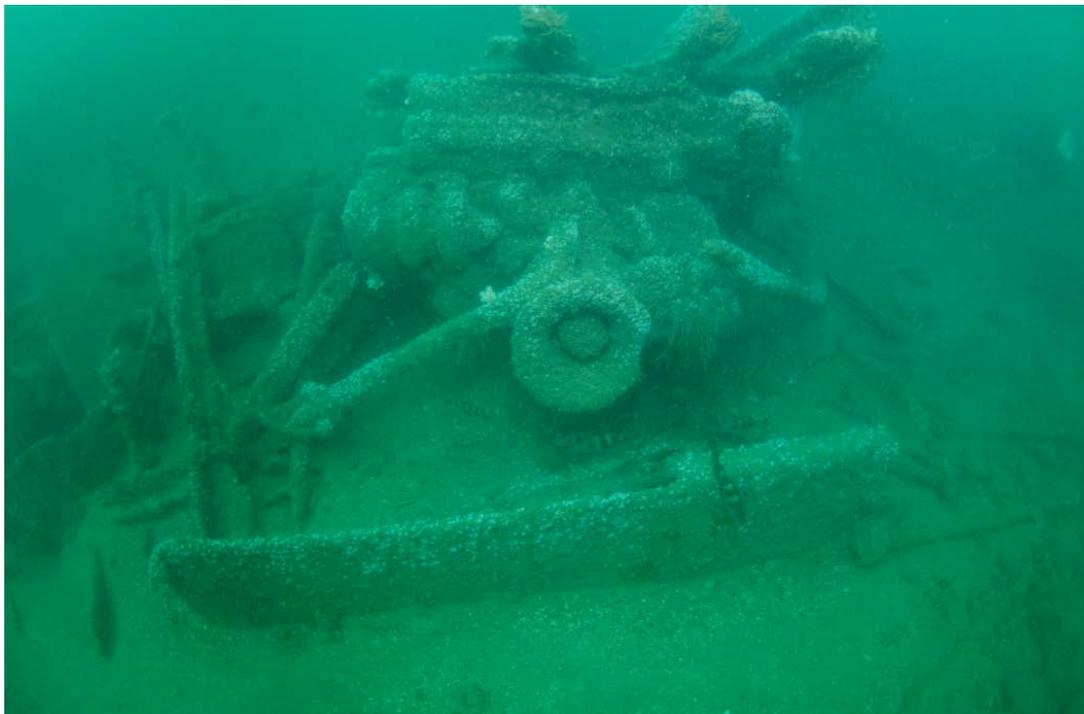
Figure 12: Windless near the bow

Near the bow there is a winch or windlass (Figure 12), and an anchor is evident amongst the piles of broken down plating scattered around. A chain is also present lying on the seabed around the bow area (Figure 13).

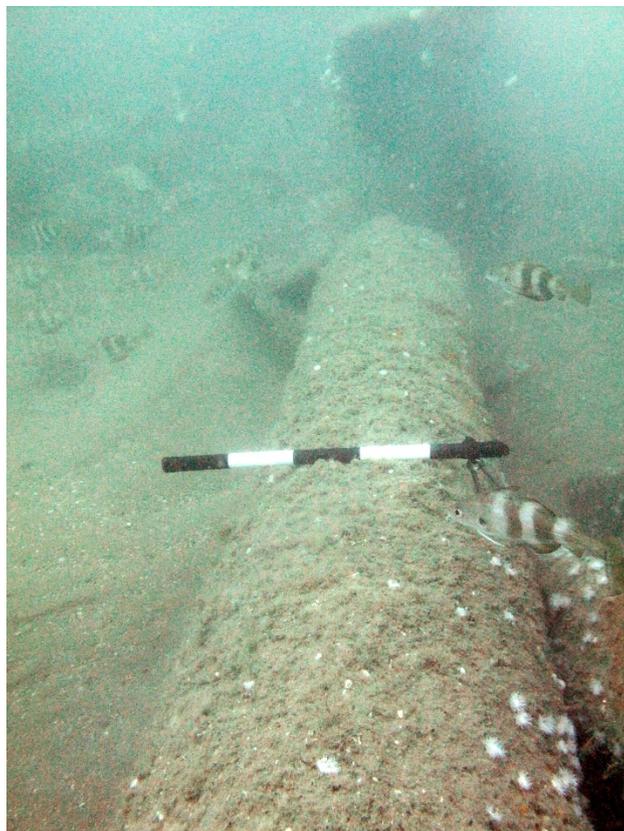
Figure 14: Possible mast

Aft of the windlass is an object lying horizontally which appears to be a possible mast with crow's nest (Figure 14). The bow has broken down and is level with the seabed and there are bollards amongst the wreckage in a range of sizes.

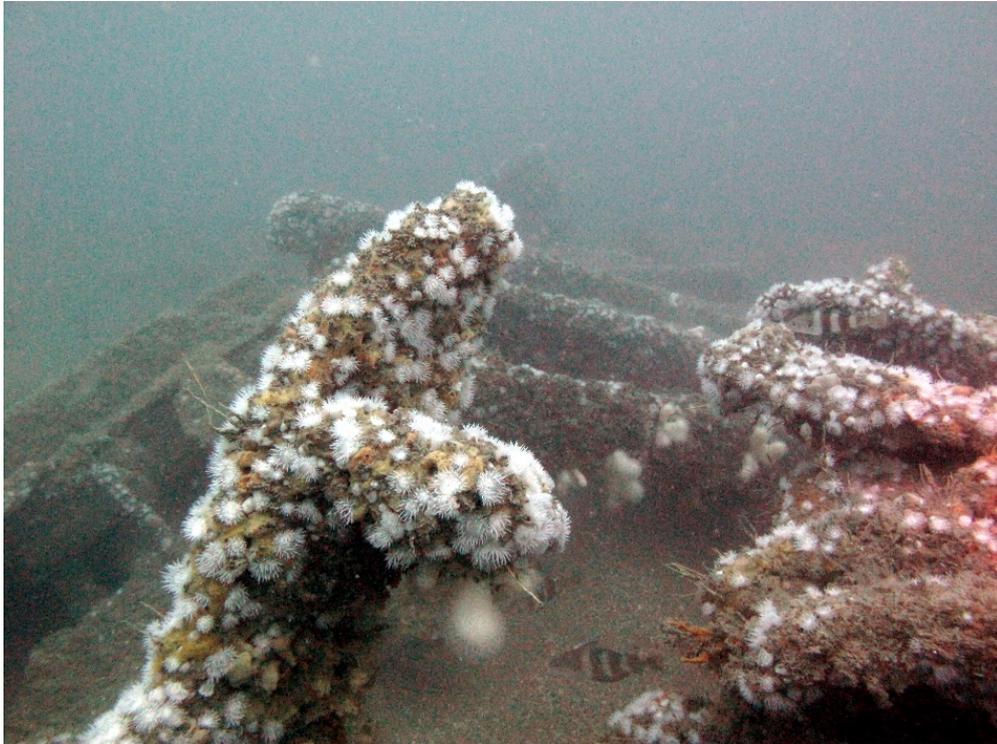
Figure 15: Marine growth on remains of the wreck

The condition of the *Western Coast* is consistent with what might be expected of a wreck that has survived the natural processes under water for nearly 100 years. Although the remains are partially broken down many aspects of the ship are still moderately preserved. A large amount of marine growth has colonised the remains such as sponges and anemones (Figure 15 and 16).
