Forgotten Wrecks  
of the  
First World War

# *SS Pandion*

## Site Report

## ***SS PANDION* SITE REPORT**

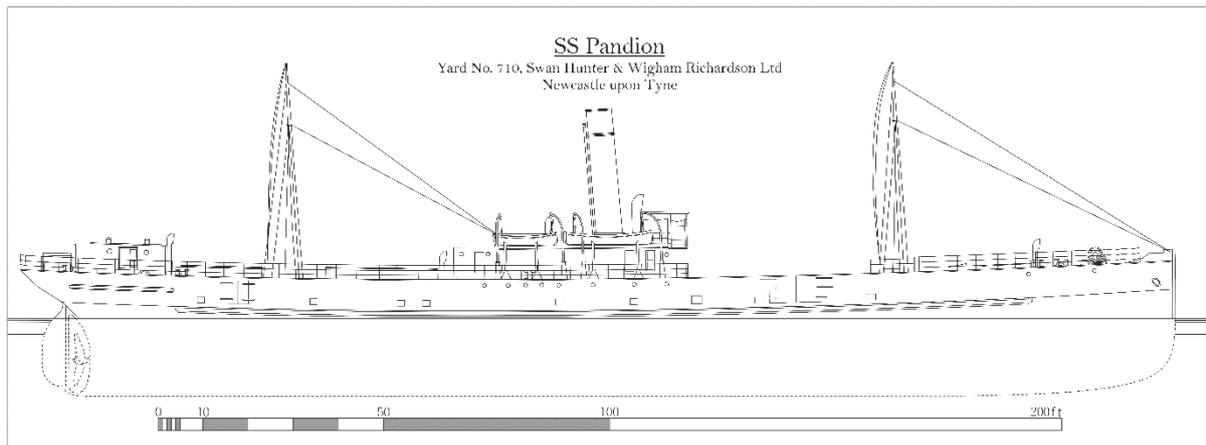
Figure 1: Drawing by Dave Wendes of SS *Pandion* built 1904 based on the original ships plan (with permission from Dave Wendes)

There were three ships of the same name, one built in 1904 and lost in 1917 (which is the subject of this report), another *Pandion* built in 1917 and a third *Pandion* built in 1926. A drawing by Dave Wendes (Figure 1), and the ships plans from the Tyne and Wear Archives (Figure 2) are those of the *Pandion* built in 1904 (Dave Wendes (2015) pers. comm).

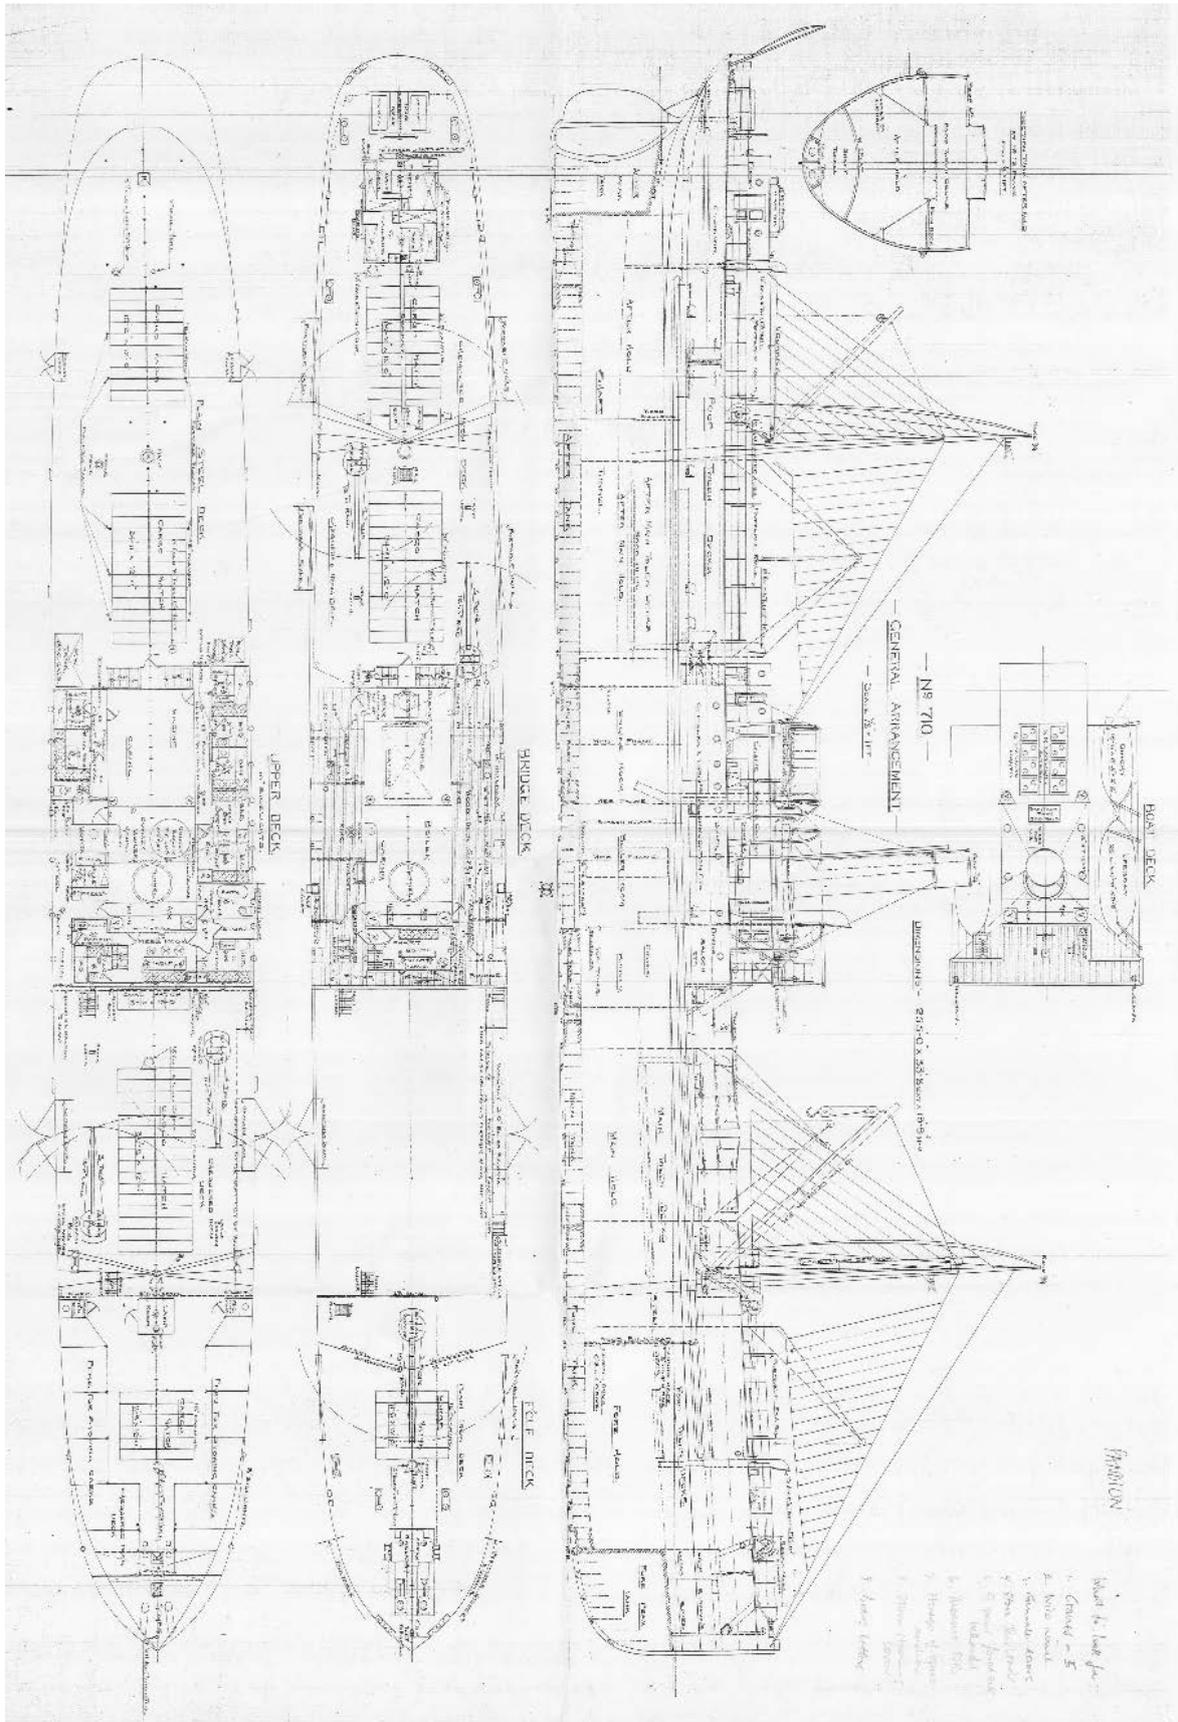
SS *Pandion* was built by Swan Hunter & Wigham Richardson Ltd in Newcastle upon Tyne and completed in May 1904. The ship was a steel screw steamer with one deck, a well deck and fitted with electric lights. Its propulsion was steam with a triple expansion three cylinder engine and two single ended boilers, a new donkey boiler was fitted in 1912. The 255ft 4in (c.77.72m) long ship had a beam of 33ft 7in (c.10.24m) and a gross tonnage of 1279 tons (Wrecksite EU, 2001-2015).

The 1904 *Pandion* had deck cranes (according to the plans) but it is uncertain if the later *Pandion*'s also had cranes (but it is possible). The plans from the 1904 *Pandion* show that the ship had access doors in the side of the hull (see ships plans section 3.1) but the *Pandion* on the photograph in question does not have these. There is also the possibility that the plans were altered during the building of the ship (Dave Wendes (2016) pers. comm., 14 July).

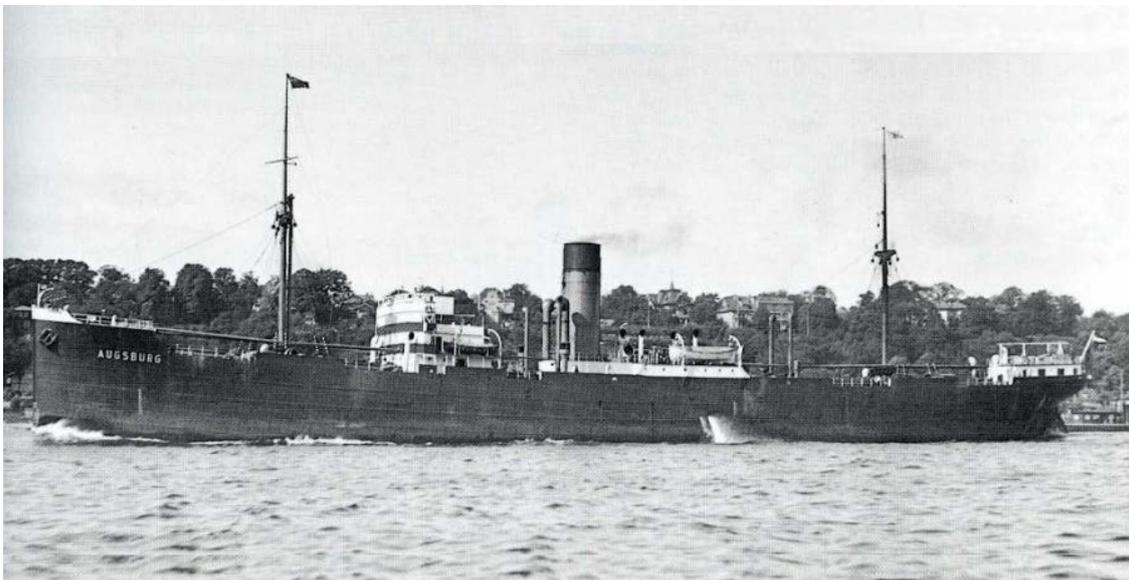
Figure 3: SS *Northwestern Miller* when named the *Augsburg* (Tyne built ships claim no copyright as in the public domain, but they credit 'courtesy of George Robinson')

The *Northwestern Miller* was built by Northumberland Shipbuilding Co Ltd in 1914 and owned by the Norfolk and North American Steam Shipping Co Ltd (Furness Withey & Co), Liverpool. In 1927 the ship was owned by Nordeutscher Lloyd, Bremen and renamed *Augsburg* (Figure 3), then Teikoku Kisen KK, Tokyo in 1941 and renamed *Teiryu Maru*. It was torpedoed by US submarine USS *Guardfish* on 19 July 1944 and sank 180 miles NW of cape Bojeador (Tyne Built Ships).

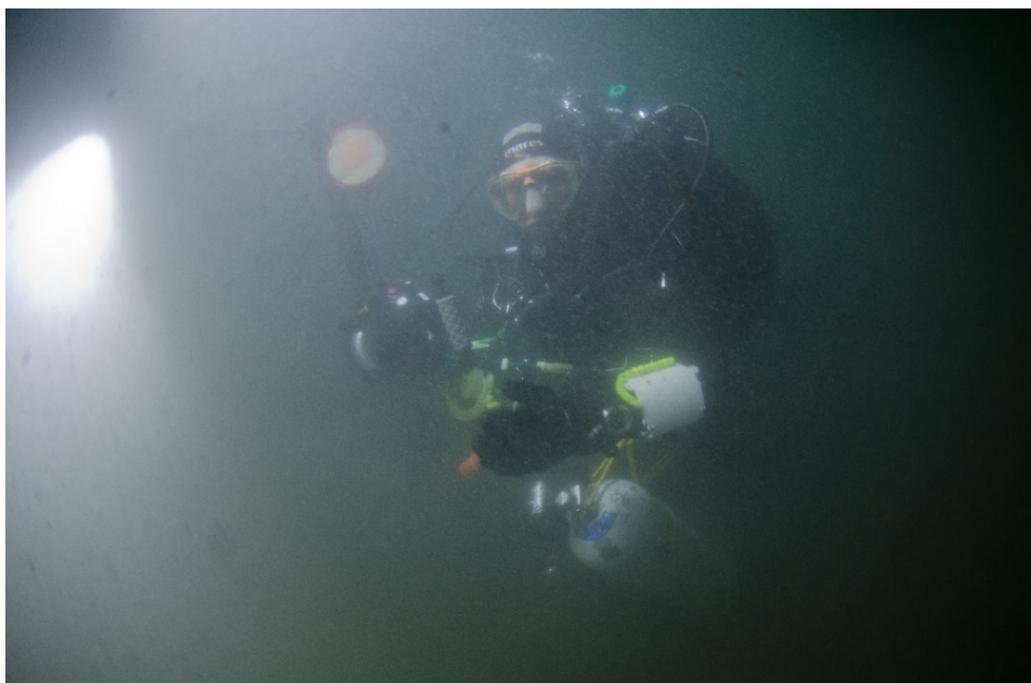
Divers reported that the wreck is listing over to its starboard side on a seabed of sand and gravel, the bows point towards the west. The dark conditions in very poor visibility hampered the divers from getting a clear picture of the remains (Figure 5). The highest part of the wreck stands around 6 meters. The hull remains are substantial with frames visible where the plating has fallen away (Figure 6), some areas near the centre of wreck structure appear to be a jumble of pipes and metal fittings (Figure 7).

Figure 5: Diver attempting photography in poor conditions diving the *Pandion*

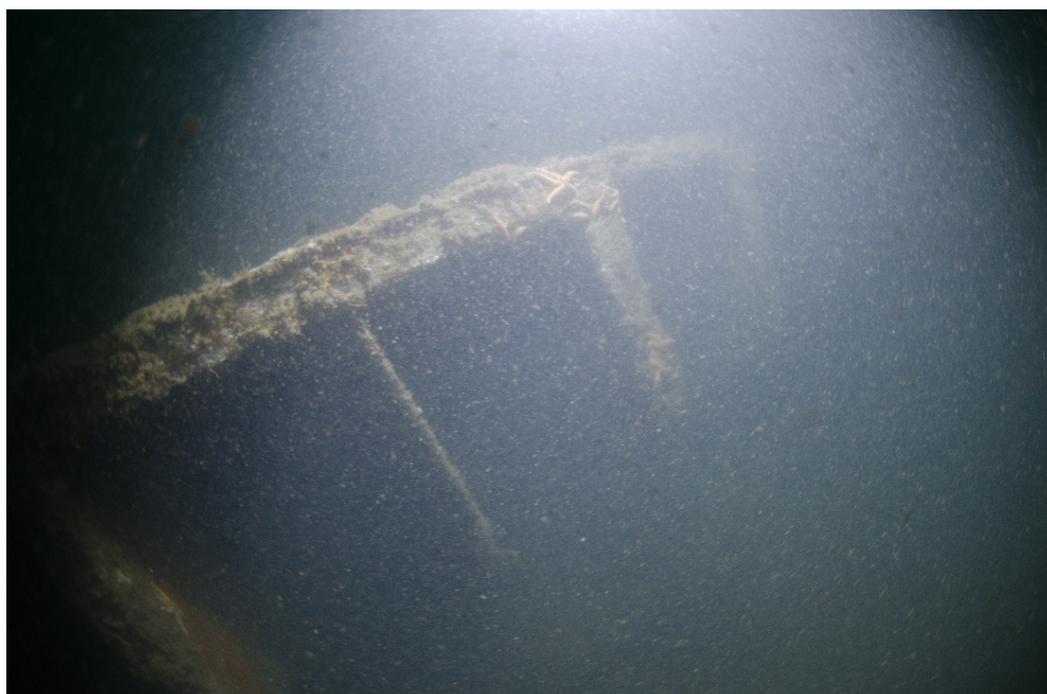
Figure 6: Hull frames of the *Pandion*

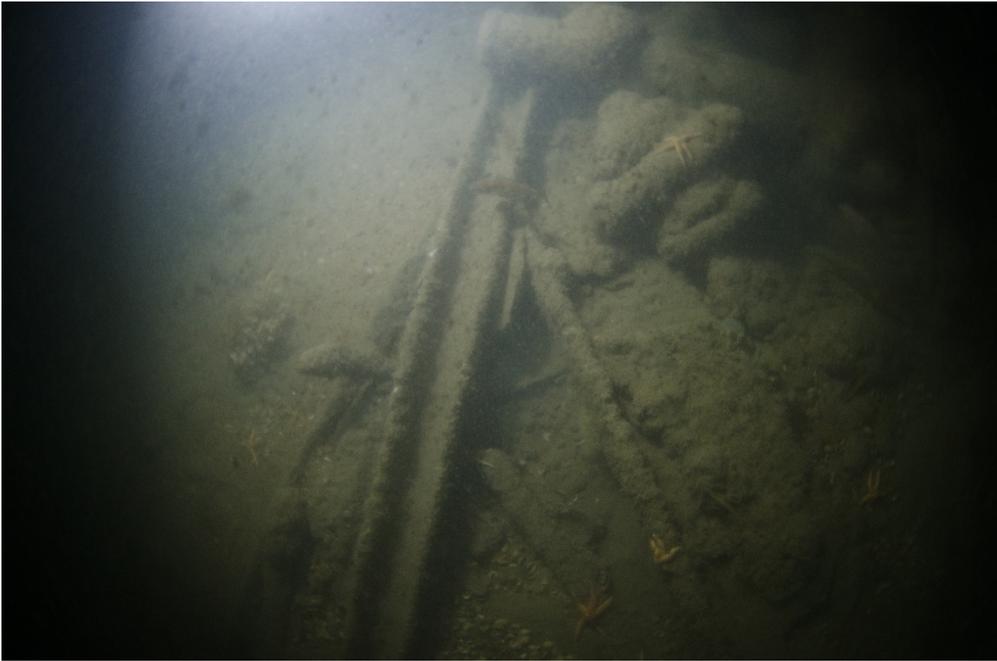
Figure 7: Jumbled fittings

The extent remains of the *Pandion* are quite coherent, but the area around the triple expansion engine has succumbed to corrosion and there are a jumble of rods, steam pipes and metal fittings in this area. Considering it has survived the natural processes under water for nearly 100 years it is still recognisable. Closer inspection in improved conditions will help clarify how intact the remains are and to try to positively identify the vessel by seeking out the specific features identified from the ships plans.

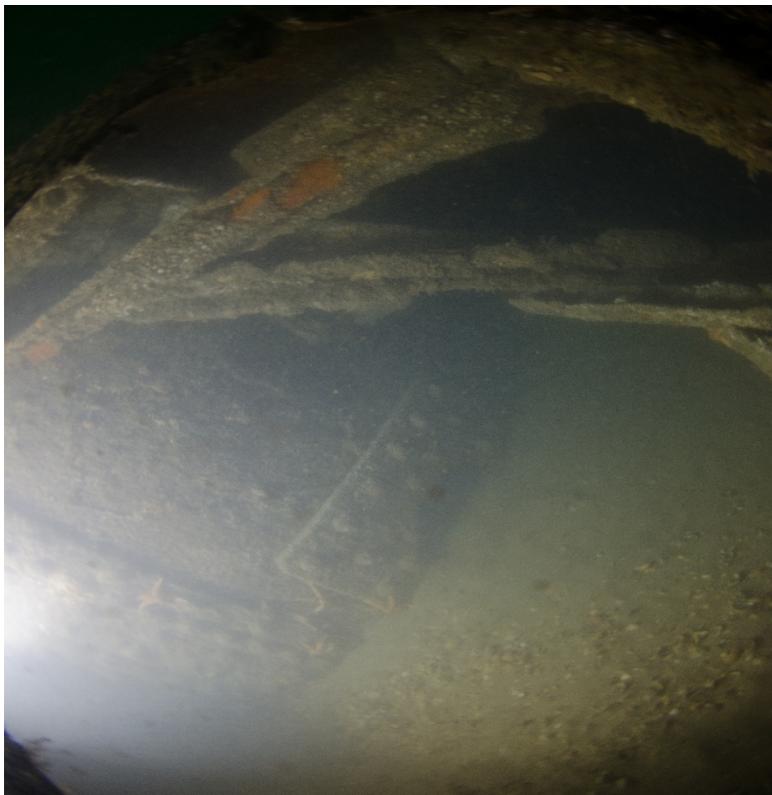
In the midships area, are two boilers which measured 360cm in length, in which rivets were observed to be present. They have rolled slightly, but are still in their original position forward of the engine. An inspection panel or gauge insert 50cm long is present in the starboard boiler and some broken down hull plating covers the port boiler (Figure 8). A toothed wheel along with a steam valve wheel is also apparent in this area.

Figure 8: Looking down through broken hull plating at the port boiler

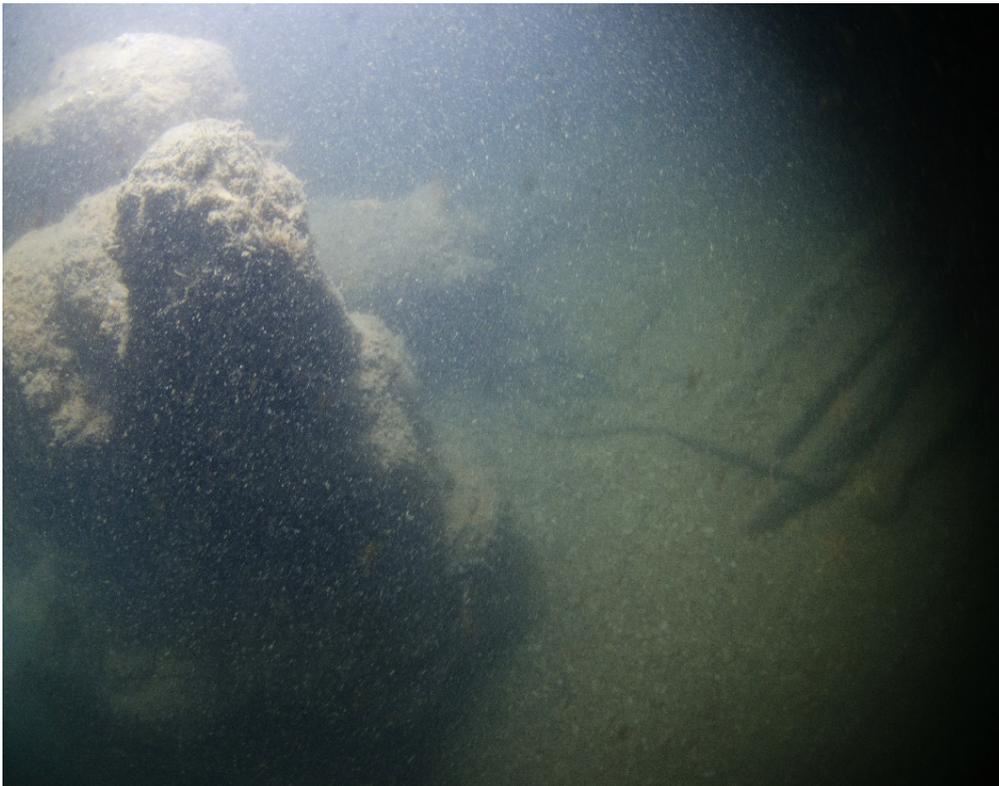
Behind the boilers, the triple expansion engine block has fallen upside down and the piston con rods stand horizontally (Figure 9, 10 and 11).

Figure 9: The engine block which has toppled over

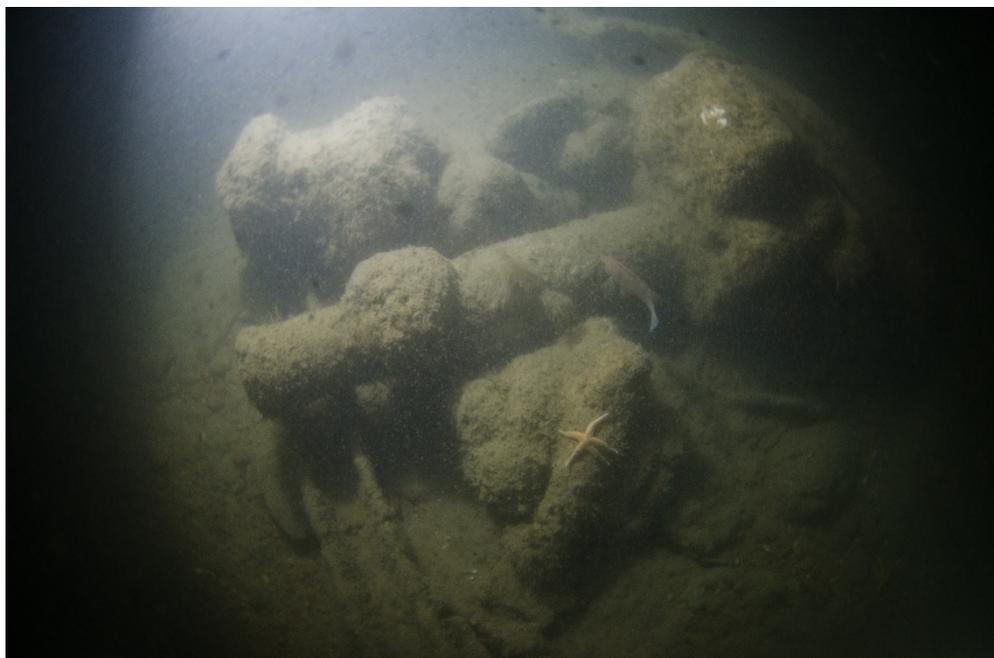
Figure 10: Parts of the conrod mechanism

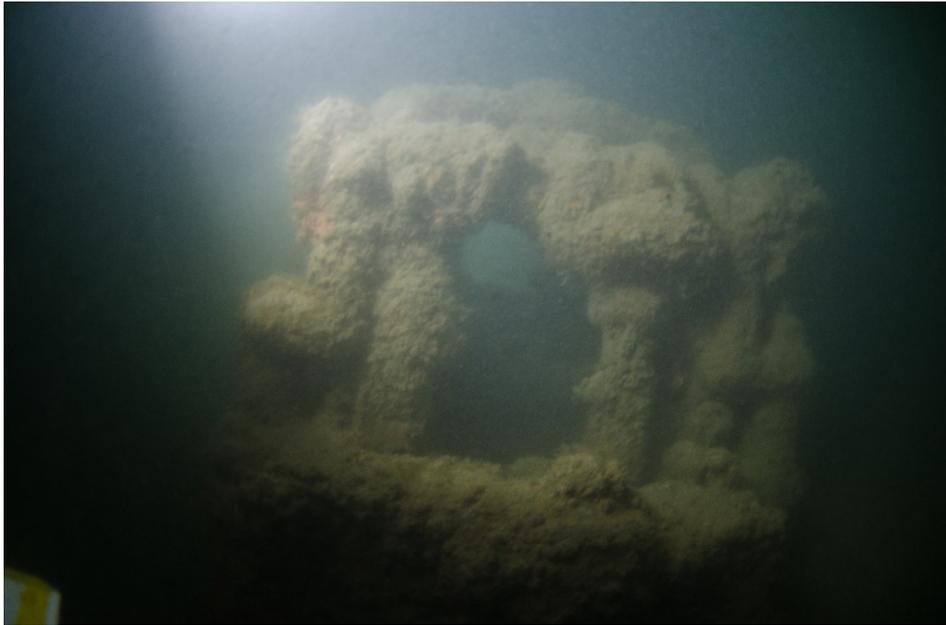
Figure 11: Part of the engine machinery

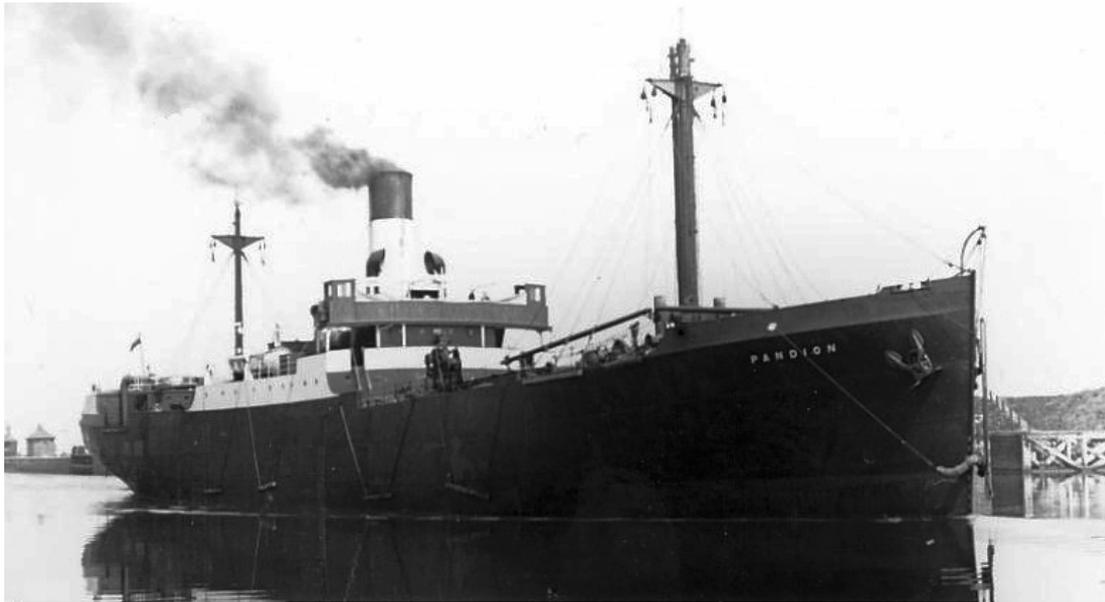
There is still some confusion over the true location of remains of SS *Pandion* as the position of the wreck investigated as part of this project does not equate to the position for the recorded loss. Other confusing factors are caused by the fact that that the *Pandion* in question was built in 1904 and was lost in 1917, another *Pandion* was built in 1917 and a third one was built in 1926. A photograph of the *Pandion* which was believed to be that built in 1904, does not adhere to the original ships plans, of which Dave Wendes has a copy, although there are similarities (Figure 12).

Figure 12: Image of the *Pandion* of 1904, but does not adhere to original ship's plans so probably not the *Pandion* in question (Tyne built ships claim no copyright as in the public domain, but they credit 'courtesy of Richard Cox')
